# NIST Technical Note 1629

## Fire Fighting Tactics Under Wind Driven Fire Conditions: 7-Story Building Experiments

Stephen Kerber  
Daniel Madrzykowski

April 2009

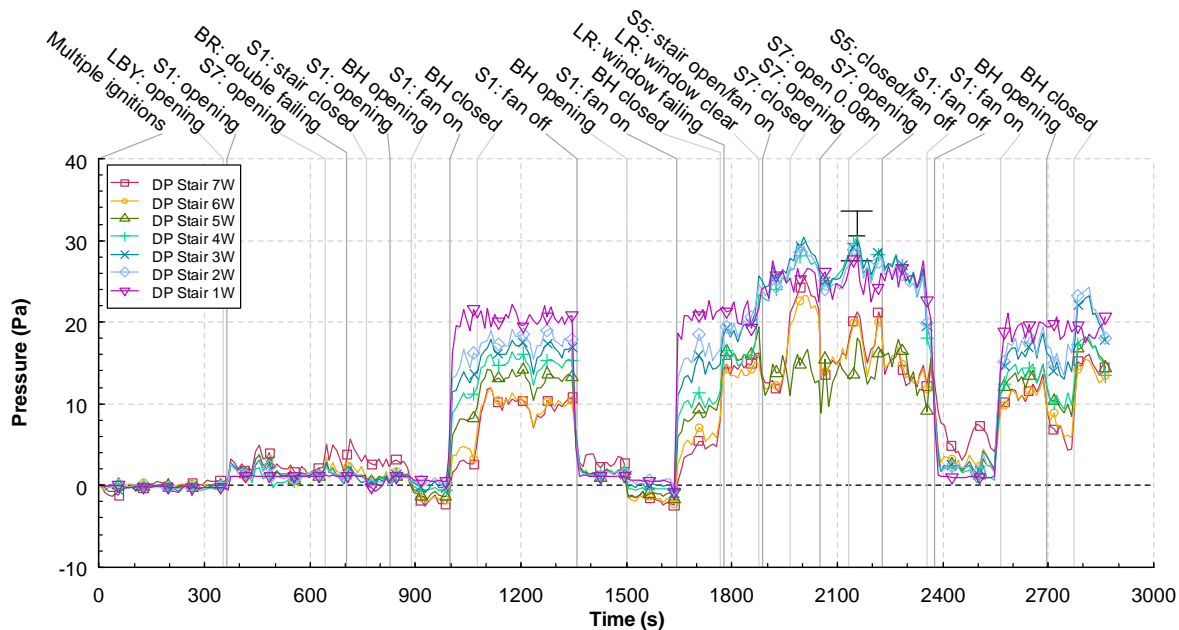
the pressures began to fluctuate but remained below 9 Pa. Opening the door at the top of the stairwell decreased pressures back to ambient conditions around 5 Pa. With the portable PPV fan operating at the base of the stair and the door to the 7<sup>th</sup> floor open the pressures averaged 13 Pa to 26 Pa. After a second portable fan was added on the 5<sup>th</sup> floor and the 7<sup>th</sup> floor door was open the pressures ranged from approximately 15 Pa to 30 Pa.

Figure 3.2-25. 7G2 stairwell pressures vs. time

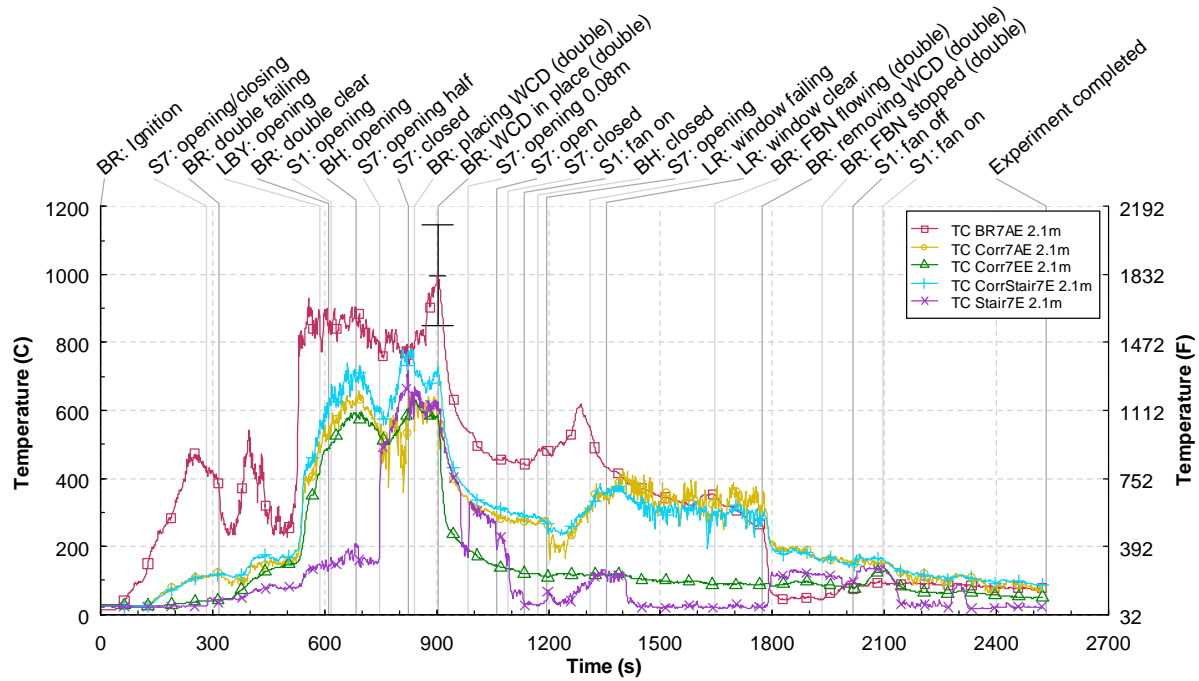
After the PPV fan was activated the temperature remained below 100 °C (212 °F) for the remainder of the experiment.

Figure 3.4-22. 7A Temperature vs. time at 2.1 m above the floor

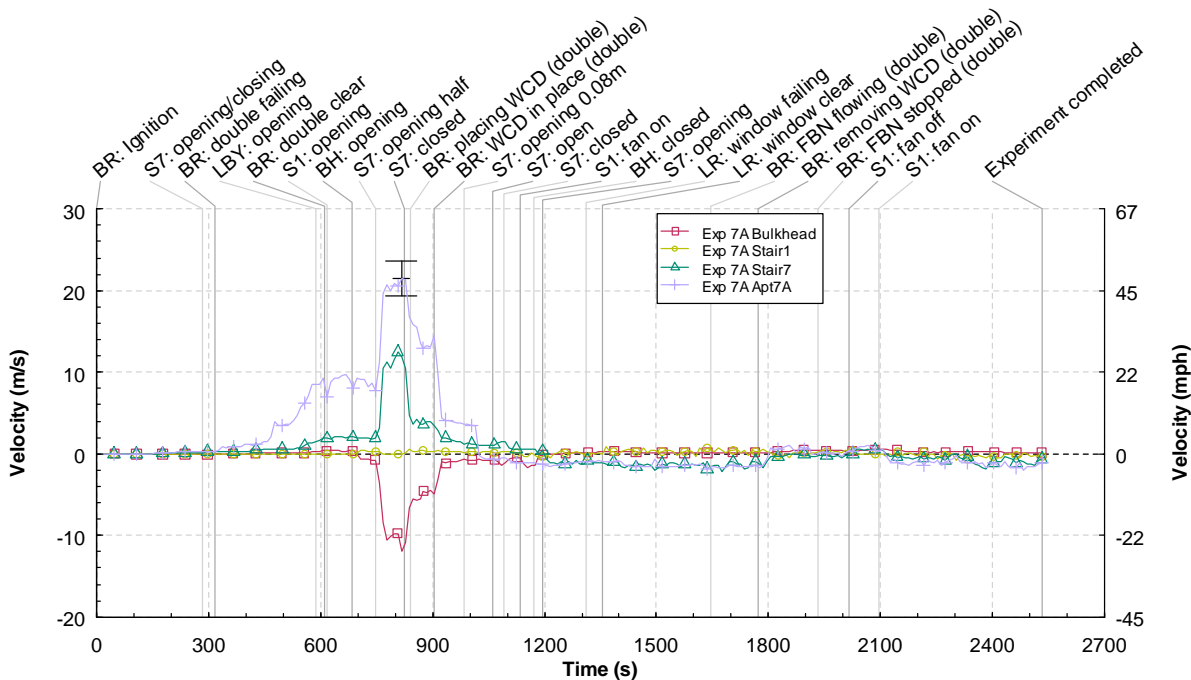
Average doorway velocities from 4 doors; the fire apartment door, the door from the fire floor to the stairwell, the door at the base of the stair and the door at the bulkhead, were recorded versus time and shown in Figure 3.4-26. The three bi-direction probes in each door were averaged to provide the bulk flow through the doors. A time history for each probe at each measurement location is located in Appendix D – Detailed Graphs. The velocity out of the open apartment door steadily increased as the fire grew. Opening the 7<sup>th</sup> floor stair door initiated the wind driven condition which had a peak velocity of 21 m/s (45 mph). The velocity into the stairwell and out of the top of the stairwell peaked at approximately 12 m/s (27 mph). After the WCD was deployed the velocities decreased even with the stairwell doors open which would be expected. With the use of the fan, the velocities were less than 2 m/s (4 mph) toward the fire apartment.

Figure 3.4-26. 7A Velocities vs. time

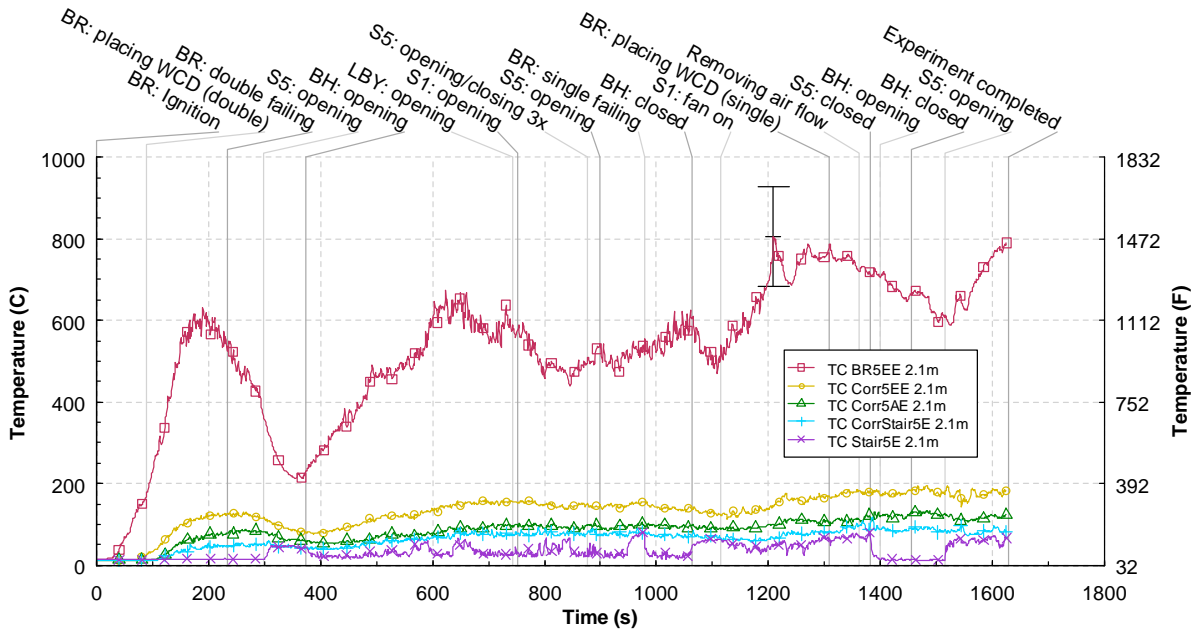
Figure 3.6-17. 5E Temperature vs. time at 2.1 m above the floor

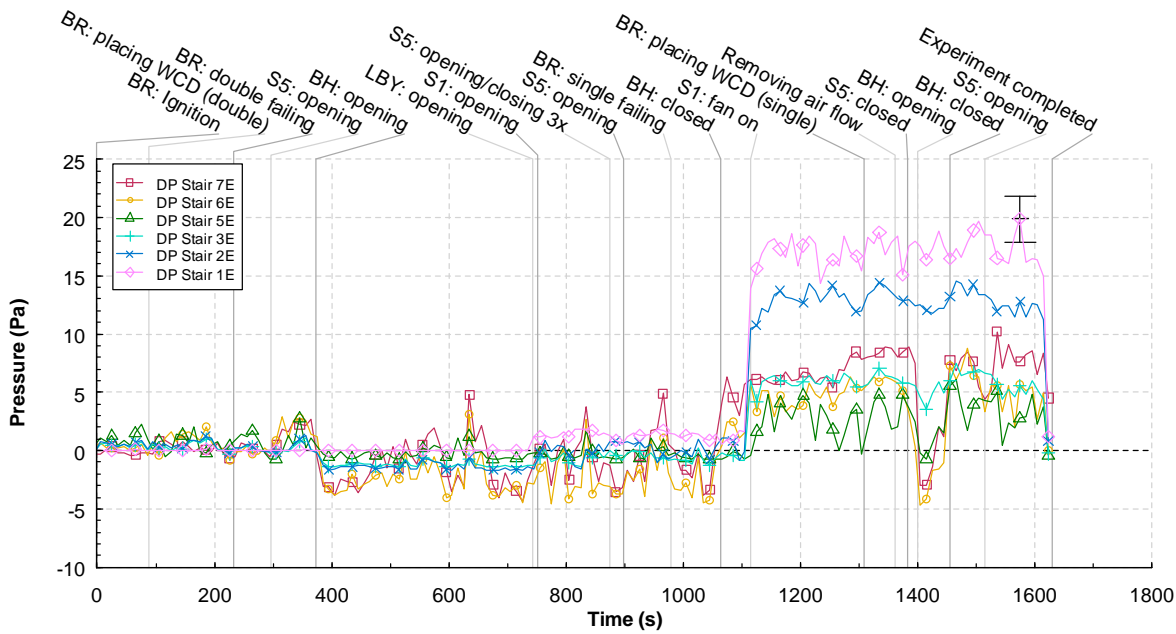
Figure 3.6-20. 5E stairwell pressures vs. time

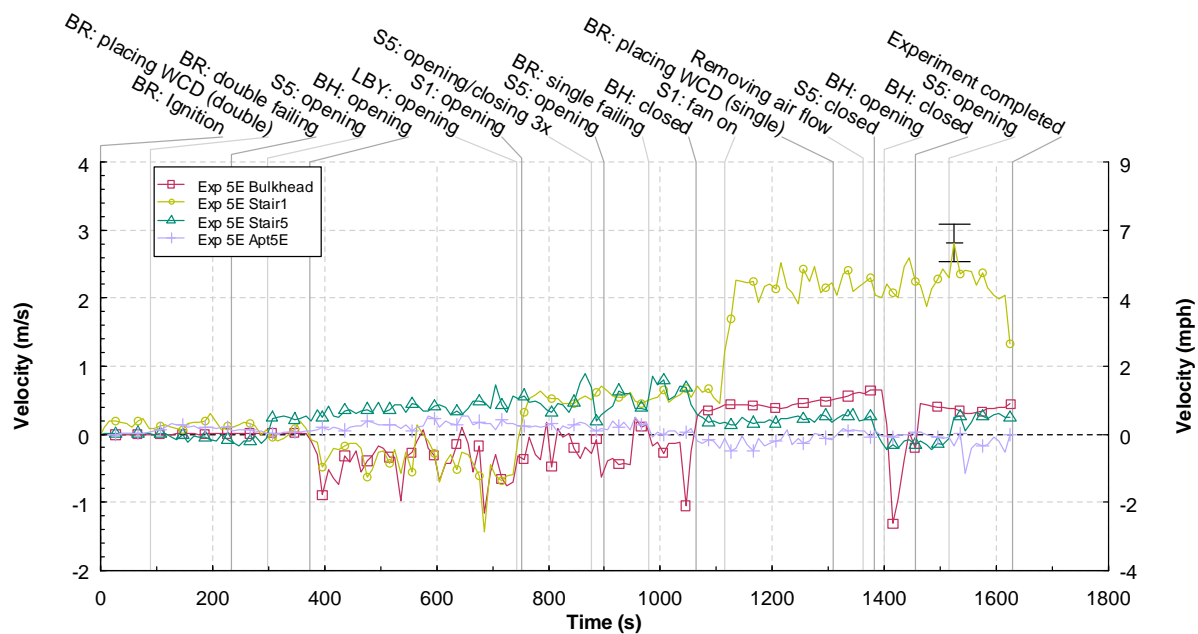
Figure 3.6-21. 5E Velocities vs. time

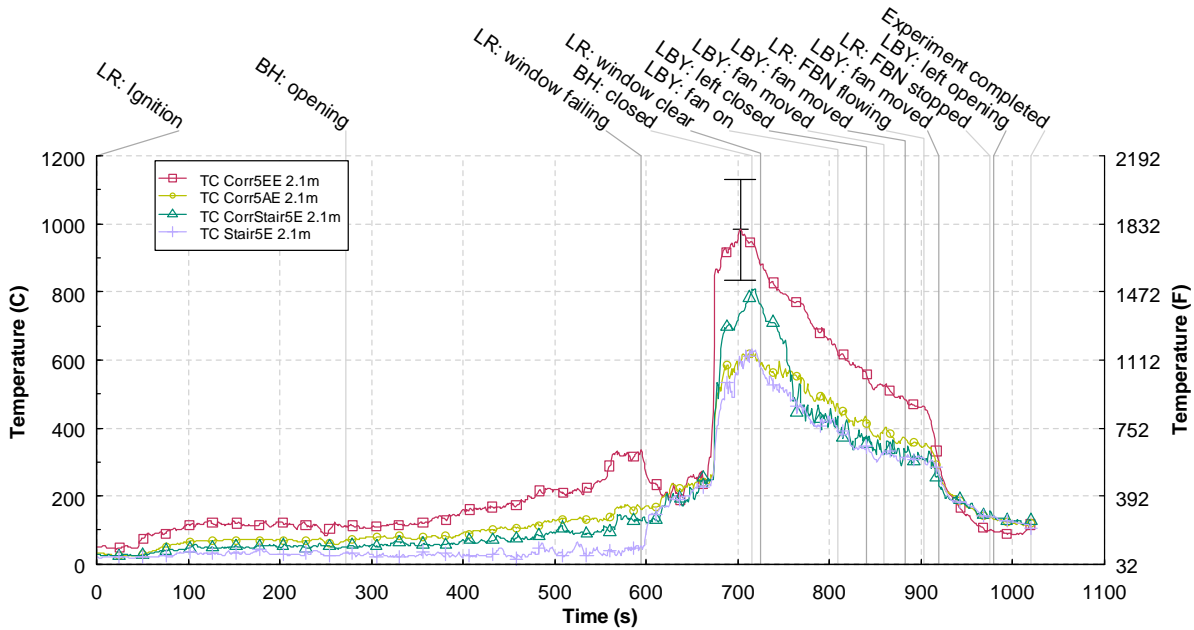
Figure 3.7-13. 5E2 Temperature vs. time at 2.1 m above the floor

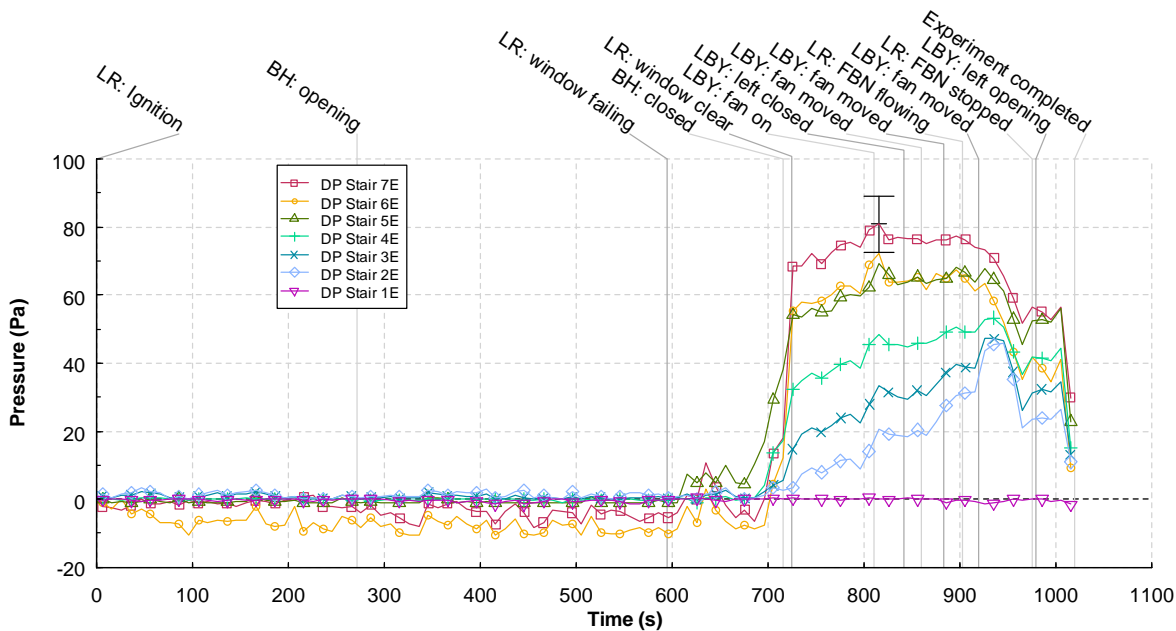
Figure 3.7-16. 5E2 stairwell pressures vs. time

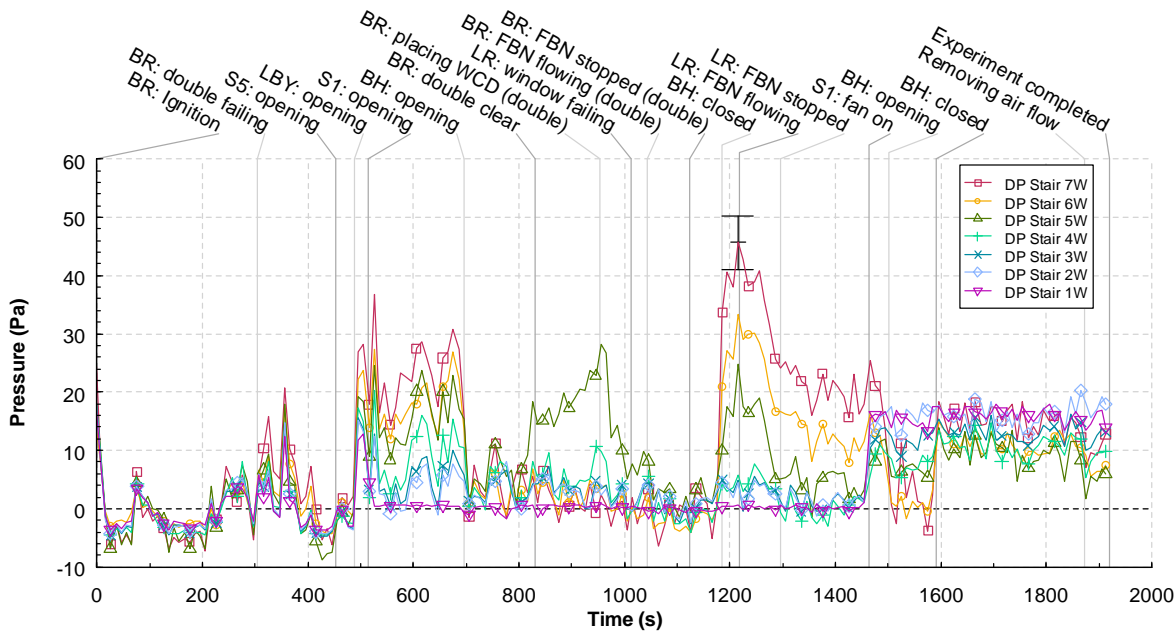
Figure 3.8-20. 5K stairwell pressures vs. time

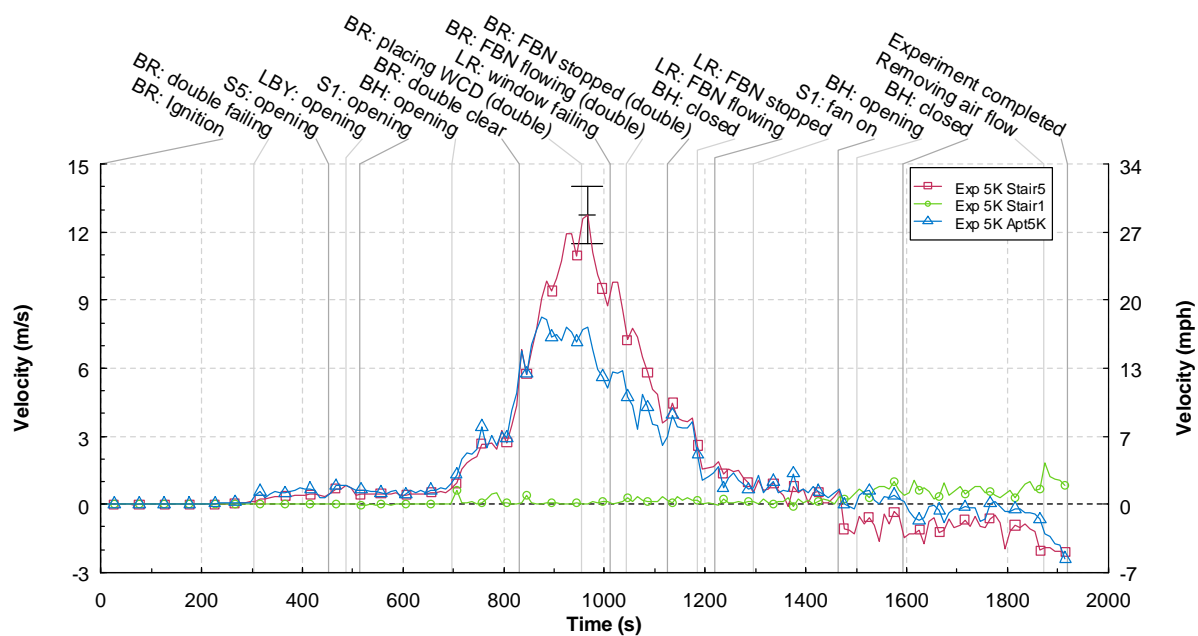
Figure 3.8-21. 5K Velocities vs. time

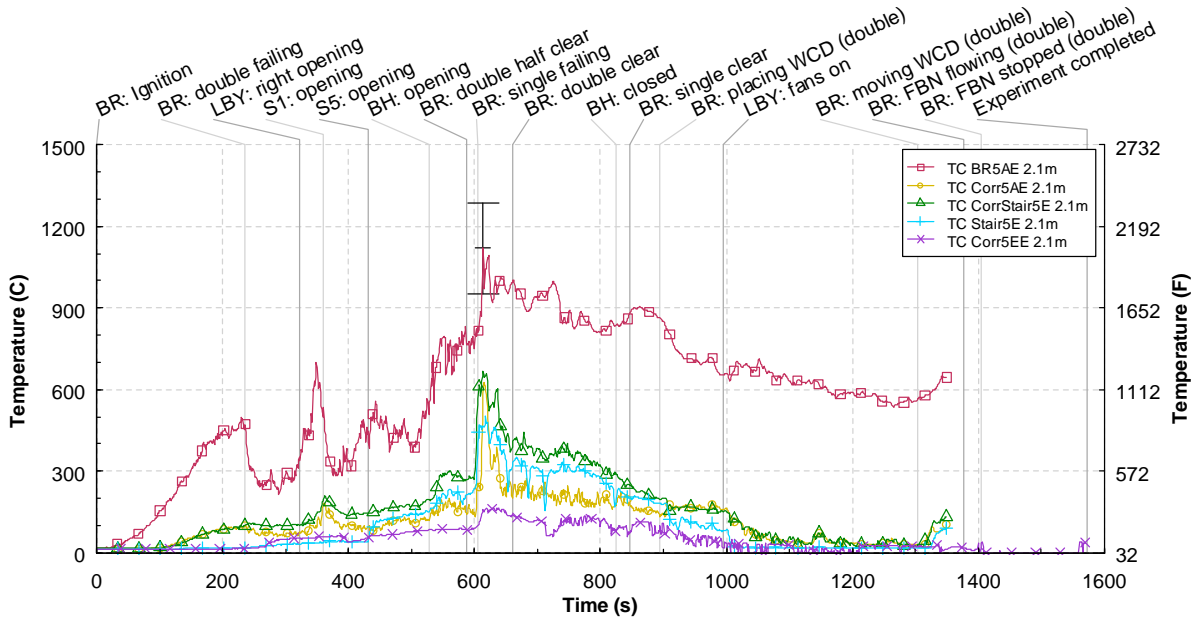
Figure 3.9-17. 5A Temperature vs. time at 2.1 m above the floor

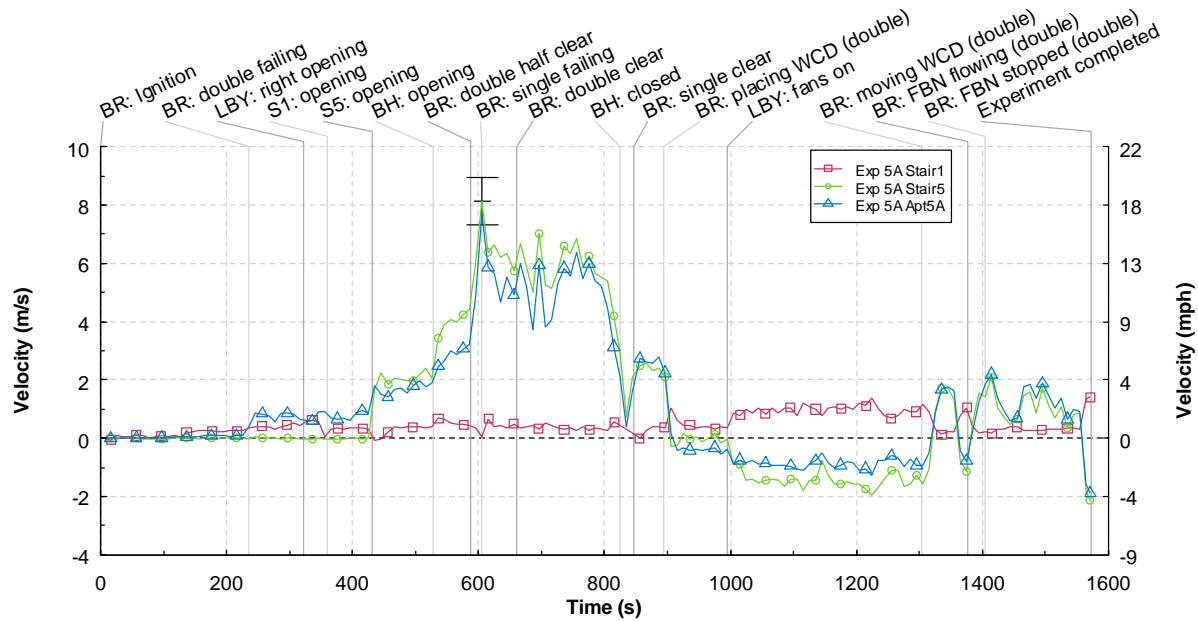
Figure 3.9-21. 5A Velocities vs. time

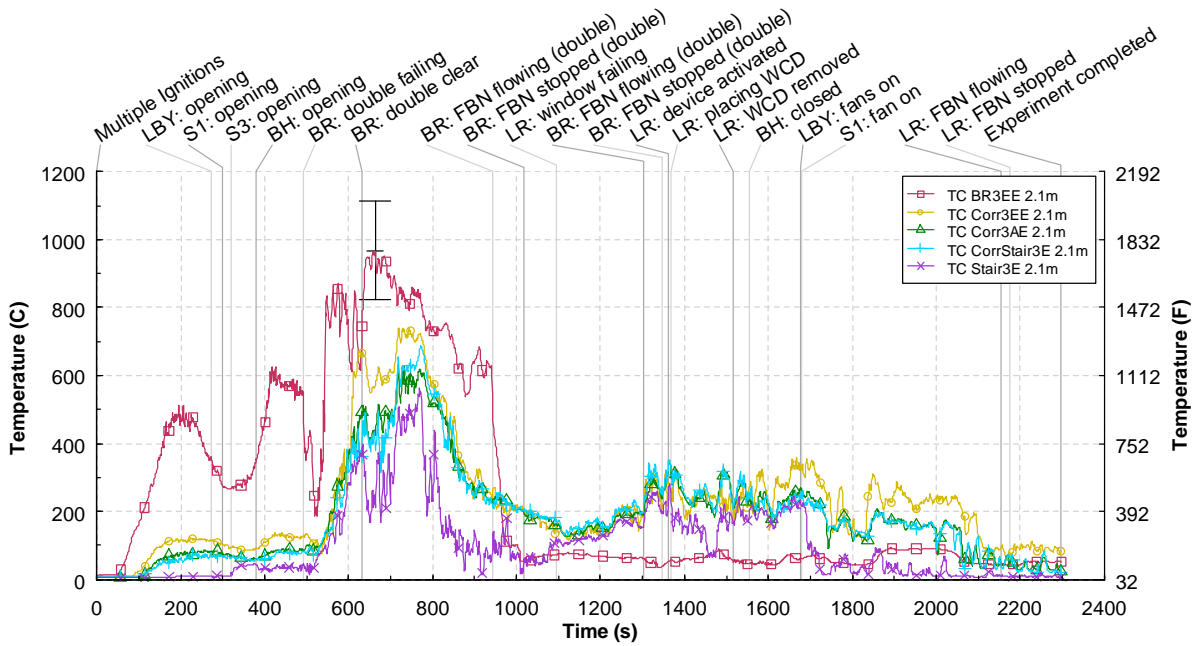
Figure 3.12-20. 3E Temperature vs. time at 2.1 m above the floor

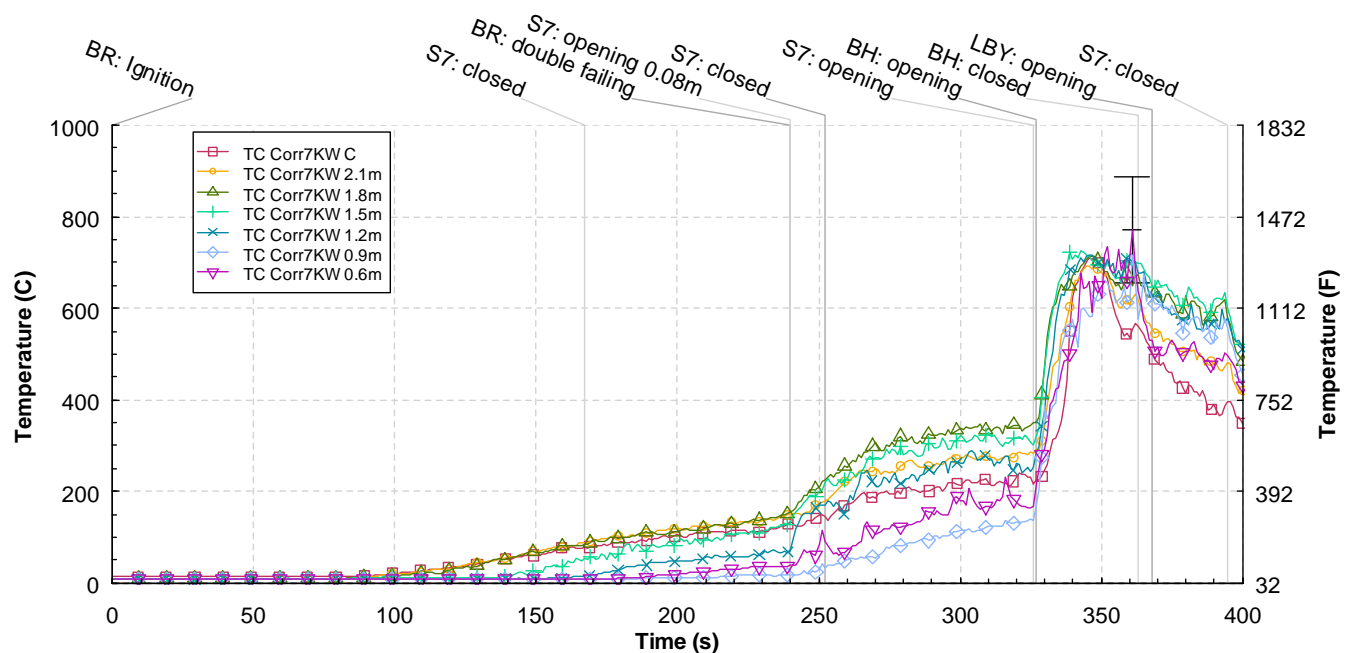
Figure 4-1. Temperature vs time from the vertical thermocouple array at the corridor position outside of apartment 7K.

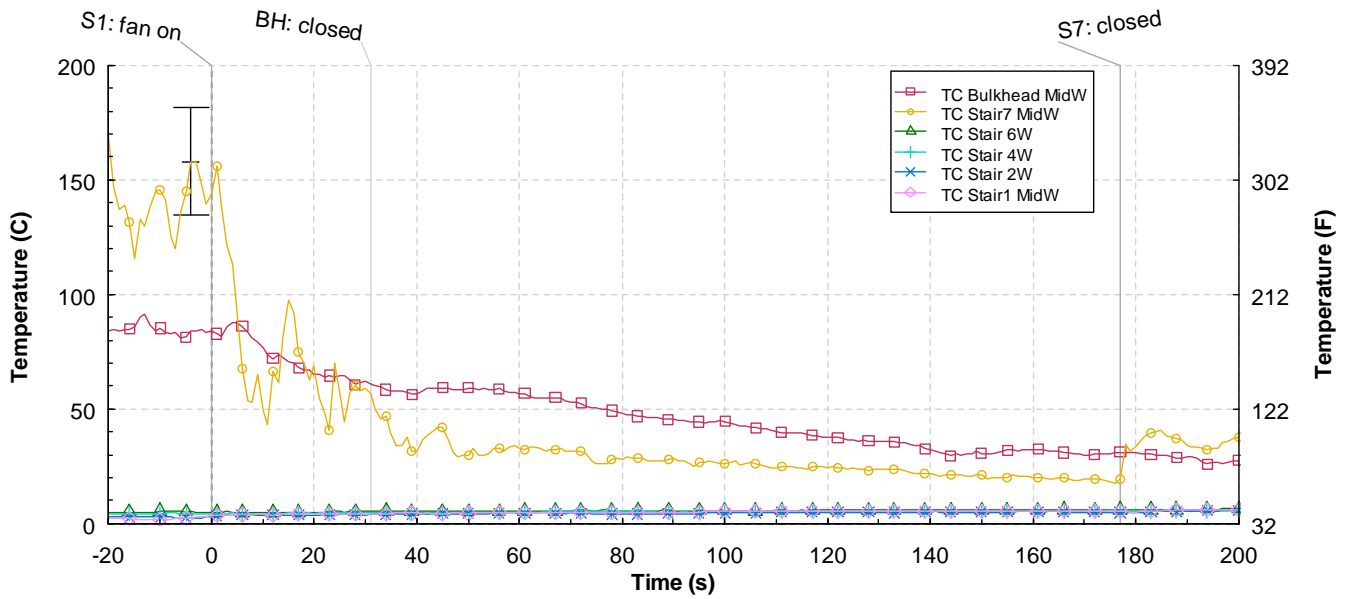
Figure 4.2-1. 7G Stairwell temperature vs time. T=0 is the time that the fan was operating at the 1<sup>st</sup> floor doorway to the stairwell.

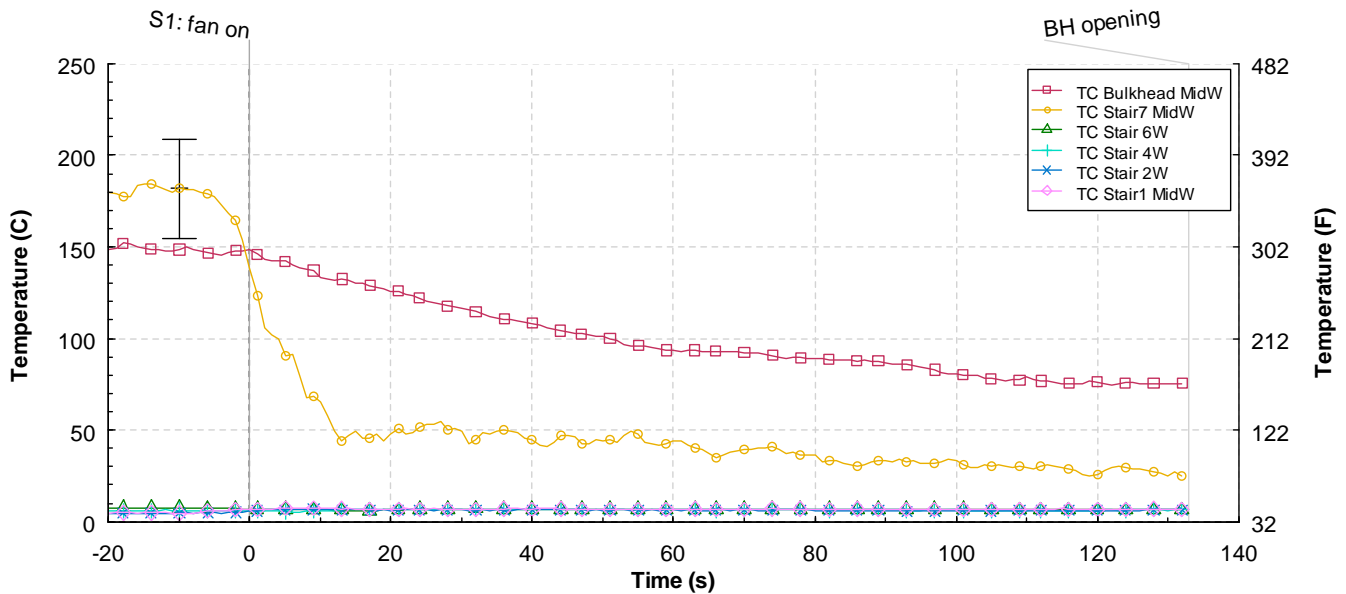
Figure 4.2-2. 7G2 Stairwell temperature vs time. T=0 is the time that the fan was operating at the 1<sup>st</sup> floor doorway to the stairwell.
