form & function

PUBLISHED FOR THE CONSTRUCTION INDUSTRY BY UNITED STATES GYPSUM COMPANY | ISSUE 4, 1975

SET A FIRE TO STOP A FIRE

A dramatic series of onsite fire tests may reduce the vulnerability to fire spread of up to 300,000 existing row houses in the U.S. The tests were conducted in the Bushwick community of Brooklyn, N.Y., because thousands of fires in this area have spread through common "cocklofts⁽¹⁾" to destroy adjacent residential units in aging row housing there.

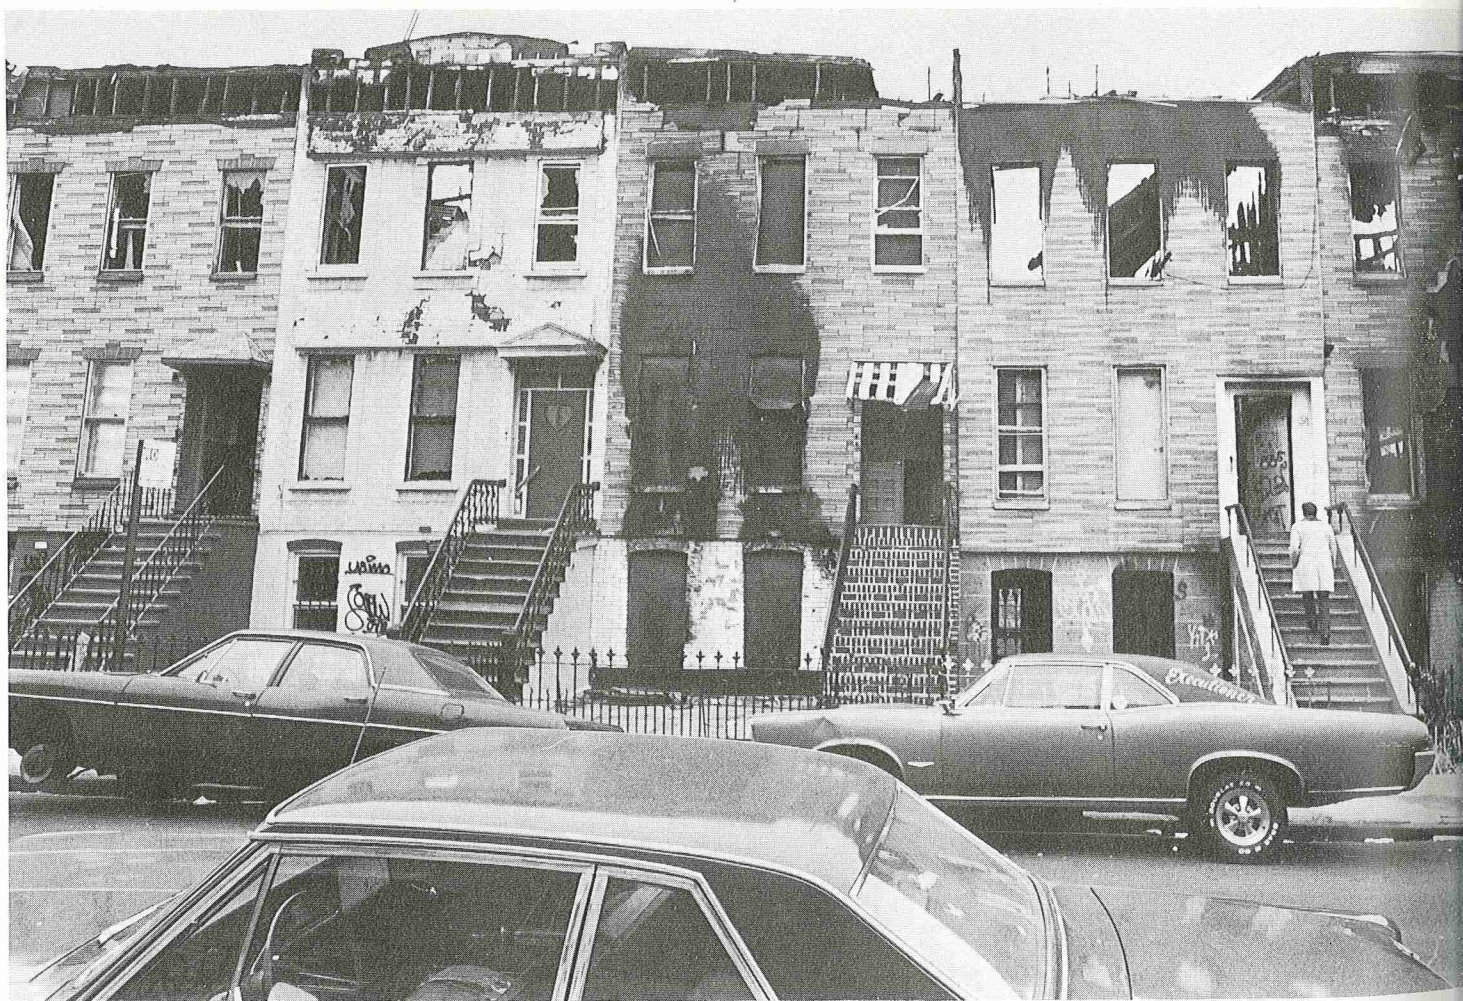
Fire disasters, as this one occurring in 17 adjacent buildings in Bushwick section of Brooklyn, N.Y., were created by vulnerability of cockloft below roof.

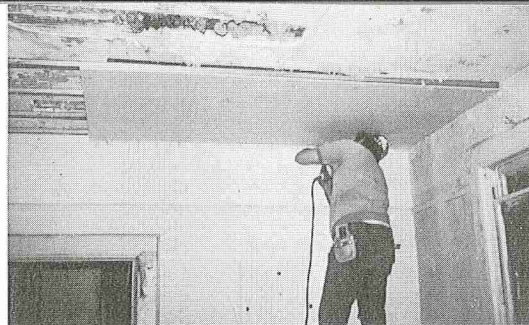
In gypsum board tests, SHEETROCK Panels were fastened to ceiling, top, and taped, left. Test results, above, show that panels discolored, but displayed no sign of failure.

In the test using SHEETROCK Gypsum Panels, USG Metal Furring Channels were applied to wood joists above a broken, plastered bedroom ceiling. Then 5/8-in. SHEETROCK FIRECODE "C" Gypsum Panels were applied and the joints treated. Furnishings providing a typical fuel load were placed in the bedroom and a fire was set. During the 13 minutes that the fire burned, the temperature reached as high as 1,600° F in the room (see Fig. 2, thermocouple C-6). At the same time, the temperature above the SHEETROCK Panel ceiling was hardly affected (Fig. 2, thermocouple CK-1), indicating that the drywall ceiling membrane had effectively prevented penetration of the fire into the cockloft area.
