NIST Technical Note 1618

Fire Fighting Tactics Under Wind Driven Conditions: Laboratory Experiments

Daniel Madrzykowski
Stephen Kerber

January 2009

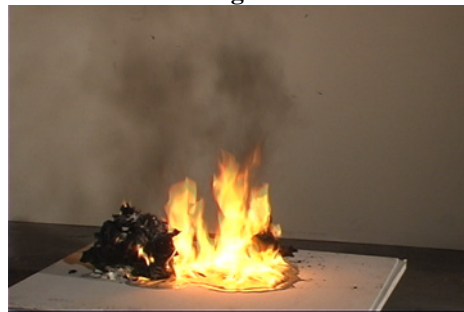
Figure 3.2-6. Trash container 1, at peak heat release rate, 406 s after ignition

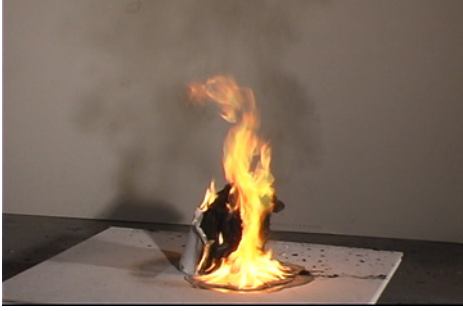
Figure 3.2-13. Trash container 2, at peak heat release rate, 363 s after ignition

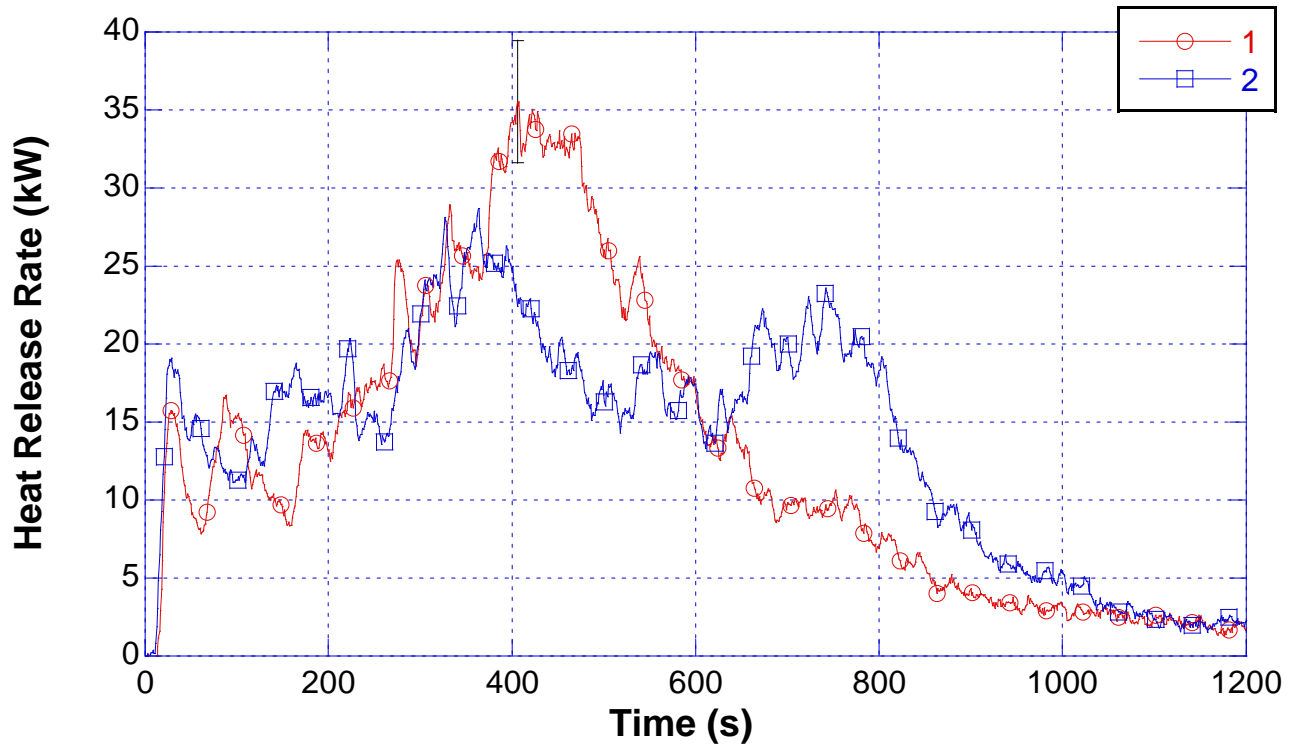
Figure 3.2-17. Heat release rate versus time for Trash Container 1 and 2.

mass loss to provide an average heat of combustion for the fuel package. This yielded effective heats of combustion of 23.2 MJ/kg and 24.3 MJ/kg. For the peak heat of combustion value, the peak heat release rate was divided by the mass loss rate occurring at the time. This value was slightly higher for each trash container at 26.9 MJ/kg and 24.3 MJ/kg.

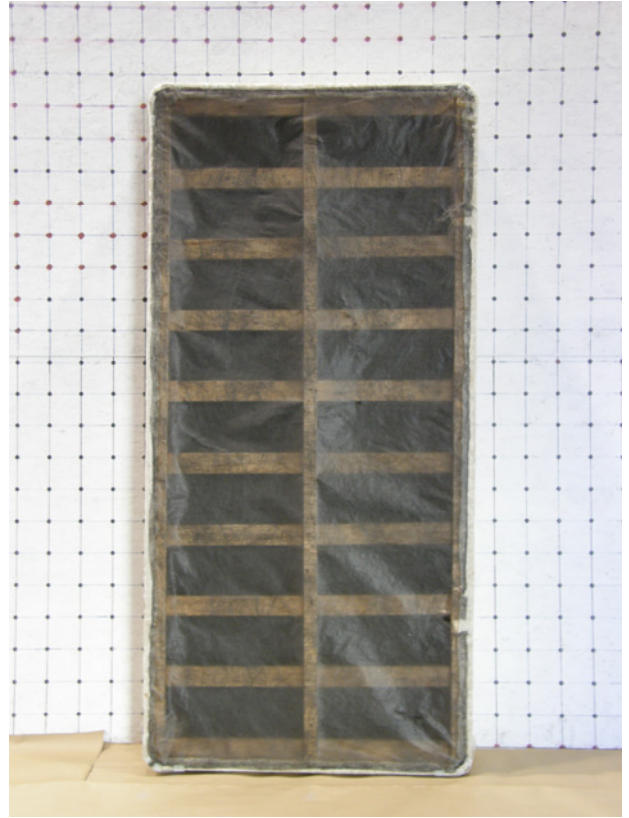
Figure 3.3-2. Bottom side of box spring.

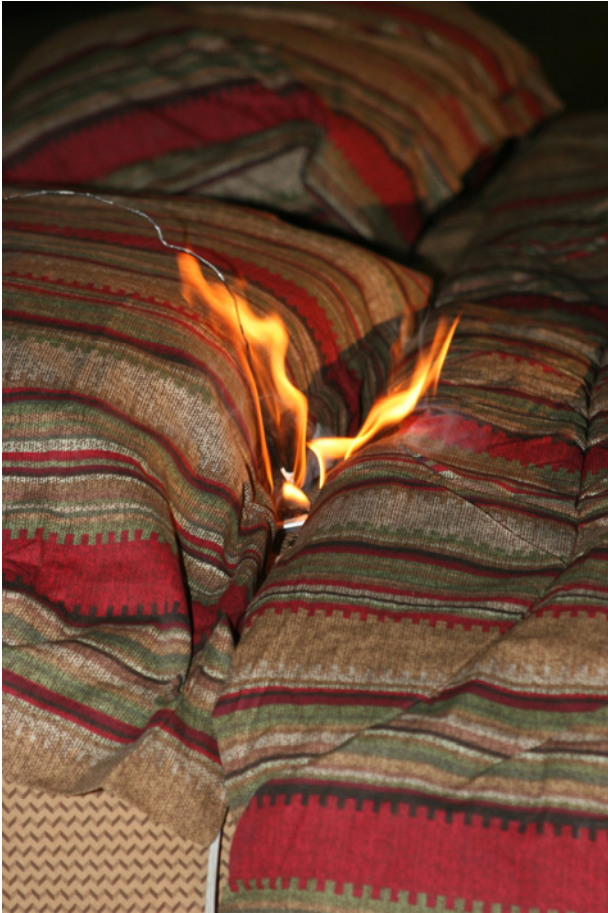
Two heat release rate experiments were conducted. In the first experiment, a bed fuel package was ignited by an electric match positioned on the top surface of the mattress, in a fold formed by the comforter and underside of the covered pillow as shown in Figure 3.3-3. The second experiment was ignited with a trash container fuel package positioned next to the bed as shown in Figure 3.3-4.

Figure 3.3-3. Electric match ignition of bed fuel package.

Bed fuel package 1 was ignited with an electric match as shown in Figure 3.3-3. Figure 3.3.2-1 through Figure 3.3.1-10 are a series of photographs showing the fire development in the first bed fuel package. The photographs document the period from ignition to 800 s after ignition at which point the fuel package has been reduced to burning debris in and under the springs of the mattress. The photographs are at intervals of 100 s with the exception of Figure 3.3.2-5, which shows the bed fuel package at the time of peak heat release rate, 484 s.

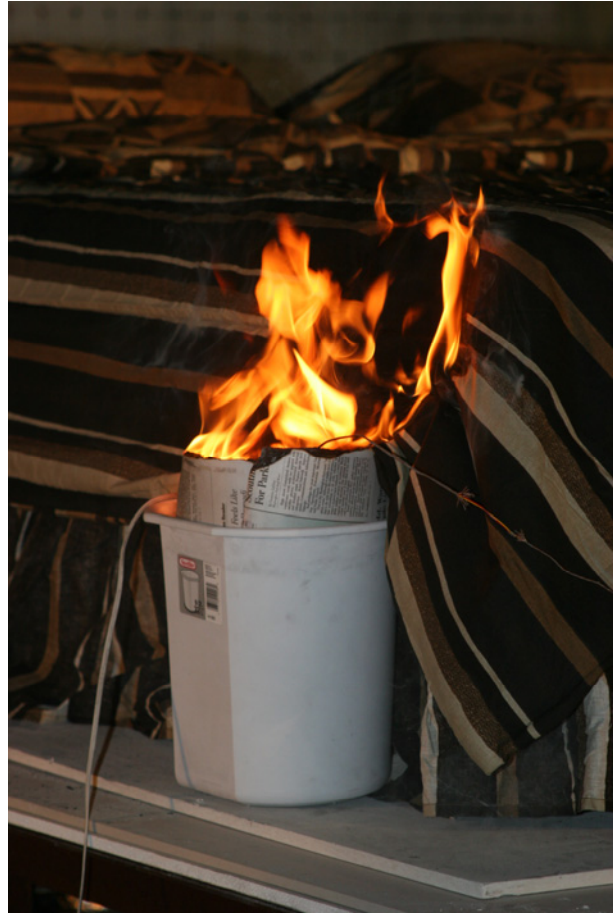
Figure 3.3-4. Trash container ignition of bed fuel package.

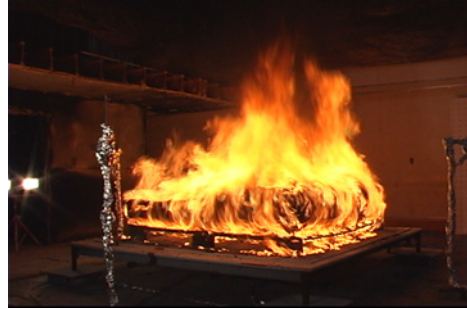
Figure 3.3.1-6. Bed 1, at peak heat release rate, 484 s after ignition

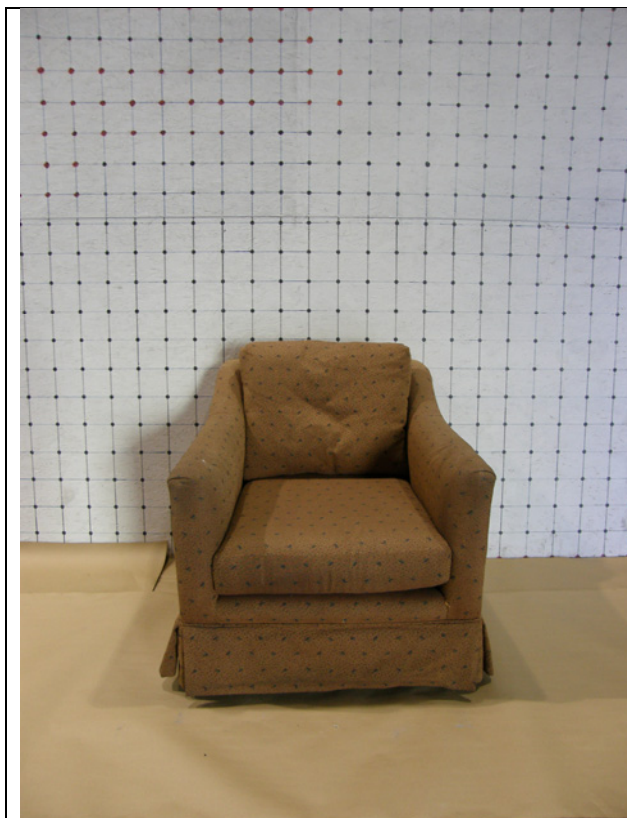
The upholstered chair was 0.72 m (2.4 ft) wide, 0.76 m (2.5 ft) deep and 0.73 m (2.4 ft) high. Based on the manufacturer’s information, the chairs had a hard wood frame which was wrapped in the arms and back portions with 10 % blended cotton and 90 % polyurethane foam. The seat cushion, which measured 0.53 m (1.75 ft) wide, 0.66 m (2.2 ft) deep and 0.15 m (0.5 ft) thick, was composed of 90 % polyurethane foam and 10 % polyester fiber. The back pillow measured approximately 0.48 m (1.6 ft) wide, 0.37 m (1.2 ft) high and 0.15 m (0.5 ft) thick. It was made up of polyester fiber 90 % and polyurethane foam 10 %. Six upholstered chairs and sets of cushions were weighed. The chairs had an average mass of 23.7 kg (52 lbs) with a range from 23.3 kg (51.4 lbs) to 24.0 kg (52.9 lbs). The seat cushion had an average mass of 2.12 kg (4.7 lbs) with a range from 2.05 kg (4.52 lbs) to 2.25 kg (4.96 lbs). The back cushions had an average mass of 1.18 kg (2.6 lbs) with a range of 1.17 kg (2.58 lbs) to 1.19 kg (2.62 lbs). Photographs of the chair and cushions are shown in Figure 3.4-1 through Figure 3.4-4.

Figure 3.4-1. Upholstered chair, front view.

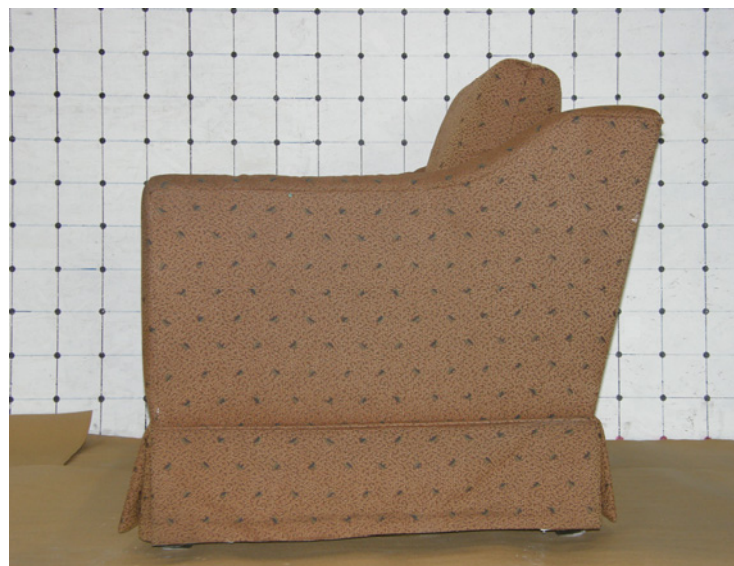
Figure 3.4-2. Upholstered chair, side view.

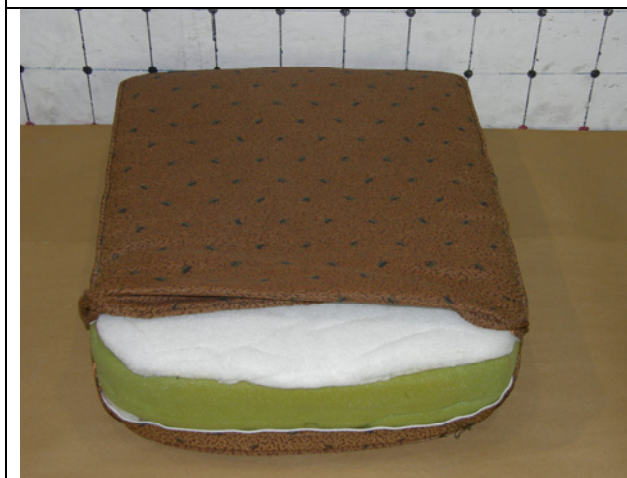
Figure 3.4-3. Seat cushion, showing layers of upholstery fabric, polyester batting and polyurethane foam.

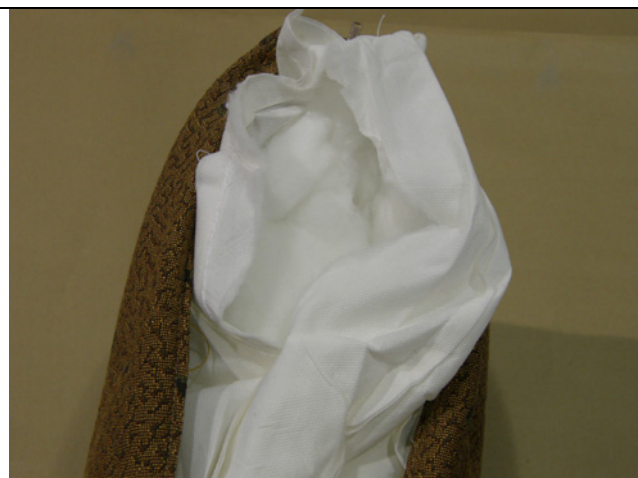
Figure 3.4-4. Back cushion, showing the upholstery fabric, inner liner, and polyurethane foam.

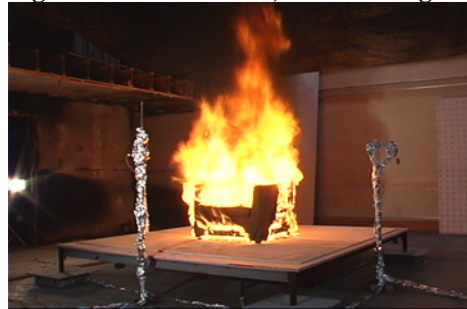
Figure 3.4.1-6. Chair 1, at peak heat release rate, 417 s after ignition

Figure 3.4.1-6 shows the chair fire at the time of peak heat release rate, 417 s after ignition. As shown in the Figures Figure 3.4.1-2 through Figure 3.4.1-4, the fire spread from a small ignition area to an area that involved a portion of both cushions and both interior surfaces of the arms of the chair. Shortly after this, the fire began to spread through the body of the chair as shown in Figure 3.4.1-5. This was due to flame contact and burning foam from the seat cushion dropping fire down to lower sections of the chair and the floor below the chair.

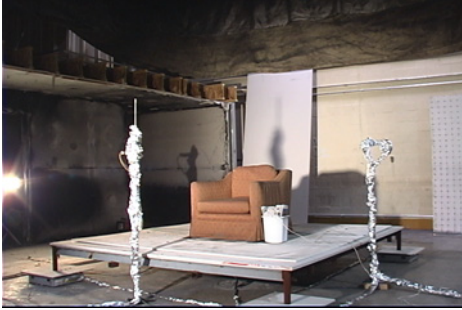
Figure 3.4.2-1. Chair 2, ignition

Upholstered chair 2 was ignited with a trash container fuel package positioned adjacent to one side of the chair as shown in Figure 3.4.2-1. Figure 3.4.2-1 through Figure 3.4.2-10 each have a photograph taken between 100 s and 800 s after ignition. Most of the photographs are taken at intervals of 100 s with the exception of Figure 3.4.2-6. The image in Figure 3.4.2-6 was recorded at the time of peak heat release rate, 437 s after ignition. Even though upholstered chair 2 had a significantly different ignition source from upholstered chair 1, the images recorded at 400 s after ignition in both cases provide similar levels of fire development within each chair.

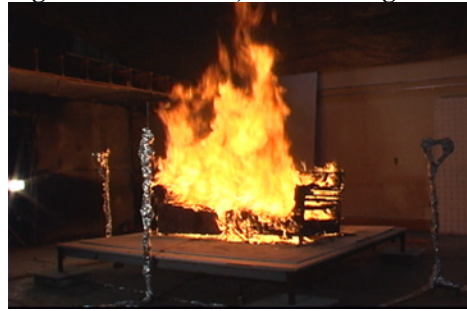
Figure 3.5-6. Sofa 1, at peak heat release rate, 455 s after ignition

Figure 3.5-1 through Figure 3.5-10 and Figure 3.5-11 through Figure 3.5-20 present images recorded between ignition and 800 s after ignition for both of the sofa experiments. Each set contains images taken every 100 s after ignition during that period. In addition, Figure 3.5-6 for sofa 1 and Figure 3.5-15 for sofa 2 show the fires at the time of peak heat release rate, 455 s and 389 s after ignition respectively. The times to peak heat release rate were more than 60 s apart. The fire spread for both of the sofas was very similar for the first 200 s. During the interval from 200 s to 300 s, sofa 1 had flames moving across the back side of the sofa, while sofa 2 contained the flames to the seat cushion area resulting in flames from one end of the sofa to the other. By 400 s after ignition sofa 1 and sofa 2 had similar levels of flame throughout. At 800 s after ignition, the wood frames of both sofas were still burning along with debris in and below the pullout mattress mechanism.

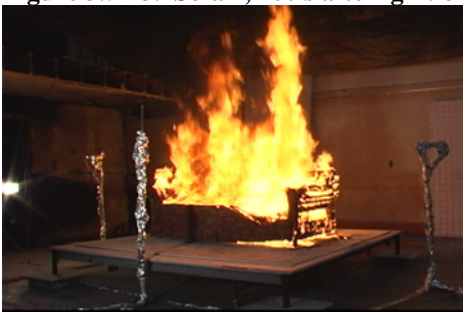
Figure 3.5-15. Sofa 2, at peak heat release rate, 389 s after ignition

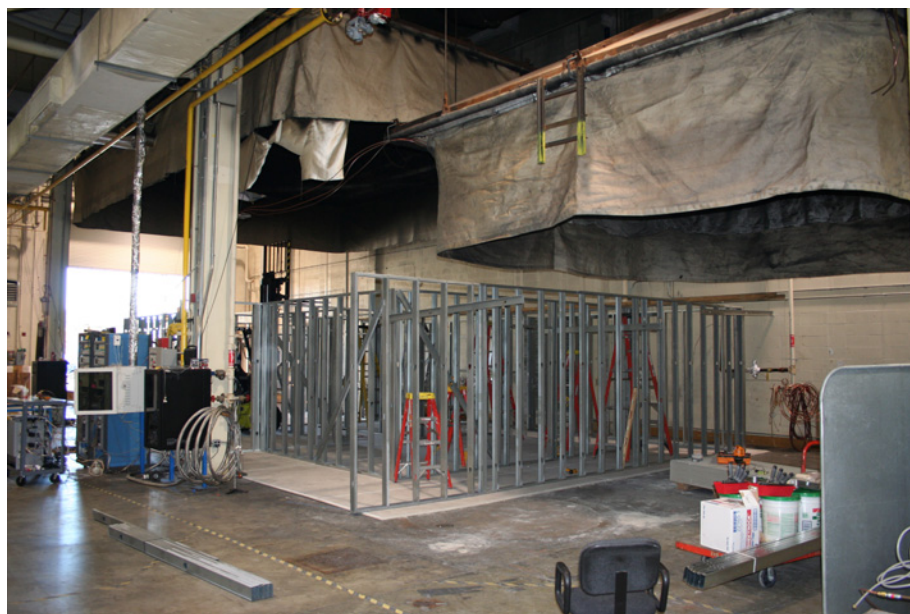
Figure 4.1.1-2. Steel framing for walls of experimental structure inside the NIST Large Fire Facility.

One layer of 13 mm (0.5 in) thick cement board panels were laid on the concrete floor of the facility to form a protective foundation for the structure. This layer was covered with 13 mm (0.5 in) thick gypsum board. The structure was framed with steel studs and track as shown in Figure 4.1.1-2. The studs were set to 0.40 m (16 in) centers. The ceiling support was composed of wood truss joist I-beams (TJIs) with a 299 mm (11.88 in) depth. The TJI was composed of laminated veneer lumber flanges with a cross section of 38 mm (1.5 in) x 57 mm (2.25 in) and an 11 mm (0.43 in) thick oriented strand board web as shown in Figure 4.1.1-3.

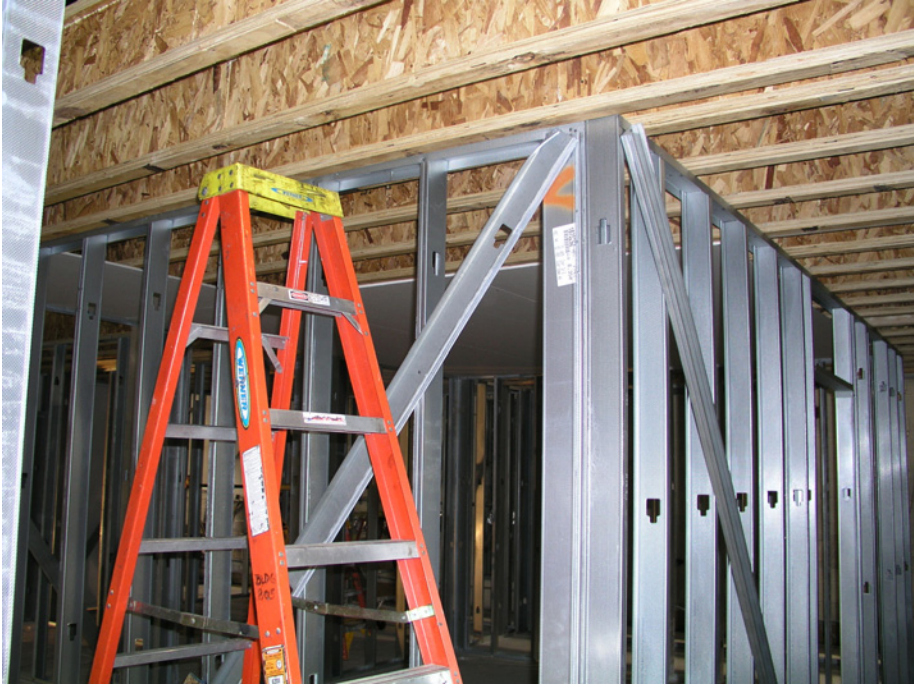
Figure 4.1.1-3. Ceiling supports for experimental structure.

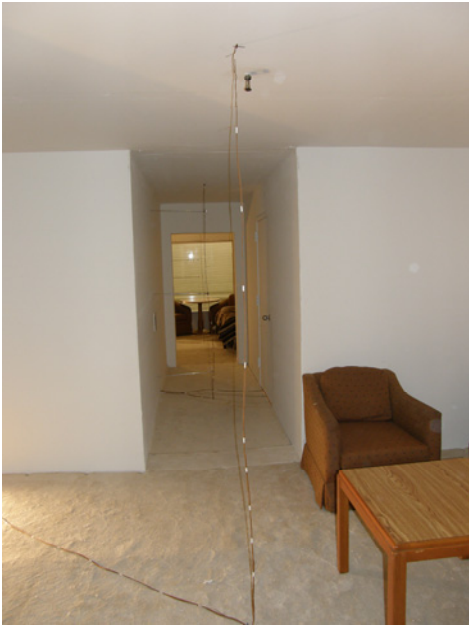
Figure 4.1.3-2. Thermocouple arrays along center line of structure looking from east to west.

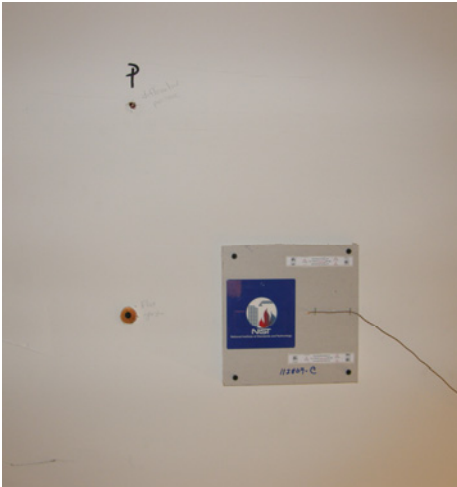
Figure 4.1.3-4. Wall mounted thermocouples, heat flux sensor, and differential pressure sampling port.

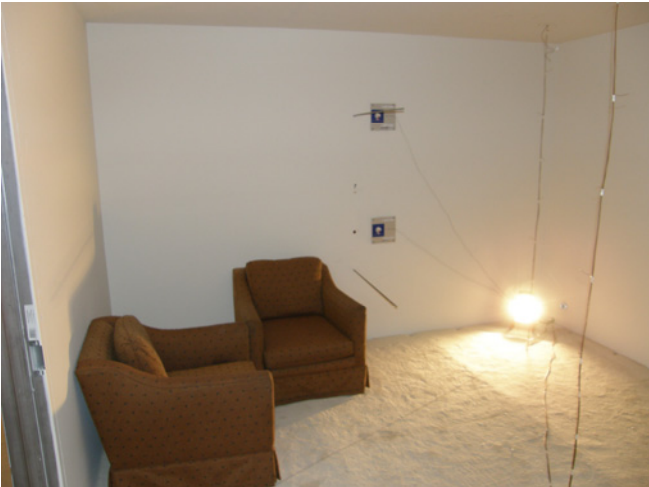
Figure 4.1.3-5. Gas sampling probe installation on south wall of living room.

sampling tubes were connected to a calibrated pump which pulled the gas samples through a sample conditioning system to eliminate moisture in the gas sample. The dry gas sample was then piped to a series of gas analyzers. In all of the experiments, oxygen was measured using paramagnetic analyzers and carbon monoxide and carbon dioxide were measured using non-dispersive infrared (NDIR) analyzers for all four locations. In the latter experiments, total unburned hydrocarbons were measured from the two upper layer positions 0.61 m (2 ft) below the ceiling using flame ionization detectors (FID). Details of this gas sampling and measurement system can be found in [0, 0]. Single thermocouples were also co-located with the gas sample inlet ports. Figure 4.1.3-5 is a photograph of the south wall of the living room, which shows the gas sampling ports.

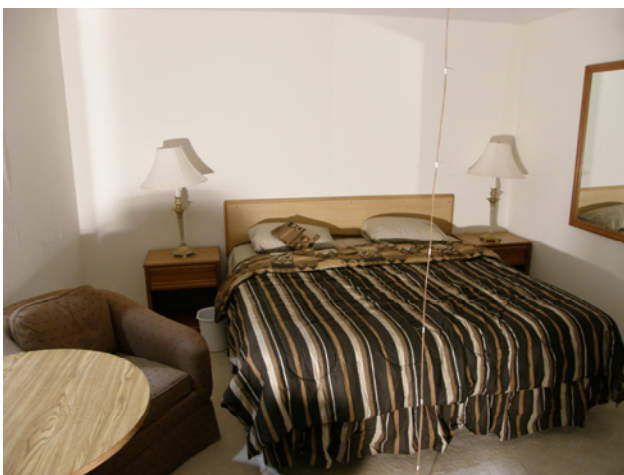
Figure 4.2-2. Bedroom furnishings, looking north.

The bedroom fuel load and its arrangement is shown in Figure 4.2-1 through Figure 4.2-3. Descriptions of the furnishing dimensions, materials, and mass are given in Table 4.2-1. The total mass of the furnishings, carpeting and carpet padding in the bedroom fuel package was 406 kg (894 lbs). Based on metal removed after the experiments, the combustible mass of the bedroom fuel package was 350 kg (769 lbs). Taking those totals and dividing by the floor area of the bedroom yielded total and combustible fuel loadings of 22.8 kg/m² (4.7 lb/ft²) and 19.6 kg/m² (4.0 lb/ft²), respectively. This did not take the subfloor or the painted gypsum board walls and ceilings into account.

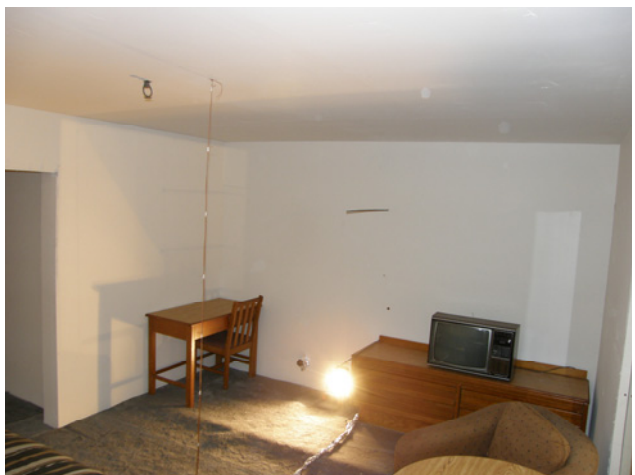
Figure 4.2-3. Bedroom furnishings, looking south.

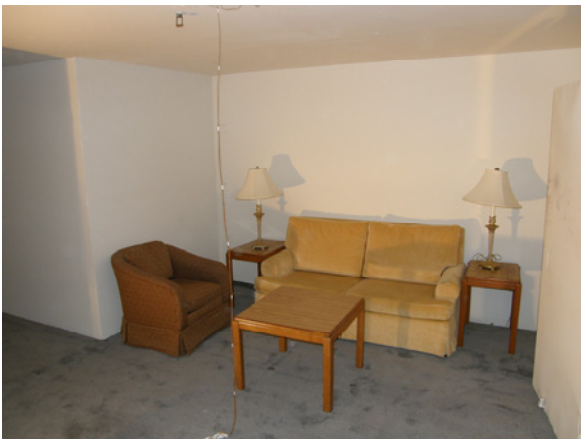
Figure 4.2-5. Living room furniture, looking north.

The living room fuel load and its arrangement is shown in Figure 4.2-4 through Figure 4.2-6. Descriptions of the furnishing dimensions, materials and mass are given in Table 4.2-2. The mass of the fuel load in the living room was less than the bedroom. The total mass of the furnishings, carpeting and carpet padding in the living room was 254 kg (558 lbs). Based on metal removed after the experiments, the approximate combustible mass of the living room fuel package was 218 kg (479 lbs). Taking those totals and dividing by the floor area of the living room yielded total and combustible fuel loadings of 14.2 kg/m² (2.9 lb/ft²) and 12.2 kg/m² (2.5 lb/ft²), respectively. Again, this did not take the subfloor or the painted gypsum board walls and ceilings into account.

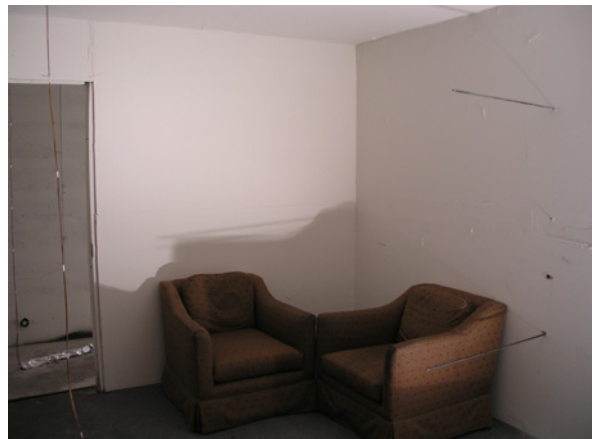
Figure 4.2-6. Living room furnishings, looking east.

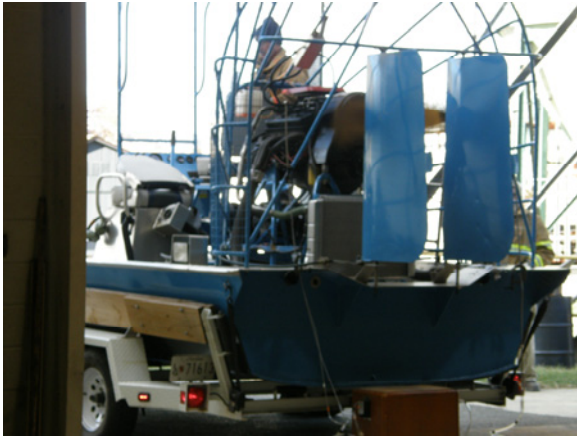
Figure 4.3-1. Air boat from inside of fire lab looking west.

The boat was positioned 9.6 m (31.5 ft) from the west exterior of the structure, The fan was centered on the window and the steering vanes were locked down in the "straight" position as shown in Figure 4.3-1. The roll-up door was raised to create an opening, 4.05 m (13.3 ft) high and 4.88 m (16.0 ft). The boat was leveled so that the centerline of the propeller hub was parallel to the floor of the large fire facility. The centerline of the propeller was 2.13 m (7.0 ft) above ground level. The fan was operated at speeds between 800 rpm and 3000 rpm. Based on hand-held anemometer readings this range provided air speeds of 2.2 m/s (5 mph) to 11.4 m/s (25 mph) at the window opening of the structure.

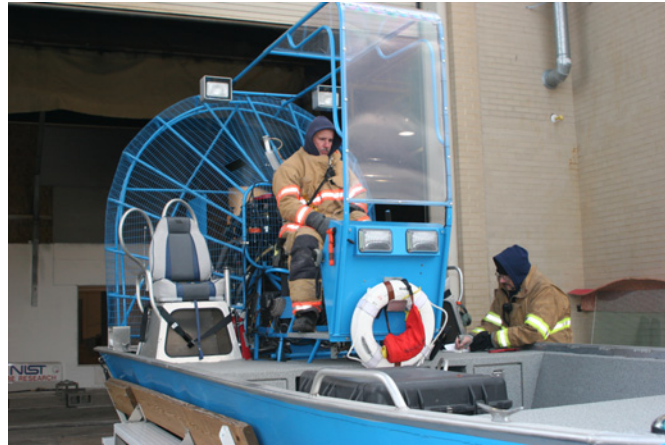
Figure 4.3-2. Air boat from outside of the fire lab looking east.

A mechanical wind source was chosen for the experiments to accommodate scheduling, repeatability and location. The Montgomery County Fire and Rescue Service/ Cabin John Park Volunteer Fire Department's Yankee Air Boat, was used to provide the "wind" for all of the wind driven experiments. The boat has a 1.98 m (6.5 ft) propeller which is driven by a 5.7 l (350 cu. in) gasoline powered engine. The boat has two steering vanes.

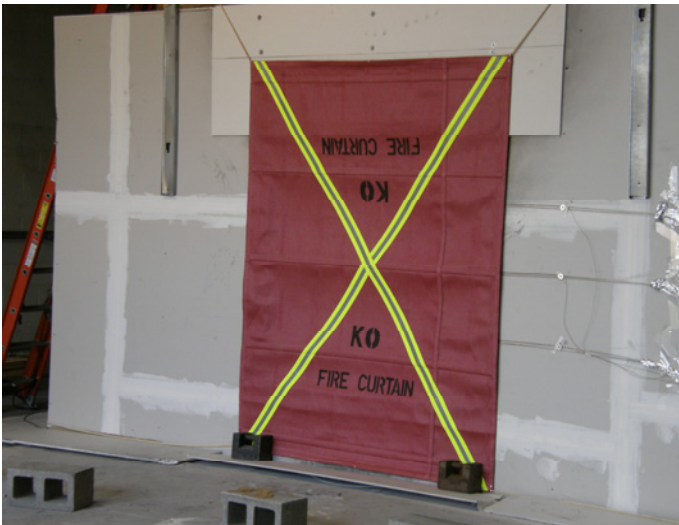
Figure 4.3.2-1. Small WCD deployed over window opening.

The main differences between the two devices are size, weight and stiffness. The smaller WCD measured 1.8 m (6.0 ft) by 2.4 m (8.0 ft) and weighed approximately 12.3 kg (27.1 lbs). It was reinforced with metal rods and had a rope fastened at each corner to secure it. This device, given the size and shape, could be deployed by one firefighter from the floor above the fire. Figure 4.3.2-1 shows the small WCD deployed over the 1.52 m (5.00 ft) by 1.52 m (5.00 ft) window opening under approximately 20 mph wind conditions as generated by the fan. The metal rods hold the fabric flush to the face of the structure. The upper corners were tied off to the structure and the lower corners were secured with weights.

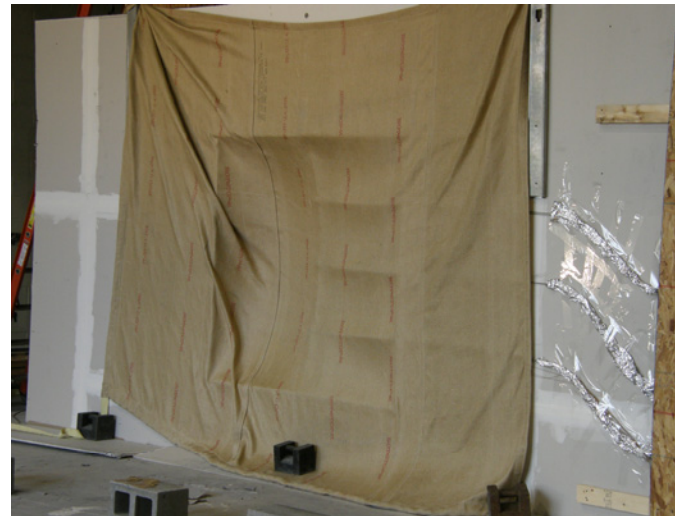
Figure 4.3.2-2. Large WCD deployed over window opening.

The second WCD measured 2.95 m (9.66 ft) by 3.66 m (12.0 ft) and weighed approximately 20.5 kg (45.2 lbs). This WCD had a chain sewn into the bottom of the curtain to assist with deployment. It also had tether straps attached at each corner. This device would typically require two or more firefighters to deploy and secure in place. Figure 4.3.2-2 shows the large WCD deployed over the same window opening under similar wind conditions as the small WCD. In this case the fabric was blown into the window opening. The upper corners were secured to the structure and the lower edge was secured with weights. The right side of the WCD may have been pushed further into the window opening but it is being held by the three bi-directional probes in the window opening.

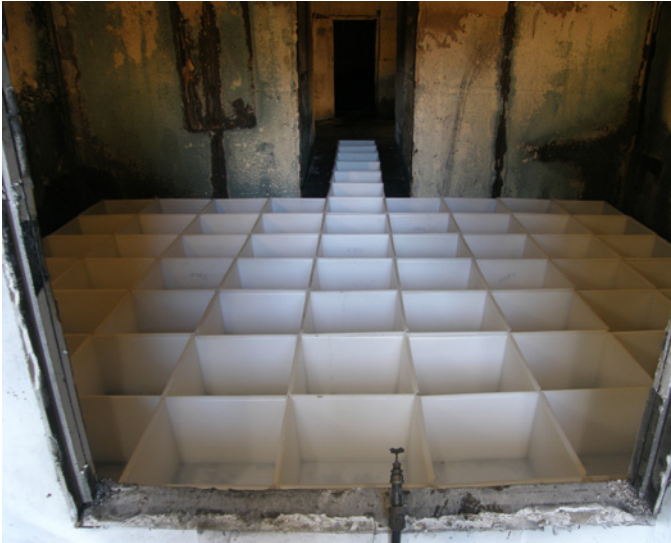
Figure 4.3.3-1. Water spray distribution experiment arrangement.

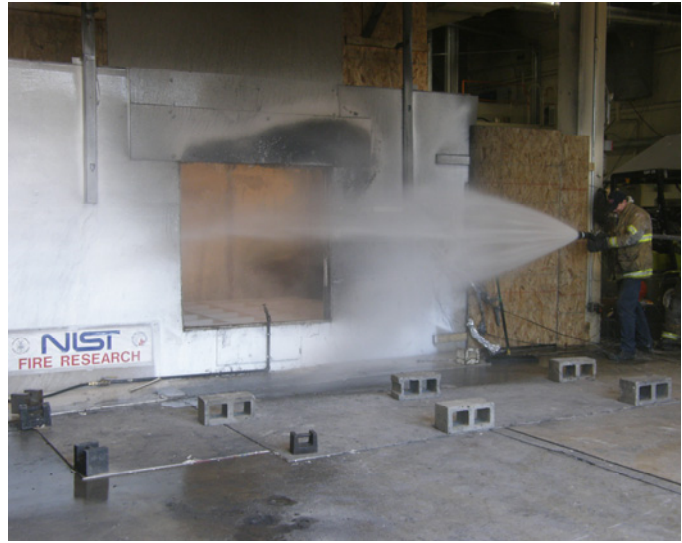
Figure 4.3.3-2. Fog stream discharged across window opening.

The fog stream across the window experiment resulted in a total of 149 kg (328 lbs) of water being collected from the pans inside the compartment. Converting to L/s yields approximately 2.49 L/s (39.5 gpm) entering the room. This is about half of the total flow rate. Figure 4.3.3-5 shows some of the “heavy streams” from the fog nozzle, which appear to be composed of larger high velocity water drops are not pushed into the window opening by the wind. It appeared that the smaller, lower velocity, dispersed drops were “pushed” by the wind toward the window opening and the west wall. However, given the pattern of distribution, it appears the momentum from the fog stream is dominant relative to the force from the wind.

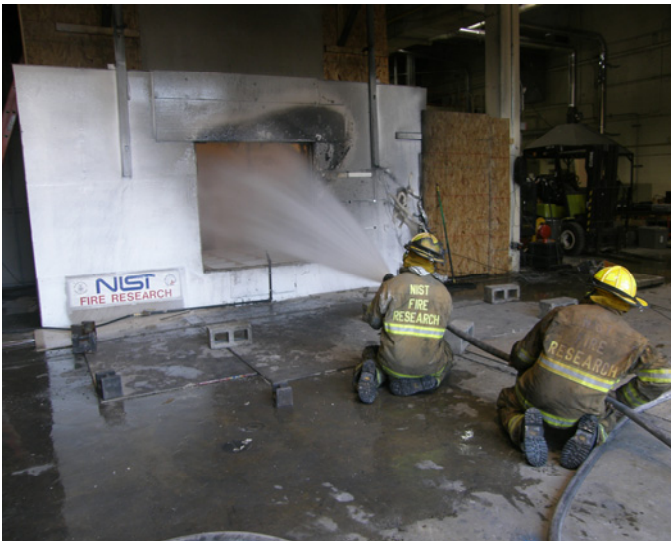
Figure 4.3.3-3. Fog stream discharged into window opening.

The water distribution data from the fog stream discharged into the window opening is given in Figure 4.3.3-6. The total mass of water collected in the pans for a one minute discharge was approximately 217 kg (478 lbs). This is equal to a flow rate of approximately 3.7 L/s (58 gpm), 73 % of the total flow. In this case, most of the water that was unaccounted for appeared to be deposited in the hallway area, on either side of the row of pans and water that ran down the east wall of the bedroom, but did not flow into the pans.

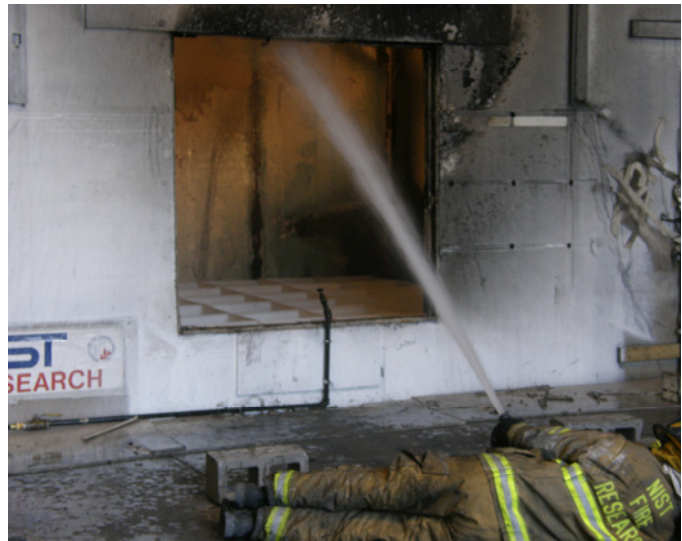
Figure 4.3.3-4. Solid stream discharged into window opening.

Figure 4.3.3-7 has the data from the solid water stream experiment. The total mass of water collected was approximately 359 kg (788 lbs). This accounts for a water flow rate of 6.0 L/s (95 gpm) out of 10 L/s (160 gpm). Similar to the narrow fog stream discharged through the window, the water that appeared to be unaccounted for was discharged against the east wall of the bedroom, but did not flow in to the pans against the wall, on either side of the pans in the hallway and beyond. Evidence of water discharge was noted through the living room and stopped just short of the door to the corridor. This is significantly deeper water penetration into the structure than from the other two methods. Also note that the pattern of water discharge in the bedroom for the hose streams discharged directly through the windows were similar. Given that the flow rate of the solid stream is twice that of the fog nozzle, it is

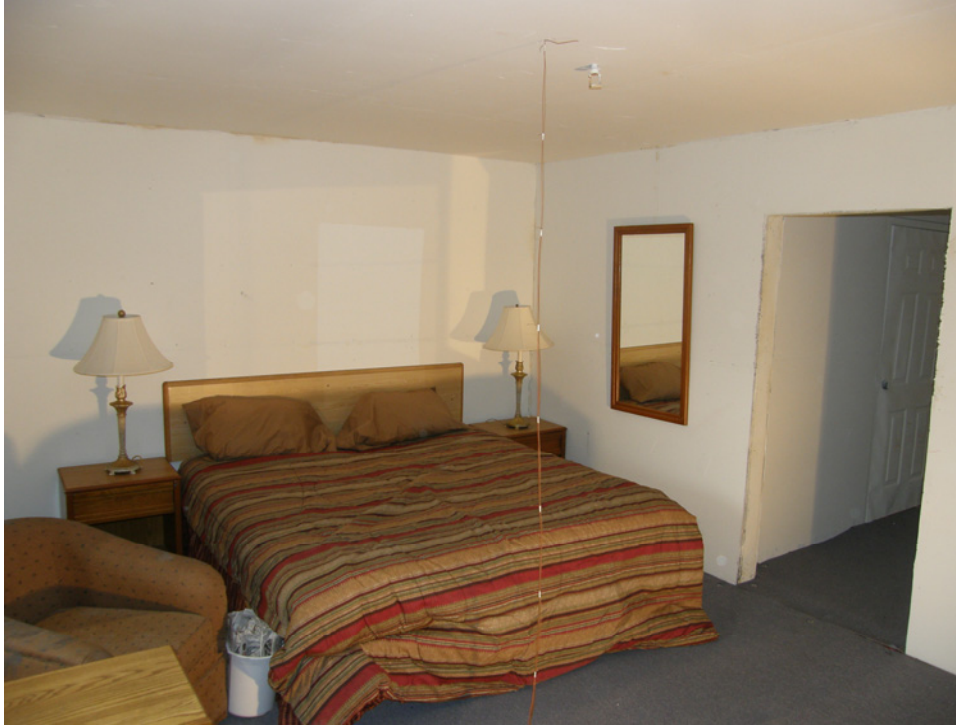
Figure 5-1. Photograph of the placement of the trash container fuel package ignition source.

After ignition, the fires grew unaided. The fires continued to grow and eventually transferred enough energy to the 6 mm (0.25 in) thick window glass to cause it to fail, either a crack or an opening created by cracking glass. After window failure, a researcher in a firefighter personal protective ensemble (PPE), would clear out the remaining pieces of glass so that the effective window opening size would be consistent for each experiment. Then the fire was observed until it appeared that it had spread through the structure and untenable conditions, even for a fully protected firefighter, existed in the corridor portion of the structure. Then, the mitigation tactics were employed, and ultimately the fire was suppressed.

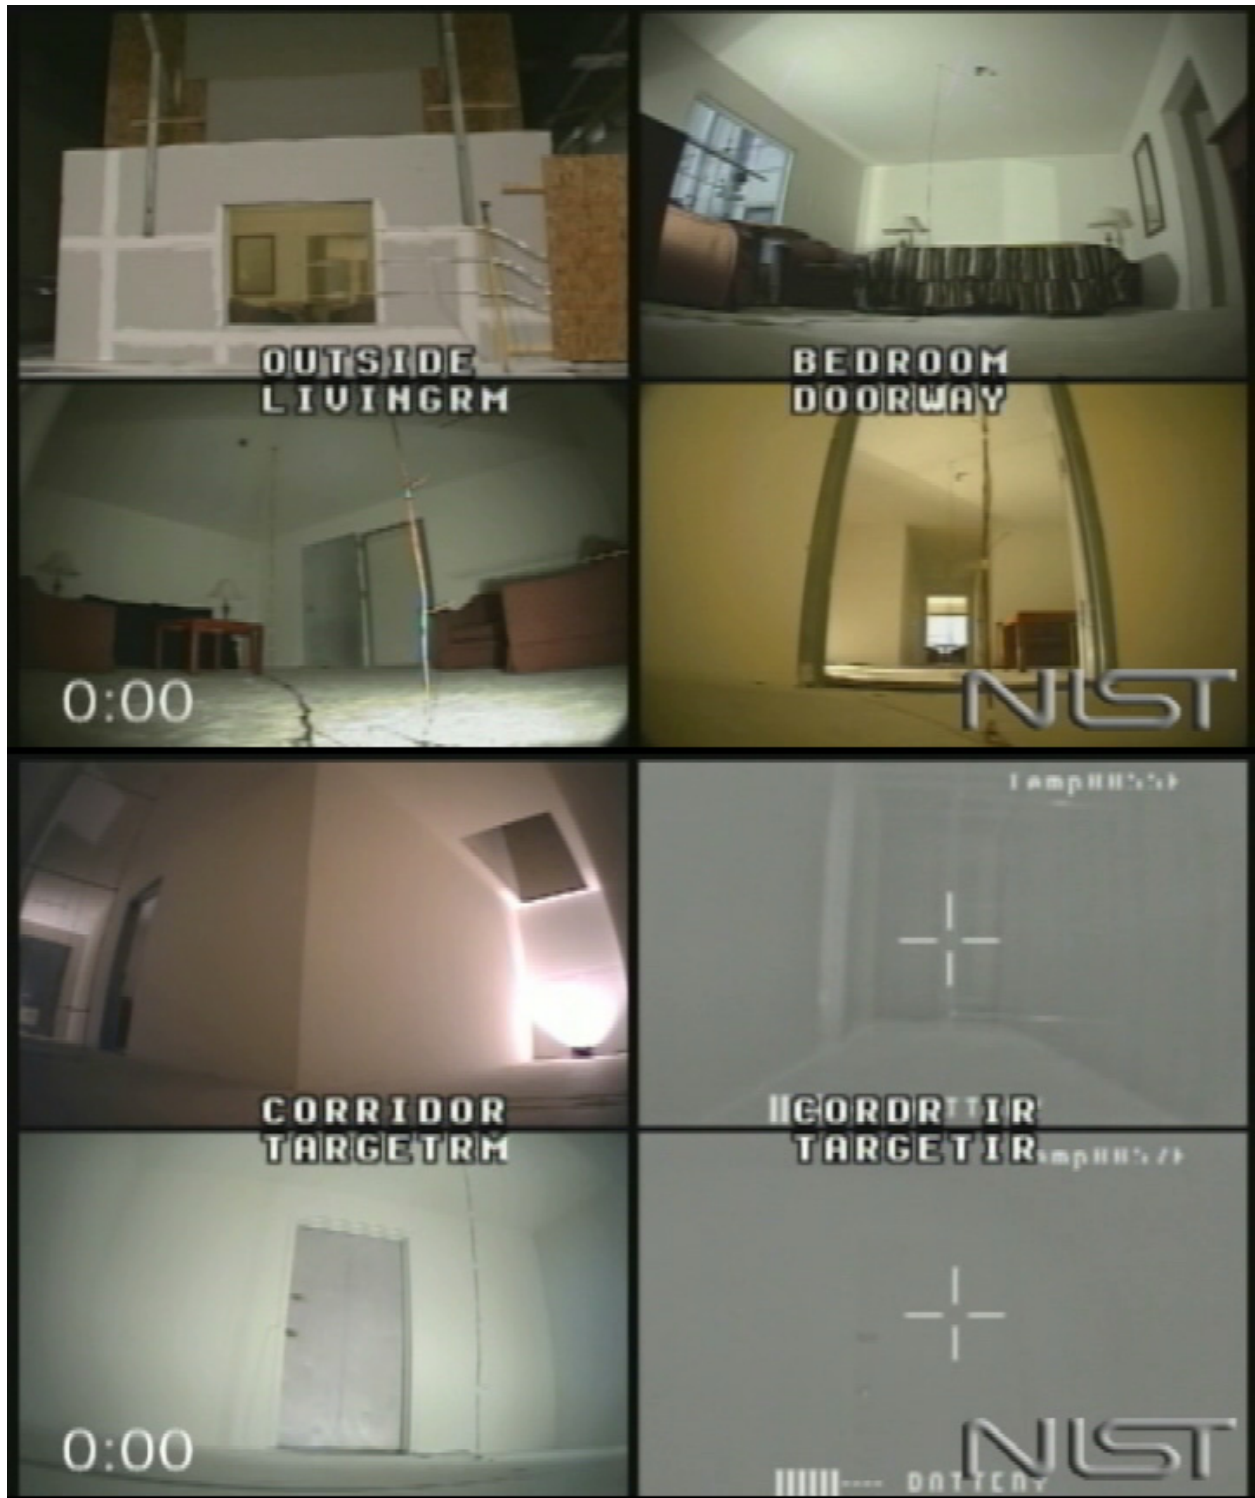
Figure 5.1.1-1. Experiment 1, ignition.

Figure 5.1.1-1 shows the conditions at the time of ignition. At this point, the six video views are clear and unobstructed. However, the thermal images provide limited thermal contrast, because the surfaces in the view were at nearly equal temperature.

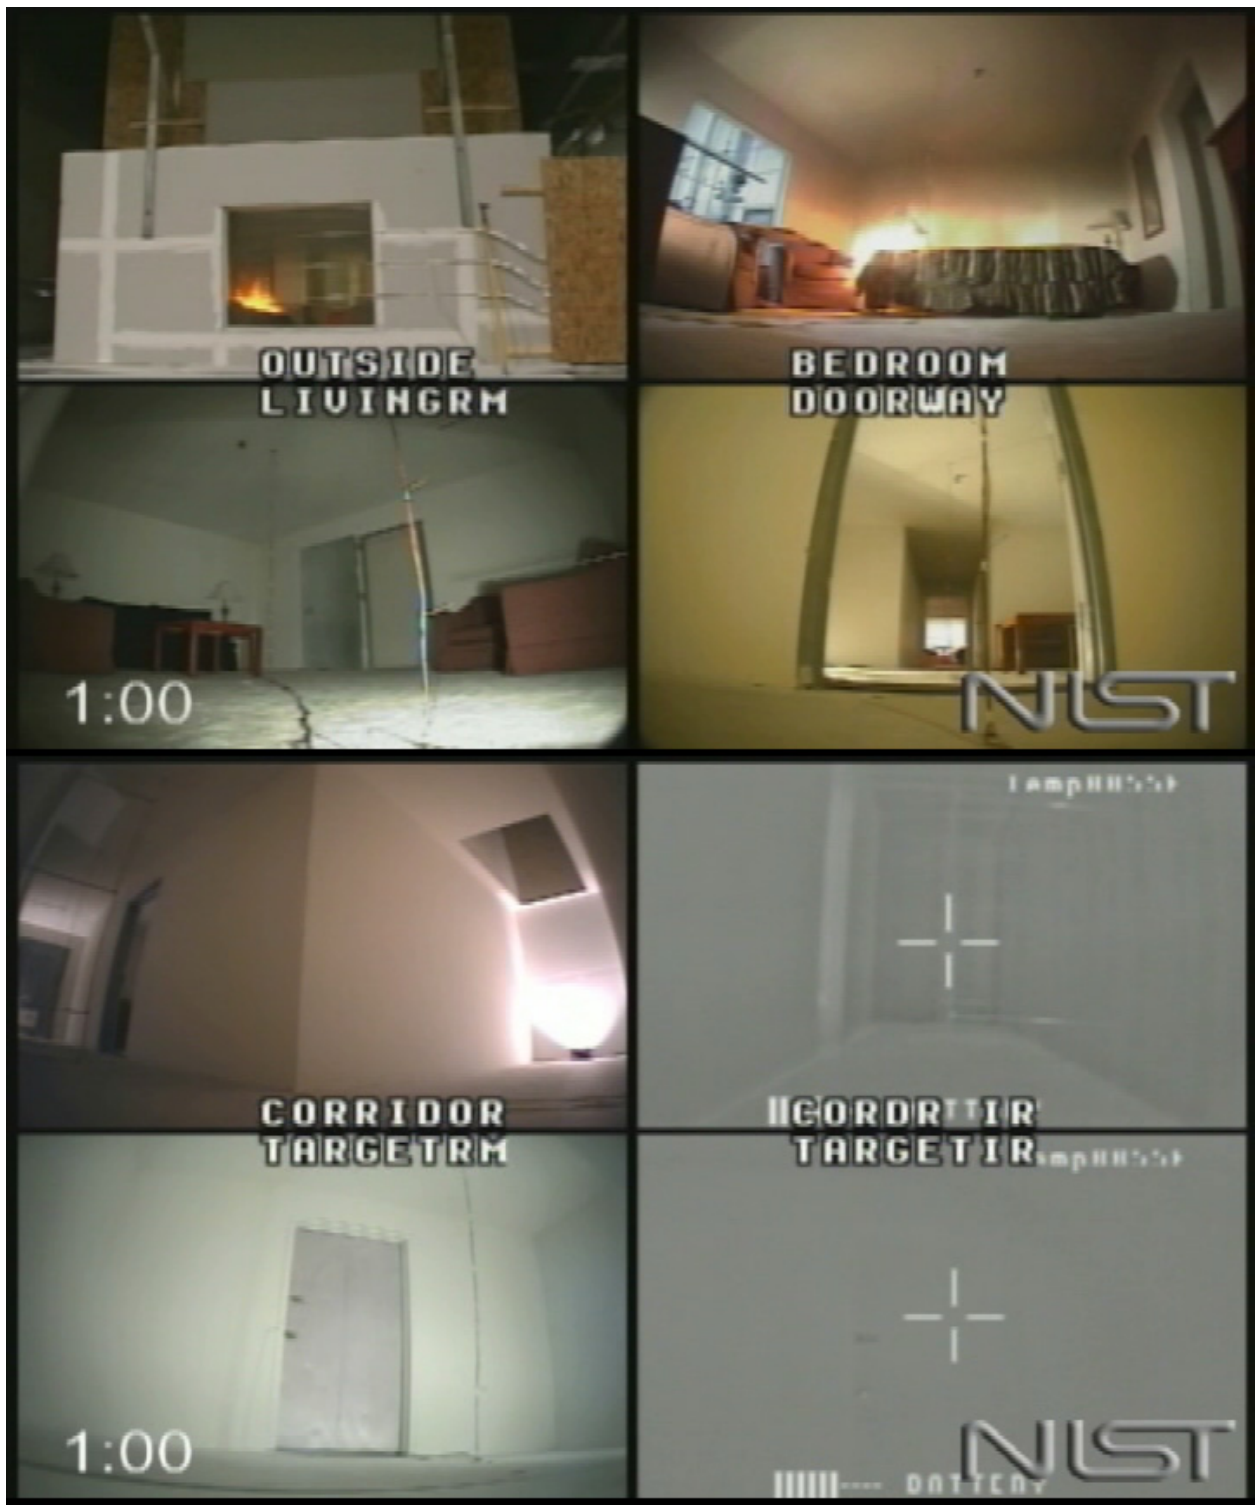
Figure 5.1.1-2. Experiment 1, 60 s after ignition.

The images in Figure 5.1.1-2 were captured 60 s after ignition. The fire from the trash container spread to both the bed and the upholstered chair. A smoke layer formed in the bedroom, and the ceiling jet started to move down the hall. There was no smoke or change in thermal condition in the living room, target room or corridor at this time.

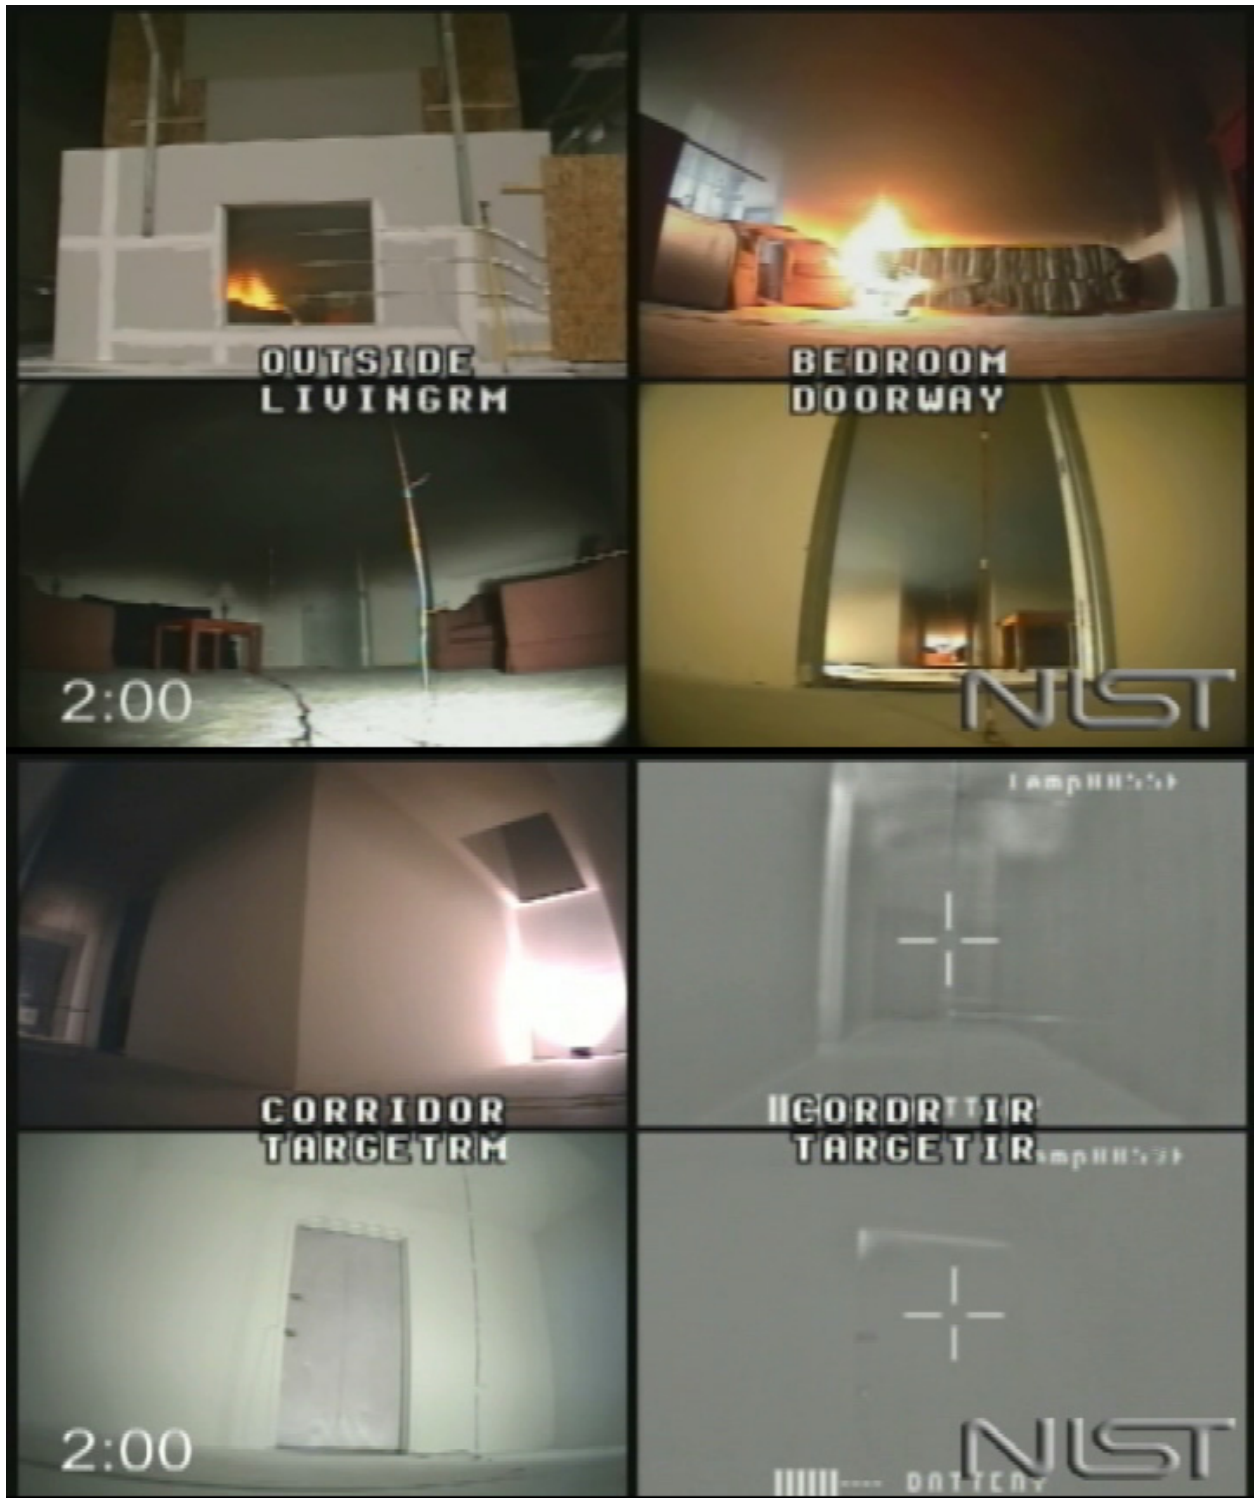
Figure 5.1.1-3. Experiment 1, 120 s after ignition.

The images in Figure 5.1.1-3 were recorded at 120 s after ignition. The area involved in fire between the bed and the chair increased in size. The smoke layer was approximately 1.2 m (4 ft) thick throughout the bedroom, hall and living room. Smoke and heat had just started to flow into the corridor. The target room appears clear of smoke, however the target room IR view shows some heat infiltration along the top edge of the door between the hall and the target room.
