NIST Technical Note 1618

Fire Fighting Tactics Under Wind Driven Conditions: Laboratory Experiments

Daniel Madrzykowski
Stephen Kerber

January 2009

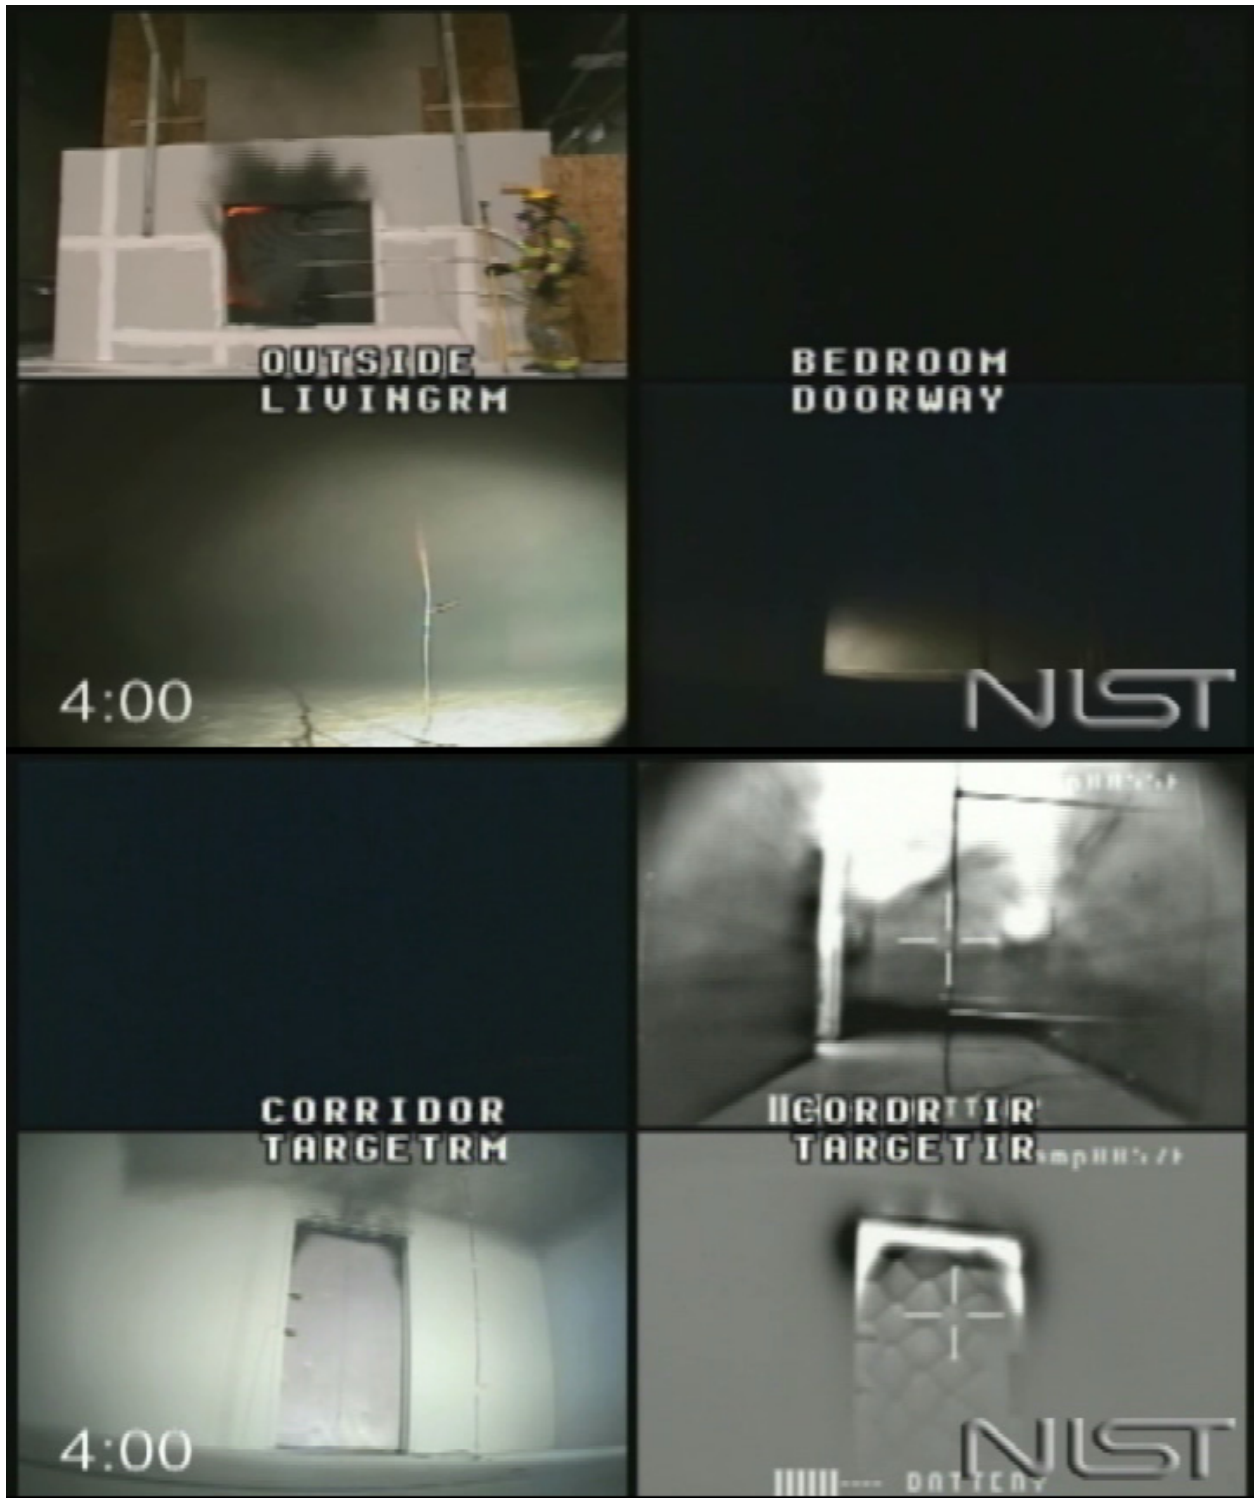
Figure 5.1.1-5. Experiment 1, 240 s after ignition.

Figure 5.1.1-5 shows the conditions at 240 s after ignition. After flames had impinged directly on the upper north side corner of the window, a section of glass had broken out along the top edge of the window, which allowed smoke to vent out. The smoke layer had descended to the floor in the bedroom. This coated the lens of the bedroom camera, which obscured the view for the remainder of the experiment. The smoke layer was down to within 0.3 m of the floor in the living room and in the corridor. The heat in the corridor was still stratified. The video view of the door to the target room showed increased smoke flow into the target room. The thermal image of the target room door showed that the door was transferring heat.

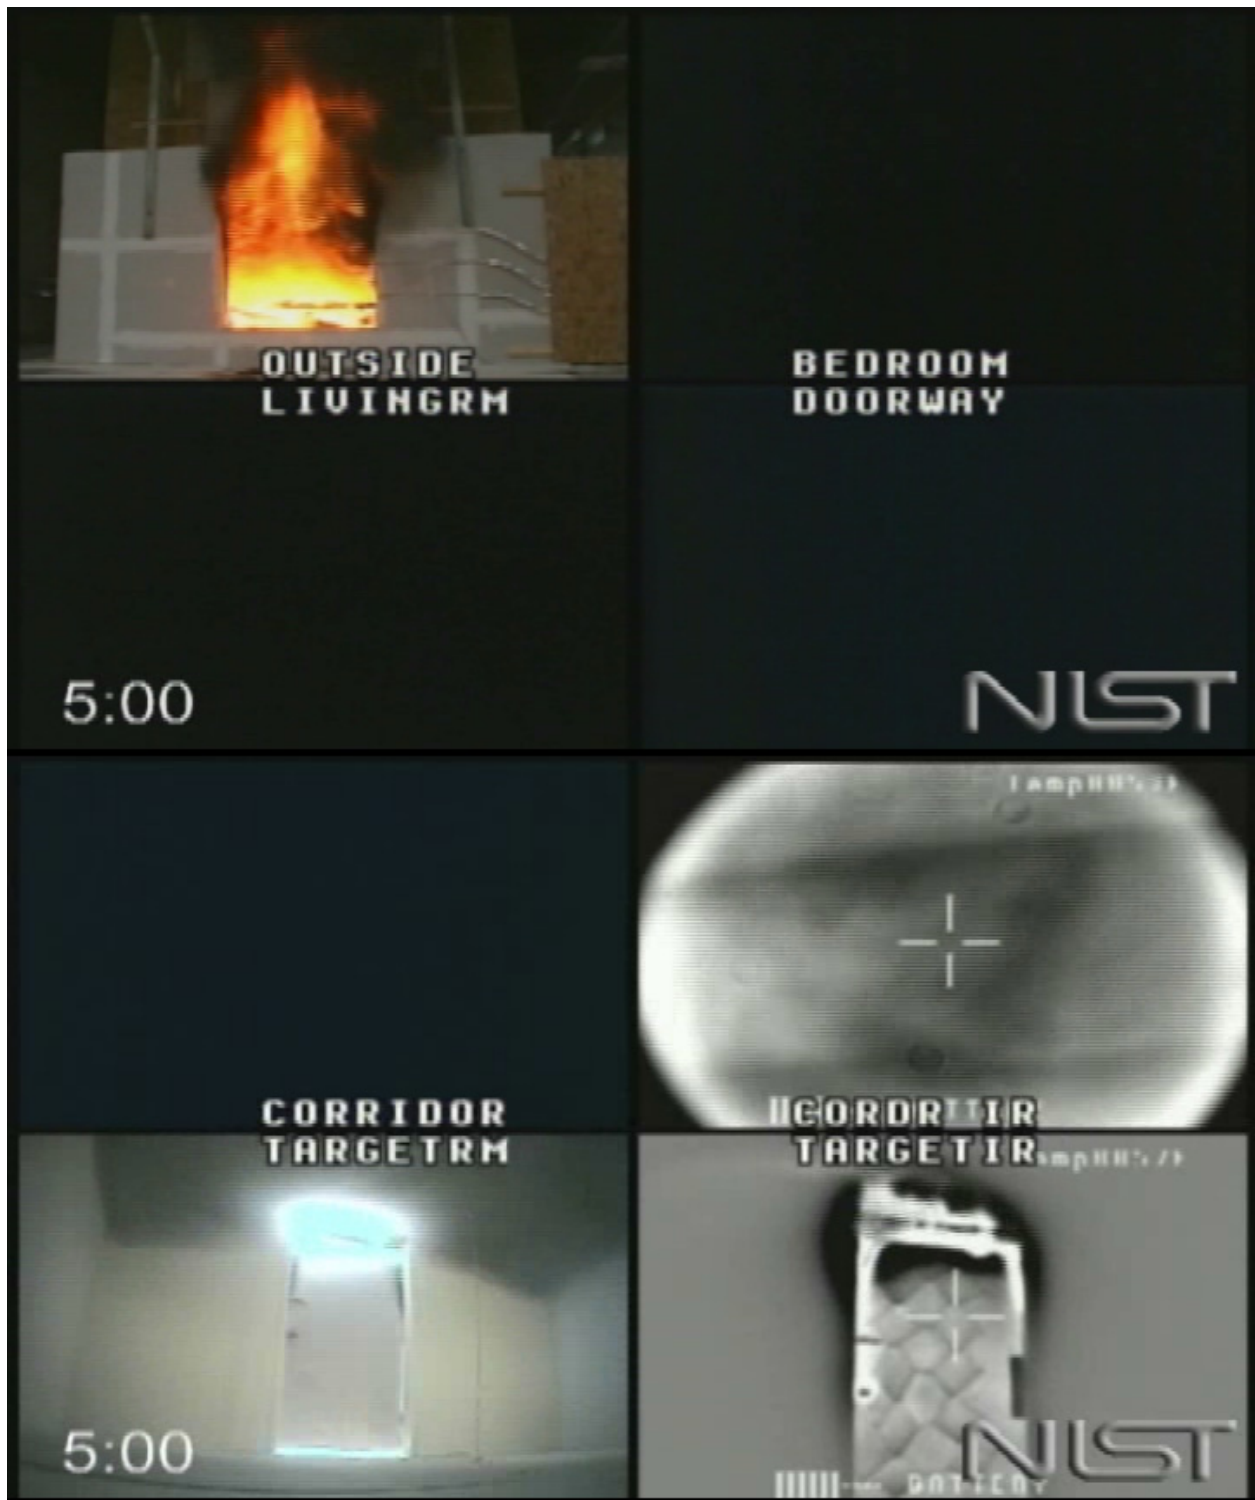
Figure 5.1.1-7. Experiment 1, 300 s after ignition.

Figure 5.1.1-7 shows the images recorded at 300 s after ignition. Flames continued to flow out of the window opening. All of the images in the flow path from the window to the corridor vent were obscured by smoke or heat. Flames had started to burn through the top of the target room door and flames can be seen at the bottom of the door as well.

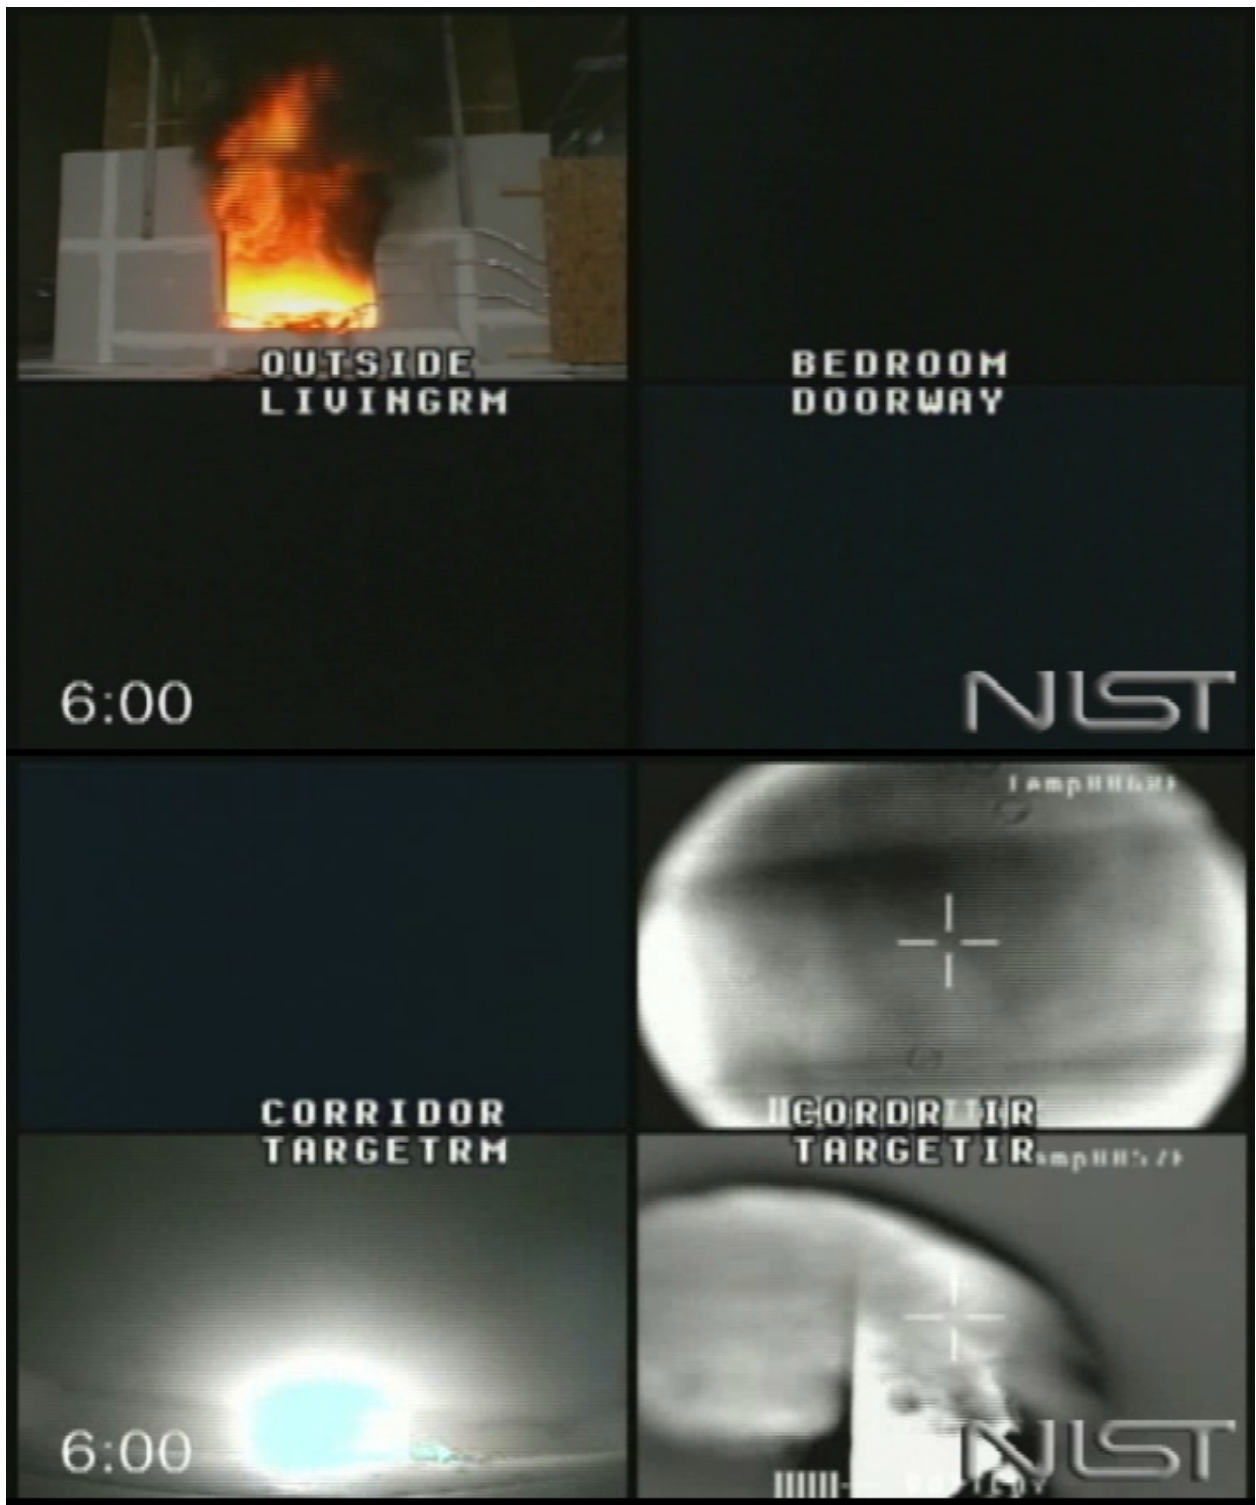
Figure 5.1.1-8. Experiment 1, 360 s after ignition.

At 360 s after ignition, Figure 5.1.1-8 conditions in the bedroom appeared to have reached a steady-state, post-flashover, condition. All of the images in the flow path from the window opening to the corridor continued to be obscured. The target room showed the biggest change in conditions, as the wood hollow core door burned through and heat and smoke filled the target room.

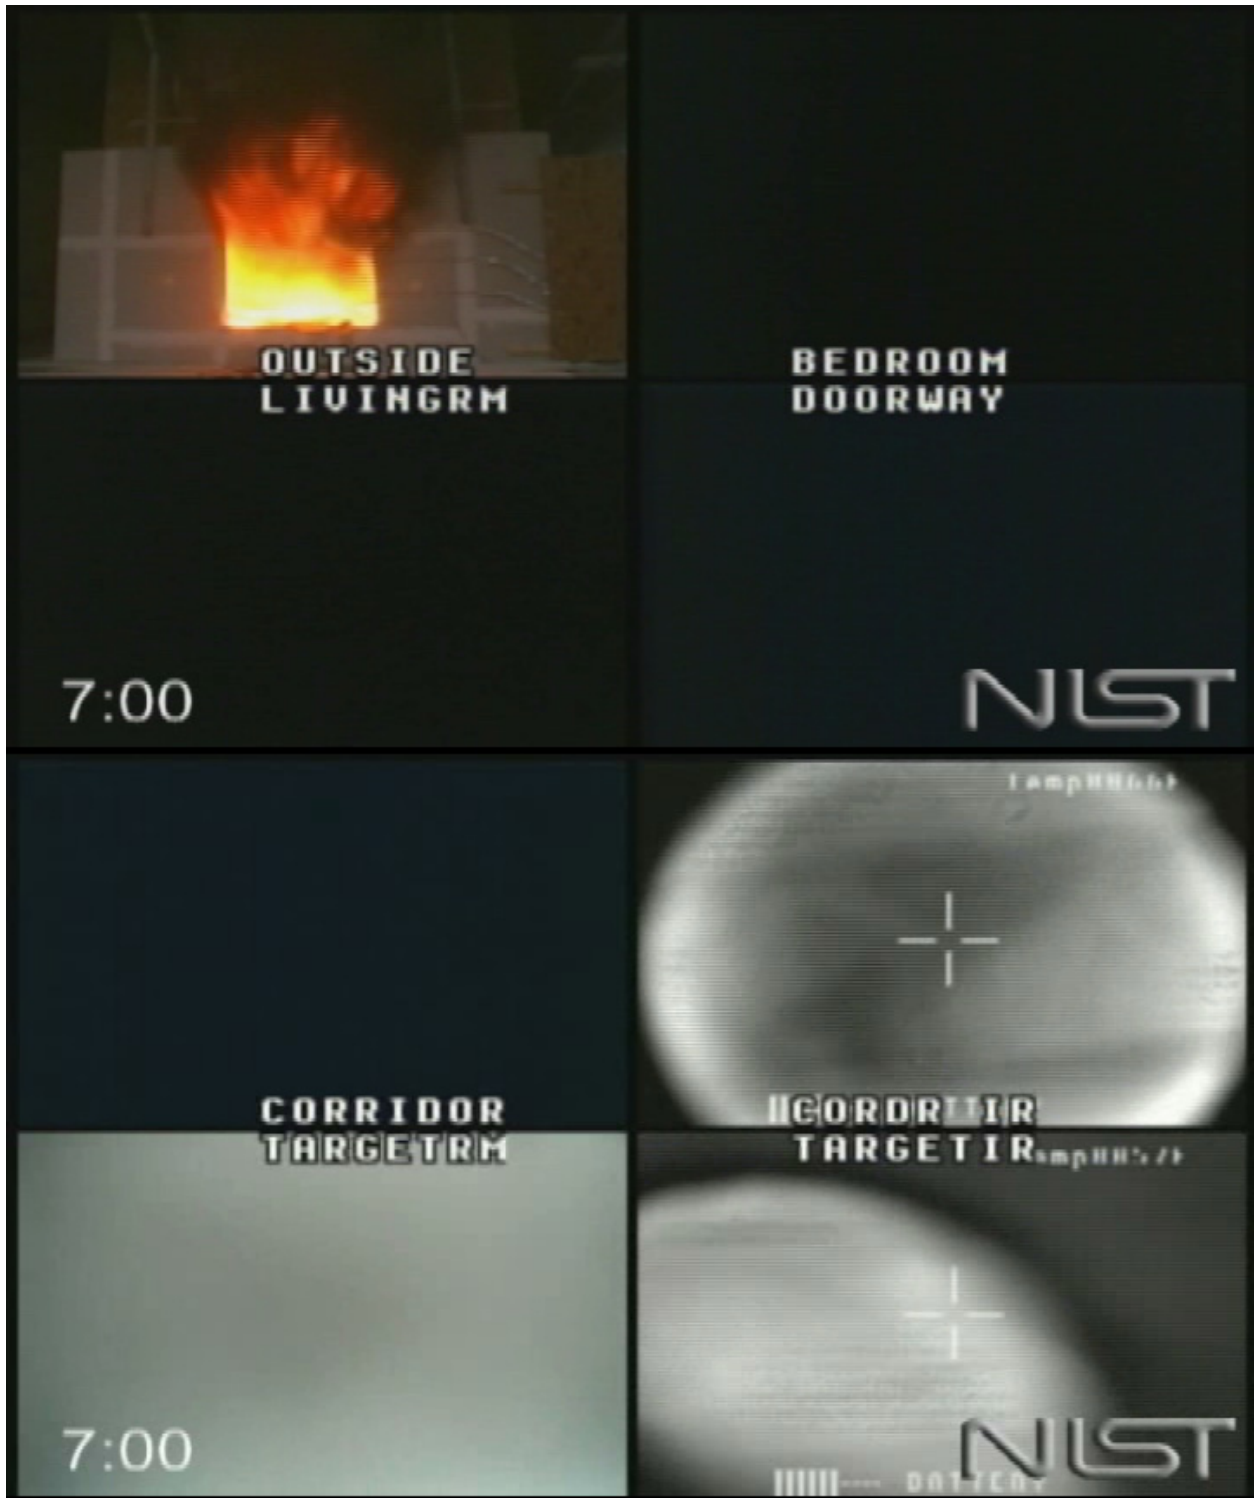
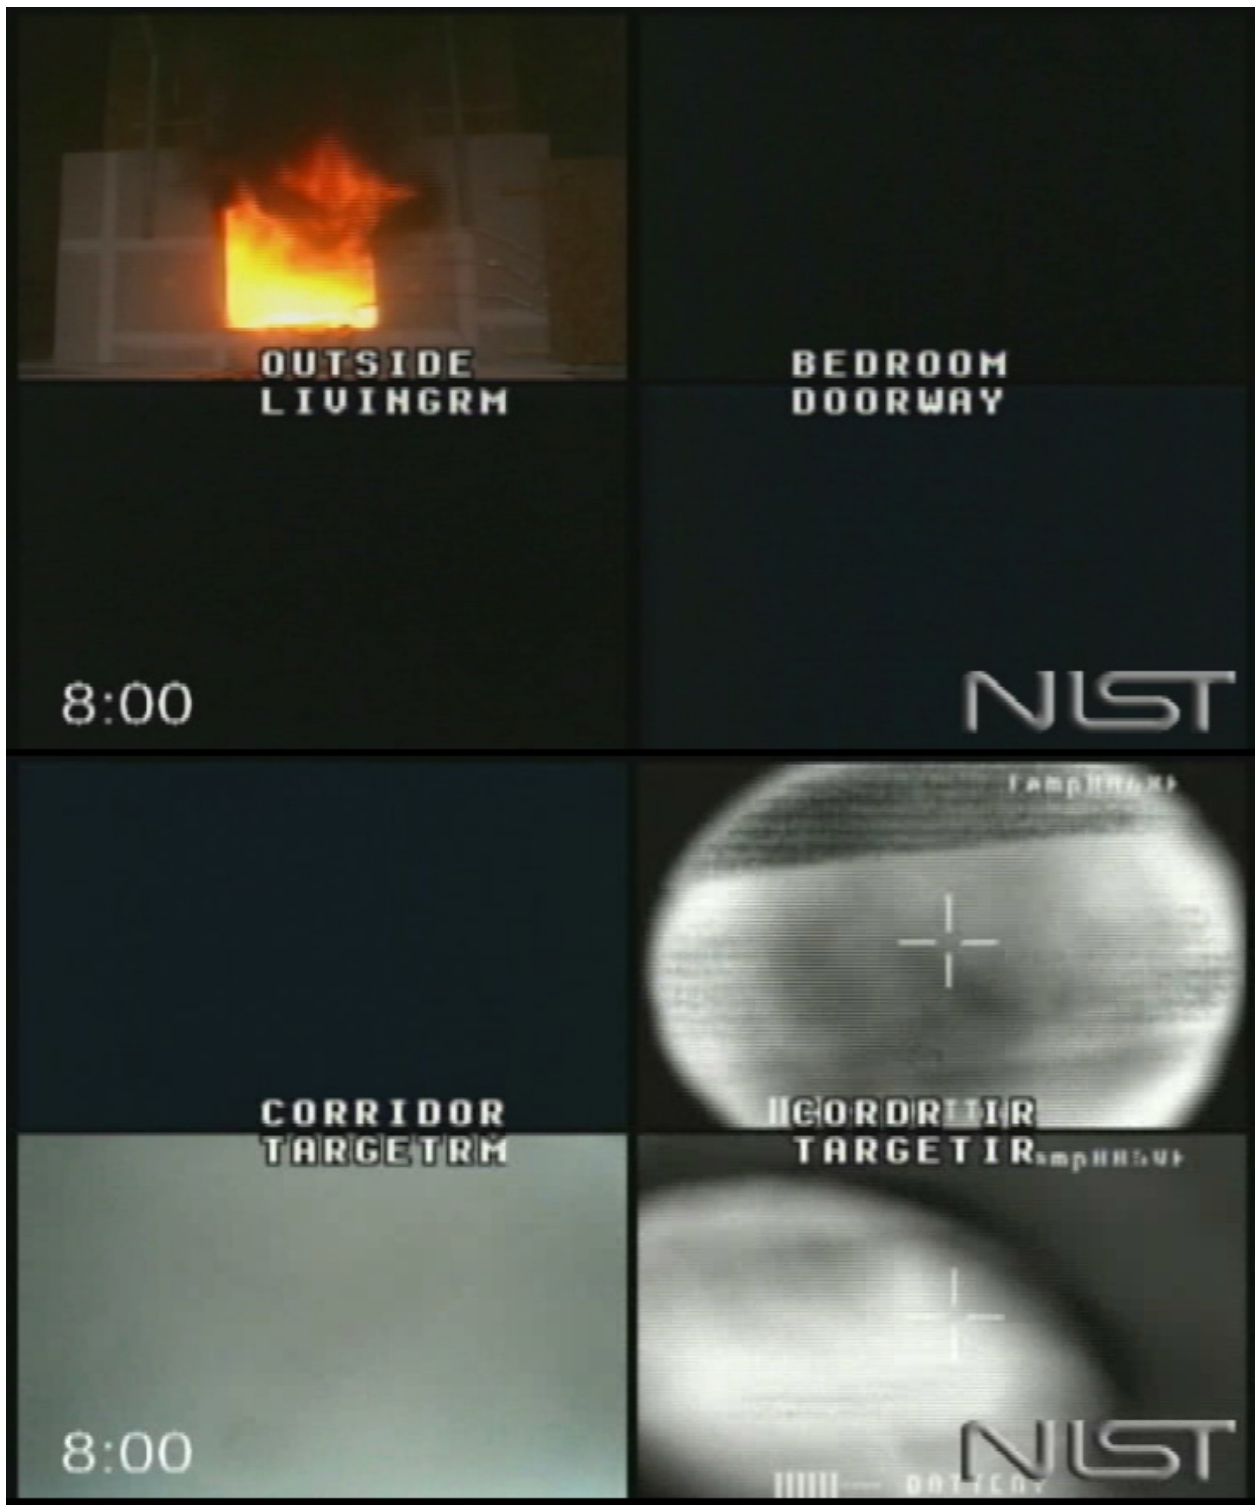
Figure 5.1.1-9. Experiment 1, 420 s after ignition.

Figure 5.1.1-10. Experiment 1, 480 s after ignition.

Figure 5.1.1-9 and Figure 5.1.1-10 show conditions very similar to those recorded at 360 s after ignition. The fire in the bedroom continued as a post-flashover compartment fire as the flames pulsed out of the window opening. This continued until the safety sprinklers were activated at approximately 490 s after ignition. Suppression continued with a hose stream being applied through the window opening at 525 s after ignition.

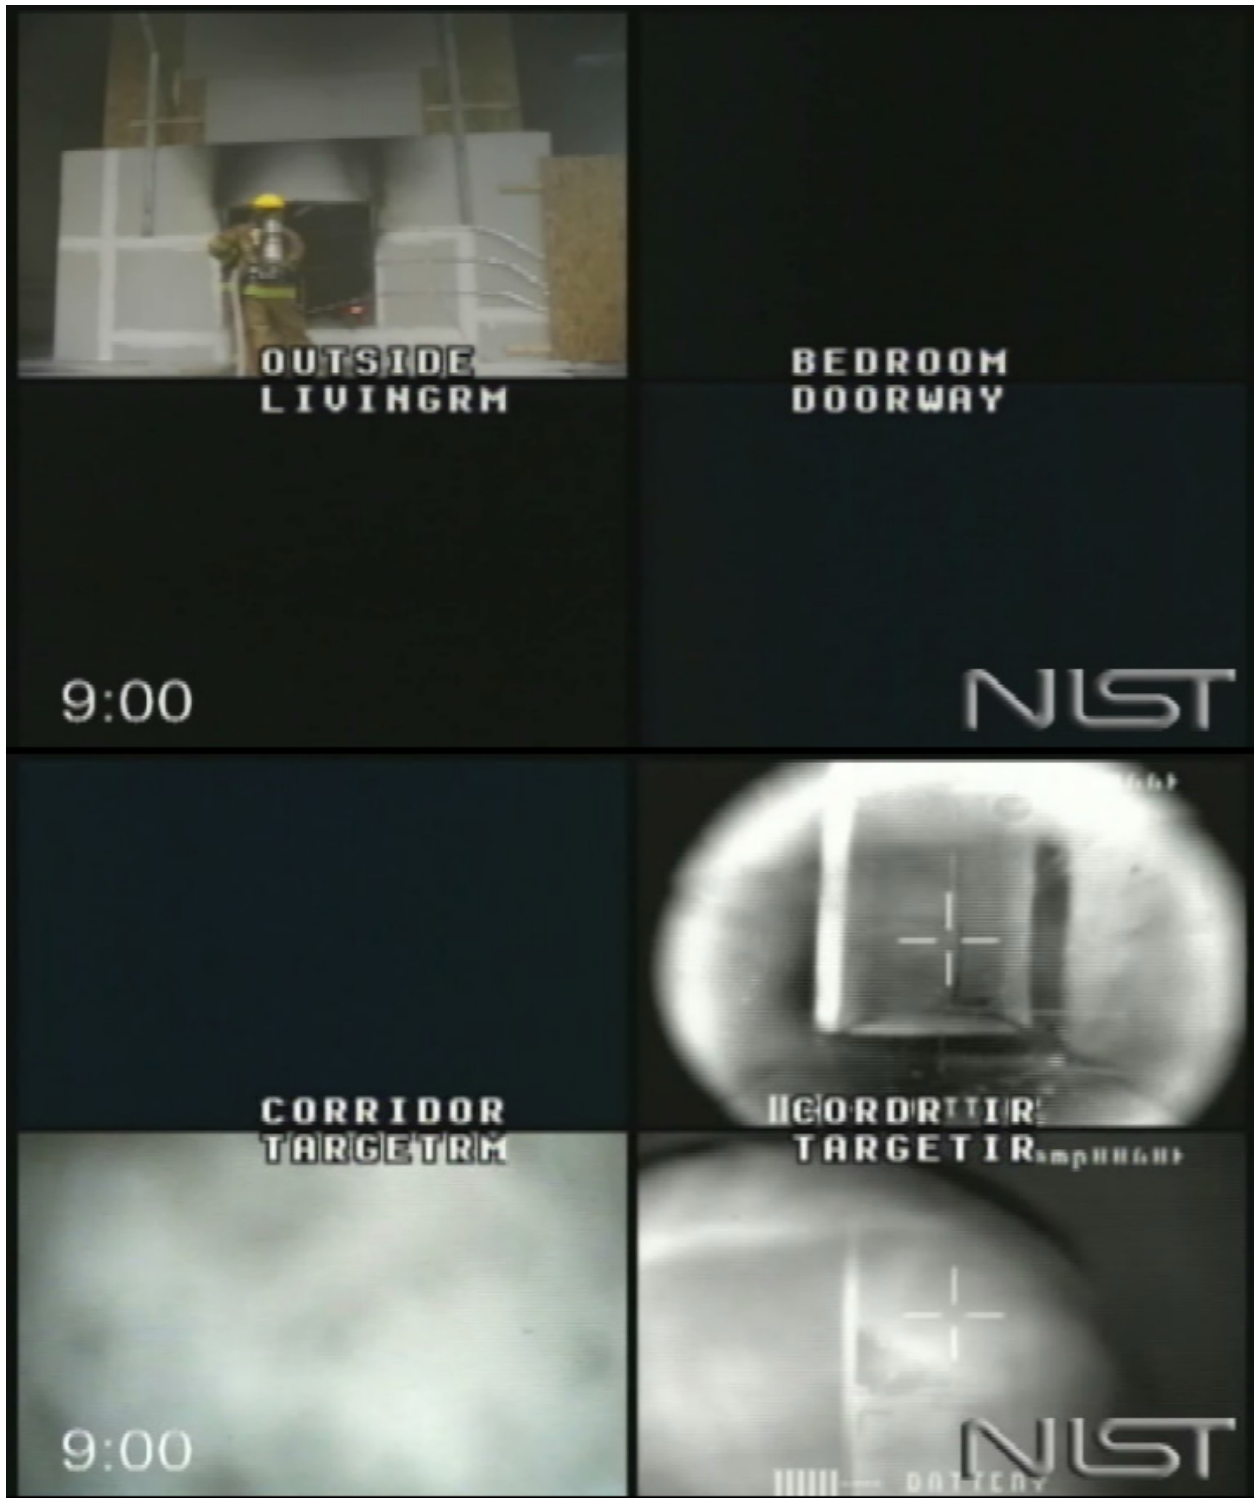
Figure 5.1.1-11. Experiment 1, 540 s after ignition.

The last set of images, Figure 5.1.1-11, was recorded at 540 s after ignition. At this point, the majority of the fire in the bedroom was suppressed. The dark areas, on the floor and the east wall of the corridor, in the corridor IR view are areas that were cooled by water from the hose streams that came through the living room doorway to the corridor.

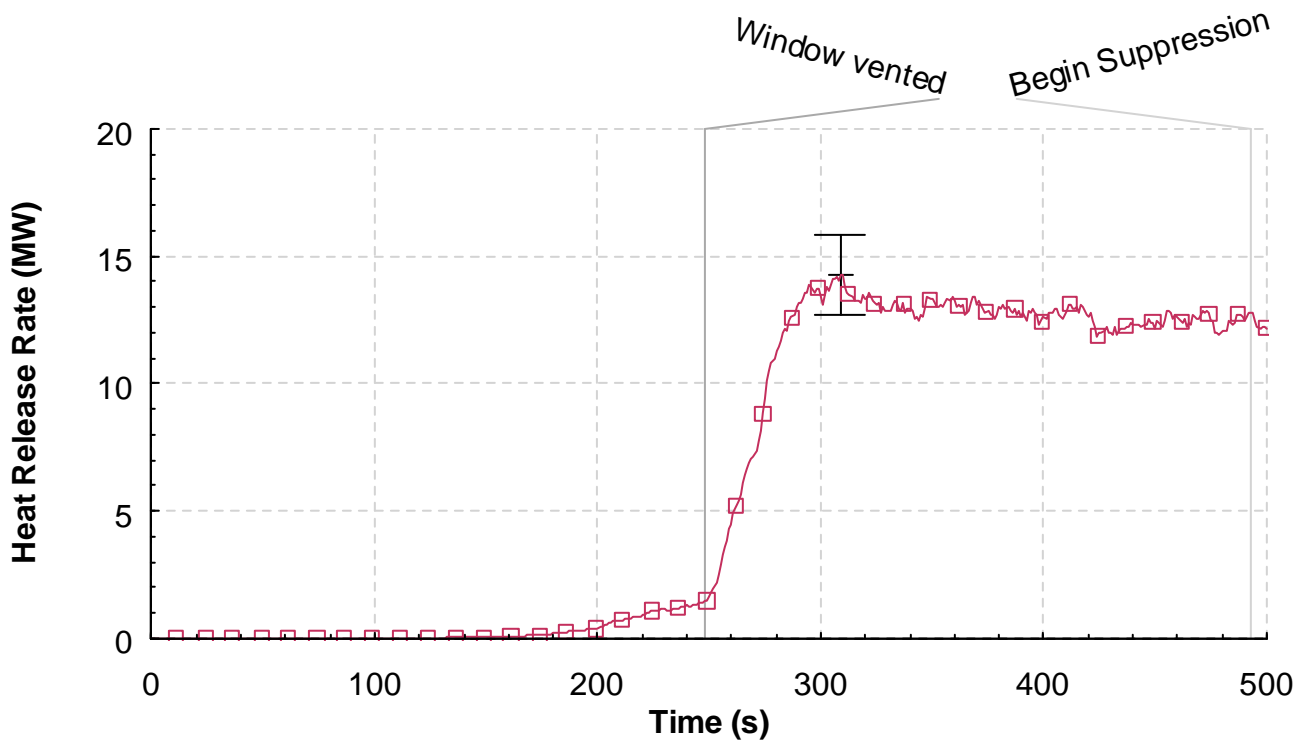
Figure 5.1.2-1. Heat release rate versus time, Experiment 1.

Figure 5.1.2-1 shows the heat release rate time history for Experiment 1. The measured heat release rate was zero for the first 150 s after ignition because the heat generated by the fire up to this time was contained within the experimental structure. After 150 s, the combustion products began to flow from the corridor vent into the oxygen consumption calorimeter. As the flow from the vent increased the heat release rate slowly increased to 1.5 MW. After the window was vented, the heat release rate increased from approximately 1.5 MW to 14 MW in less than 60 s. The heat release rate held steady between 12 MW and 13 MW for almost 180 s, then suppression was started.

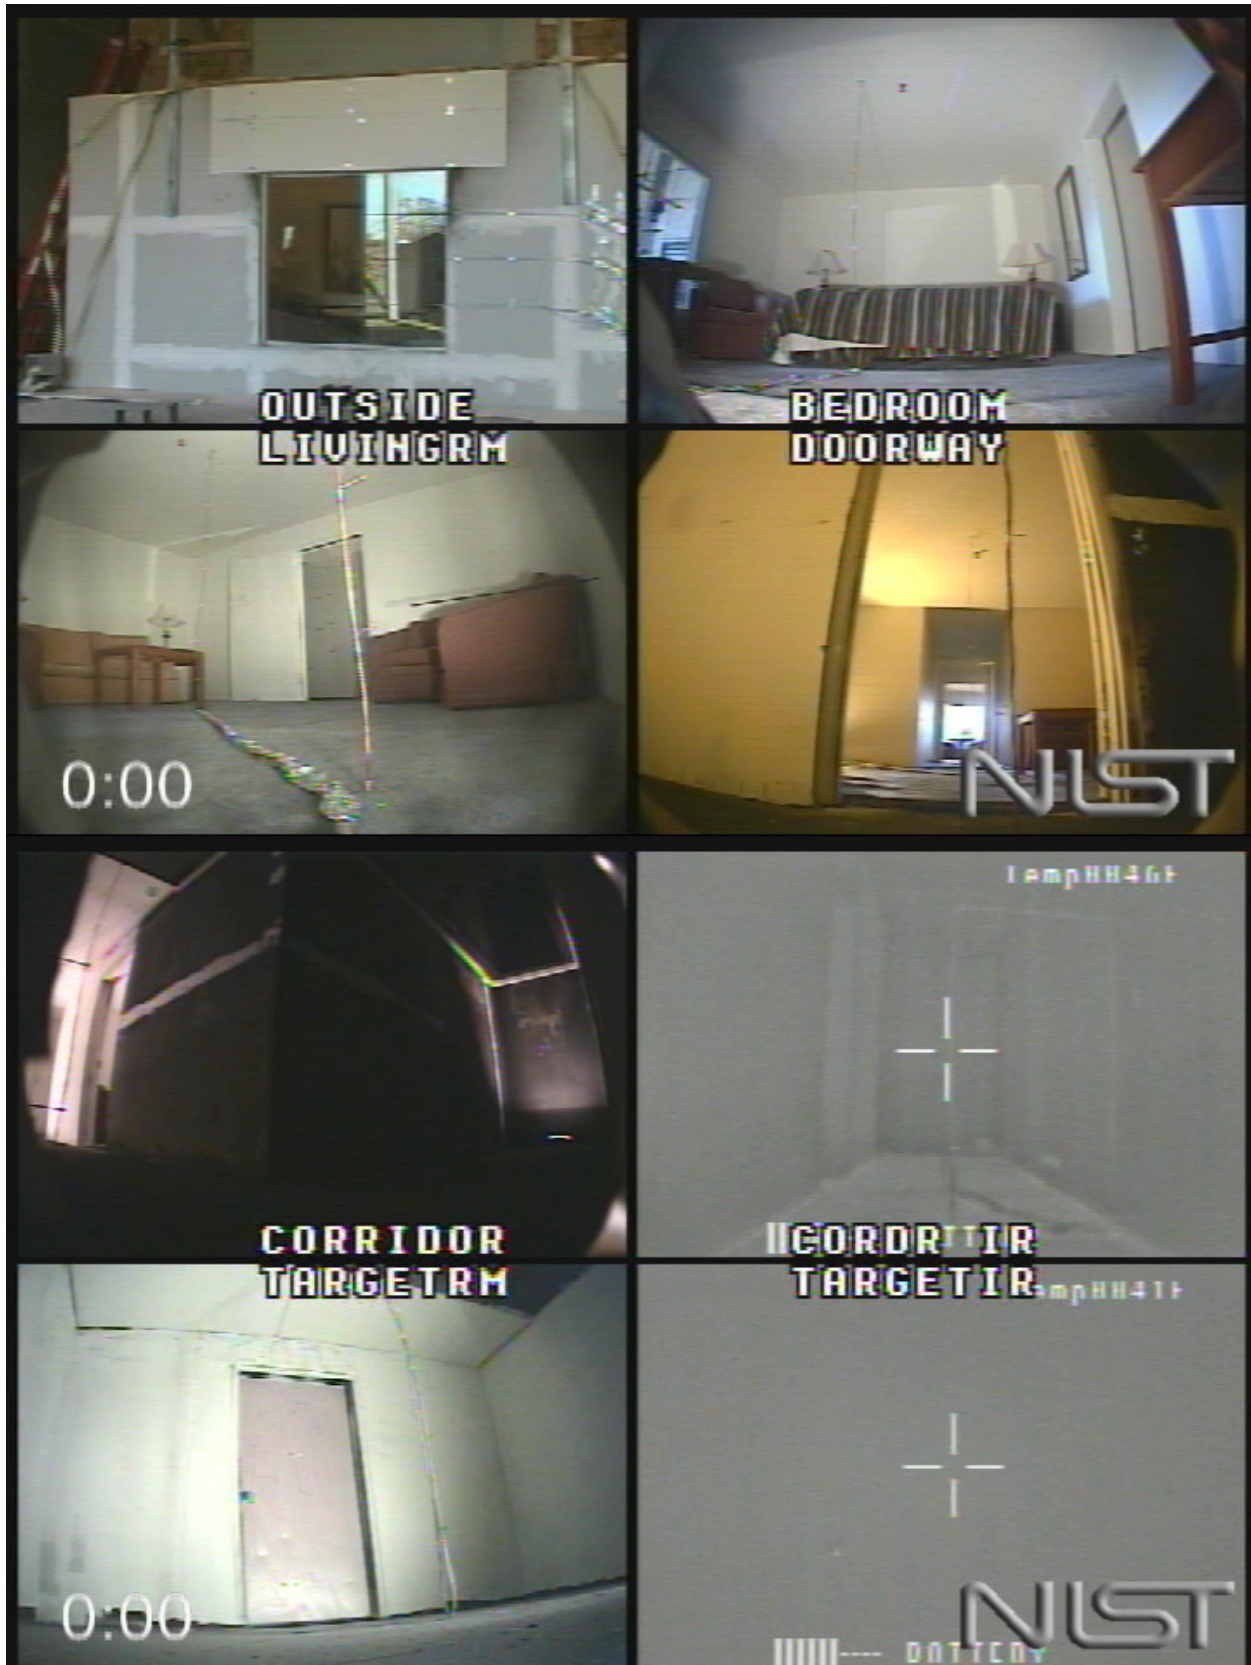
Figure 5.2.1-1. Experiment 2 ignition.

Figure 5.2.1-1 shows the conditions at the time of ignition. At this point, the six video views are clear and unobstructed. However, the thermal images provide limited thermal contrast because the surfaces in the view were at nearly equal temperature.

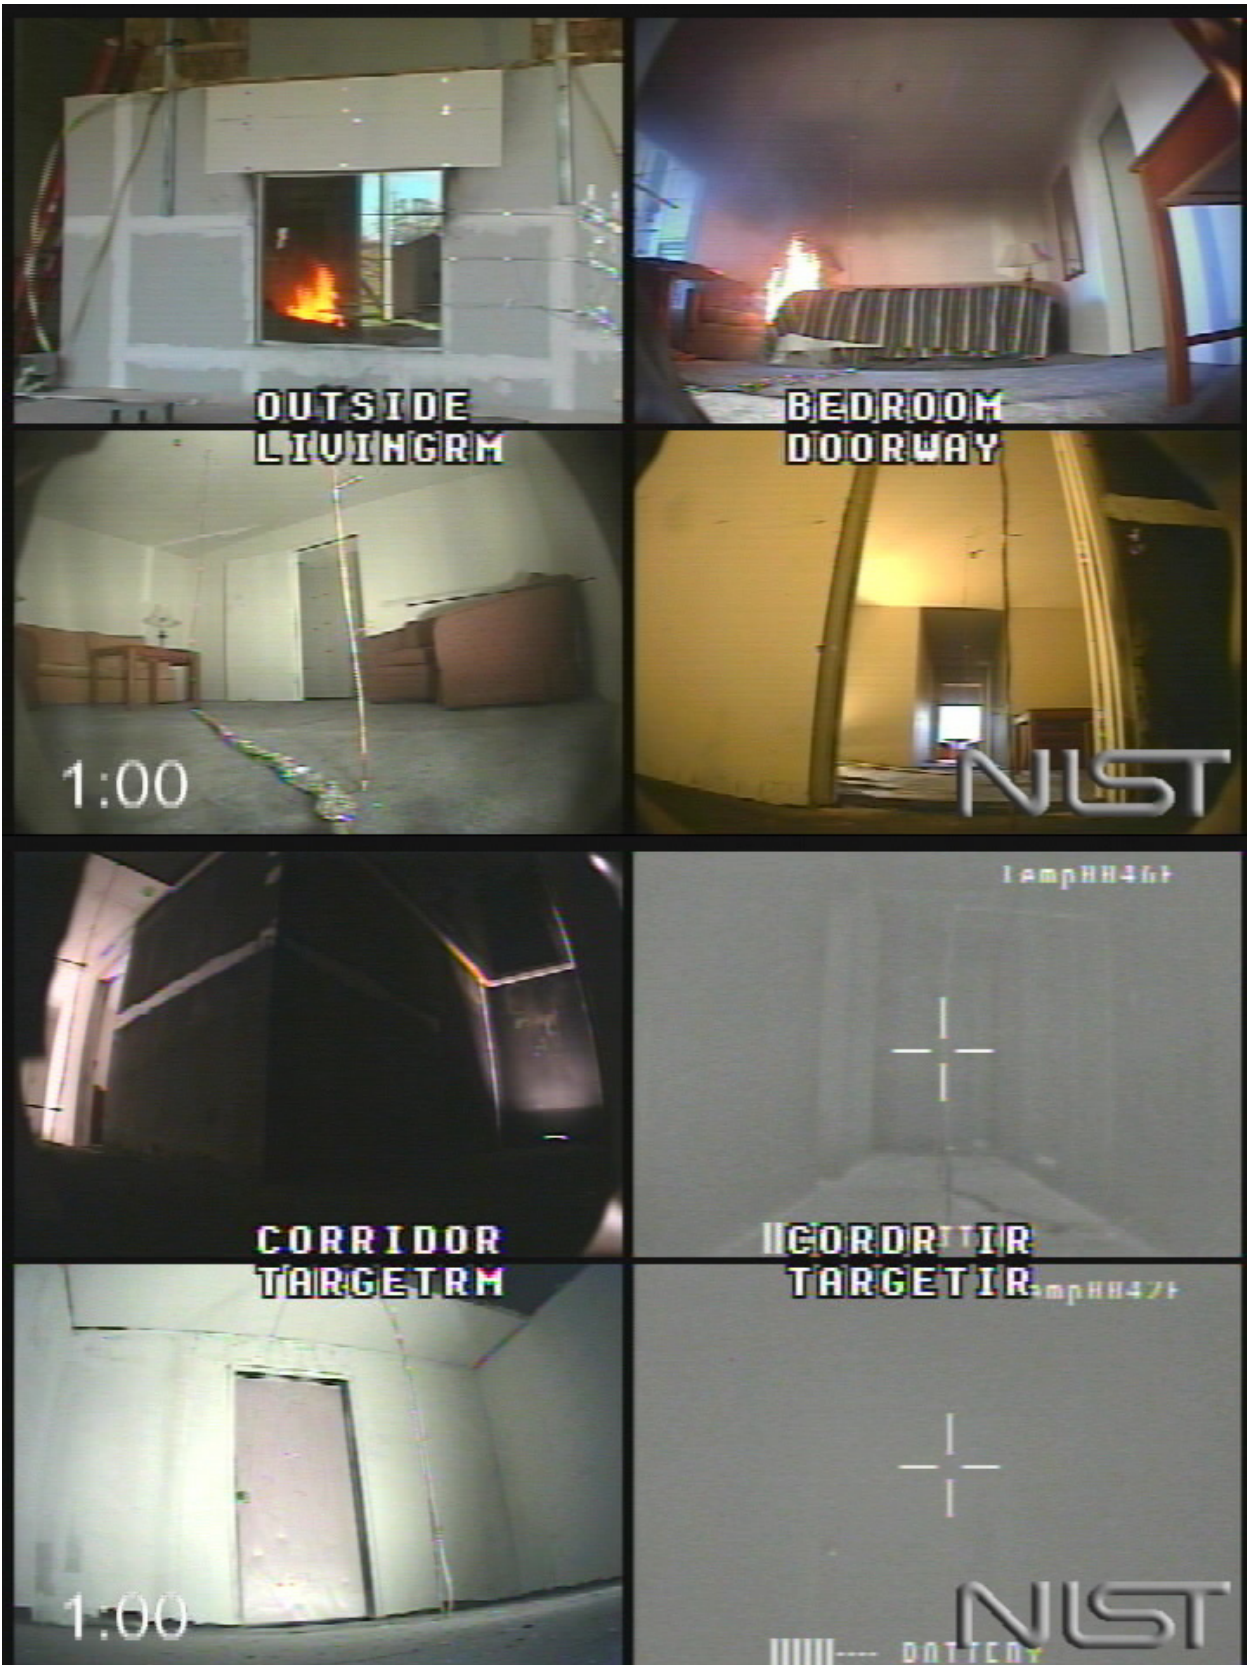
Figure 5.2.1-2. Experiment 2, 60 s after ignition.

The images in Figure 5.2.1-2 were captured 60 s after ignition. The fire from the trash container spread to both the bed and the upholstered chair. A smoke layer formed in the bedroom, and the ceiling jet started to move down the hall. There was no smoke or change in thermal condition in the living room, target room or corridor at this time.

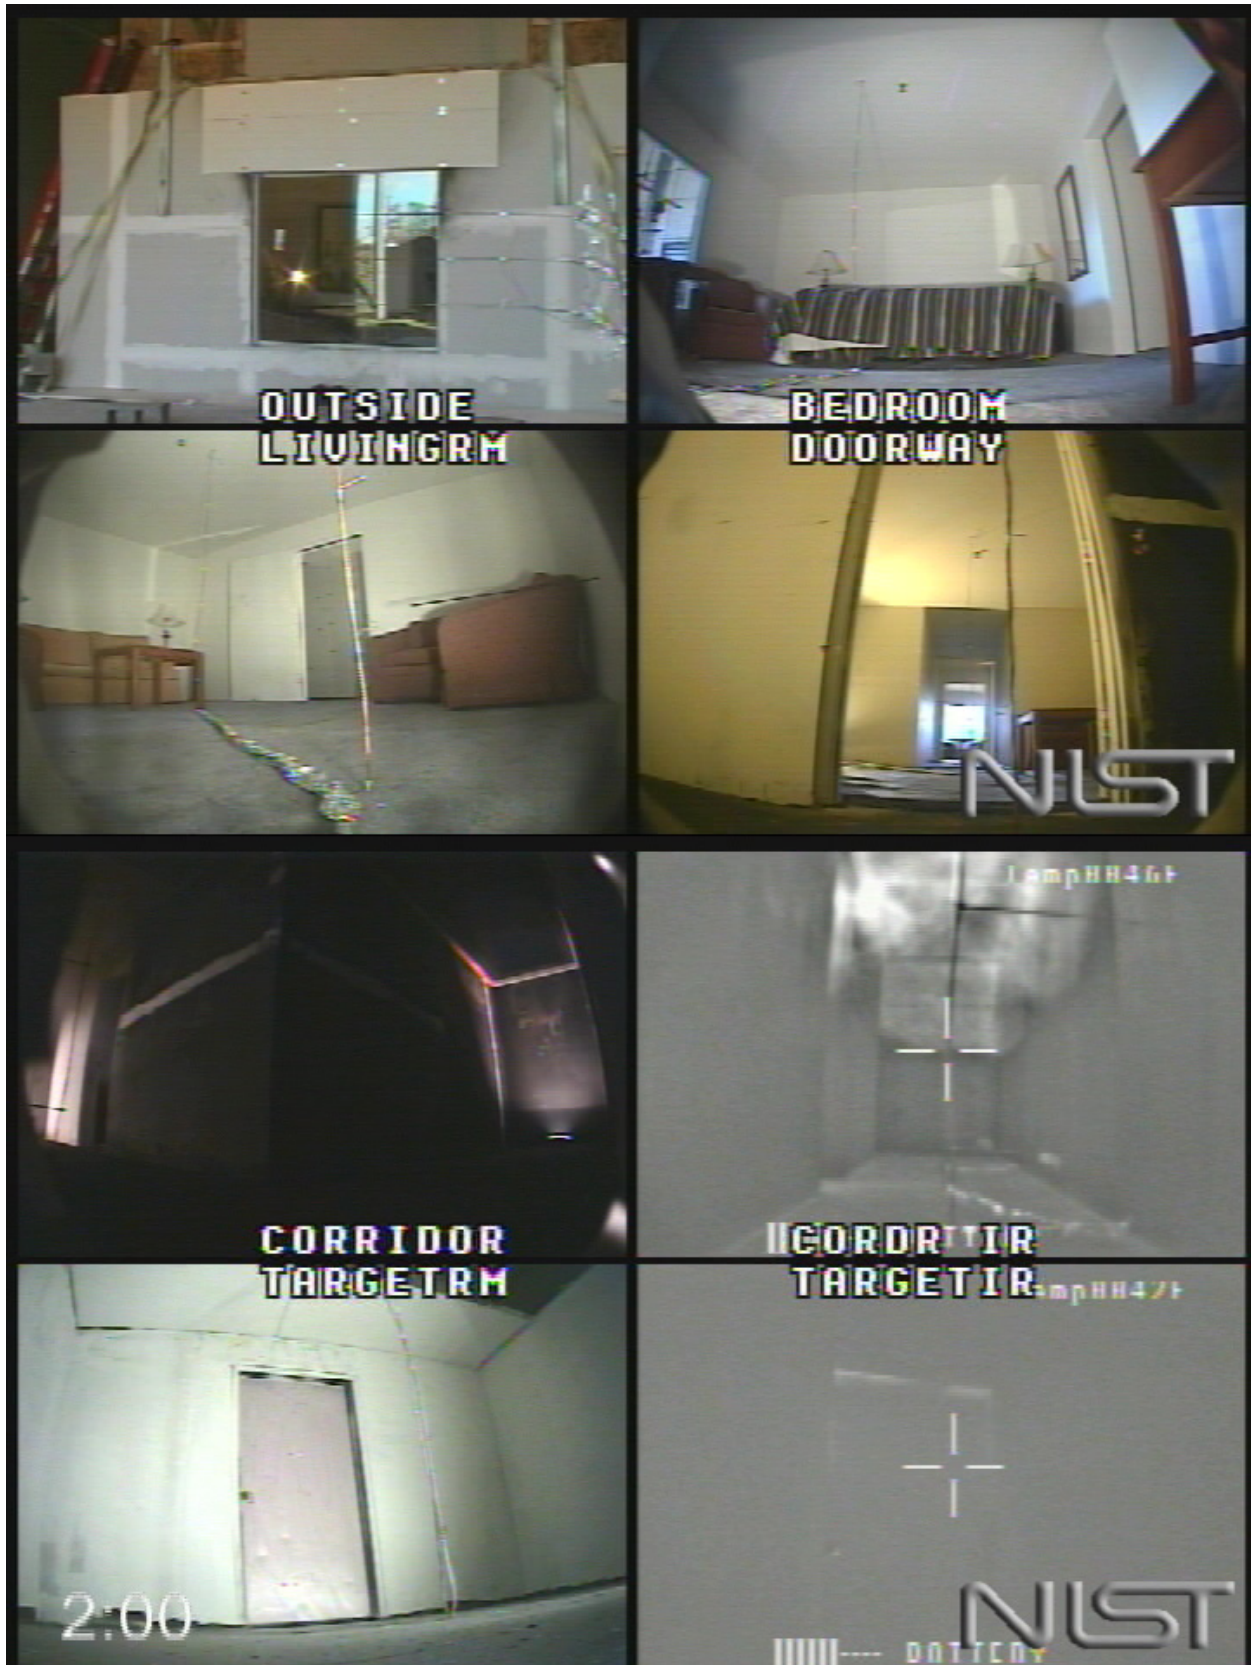
Figure 5.2.1-3. Experiment 2, 120 s after ignition.

The images in Figure 5.2.1-3 were recorded at 120 s after ignition. The area involved in fire between the bed and the chair increased in size. The smoke layer was approximately 1.2 m (4 ft) thick throughout the bedroom, hall and living room. Smoke and heat had just started to flow into the corridor. The target room appears clear of smoke, however the target room IR view shows some limited heat infiltration along the top edge of the door between the hall and the target room.

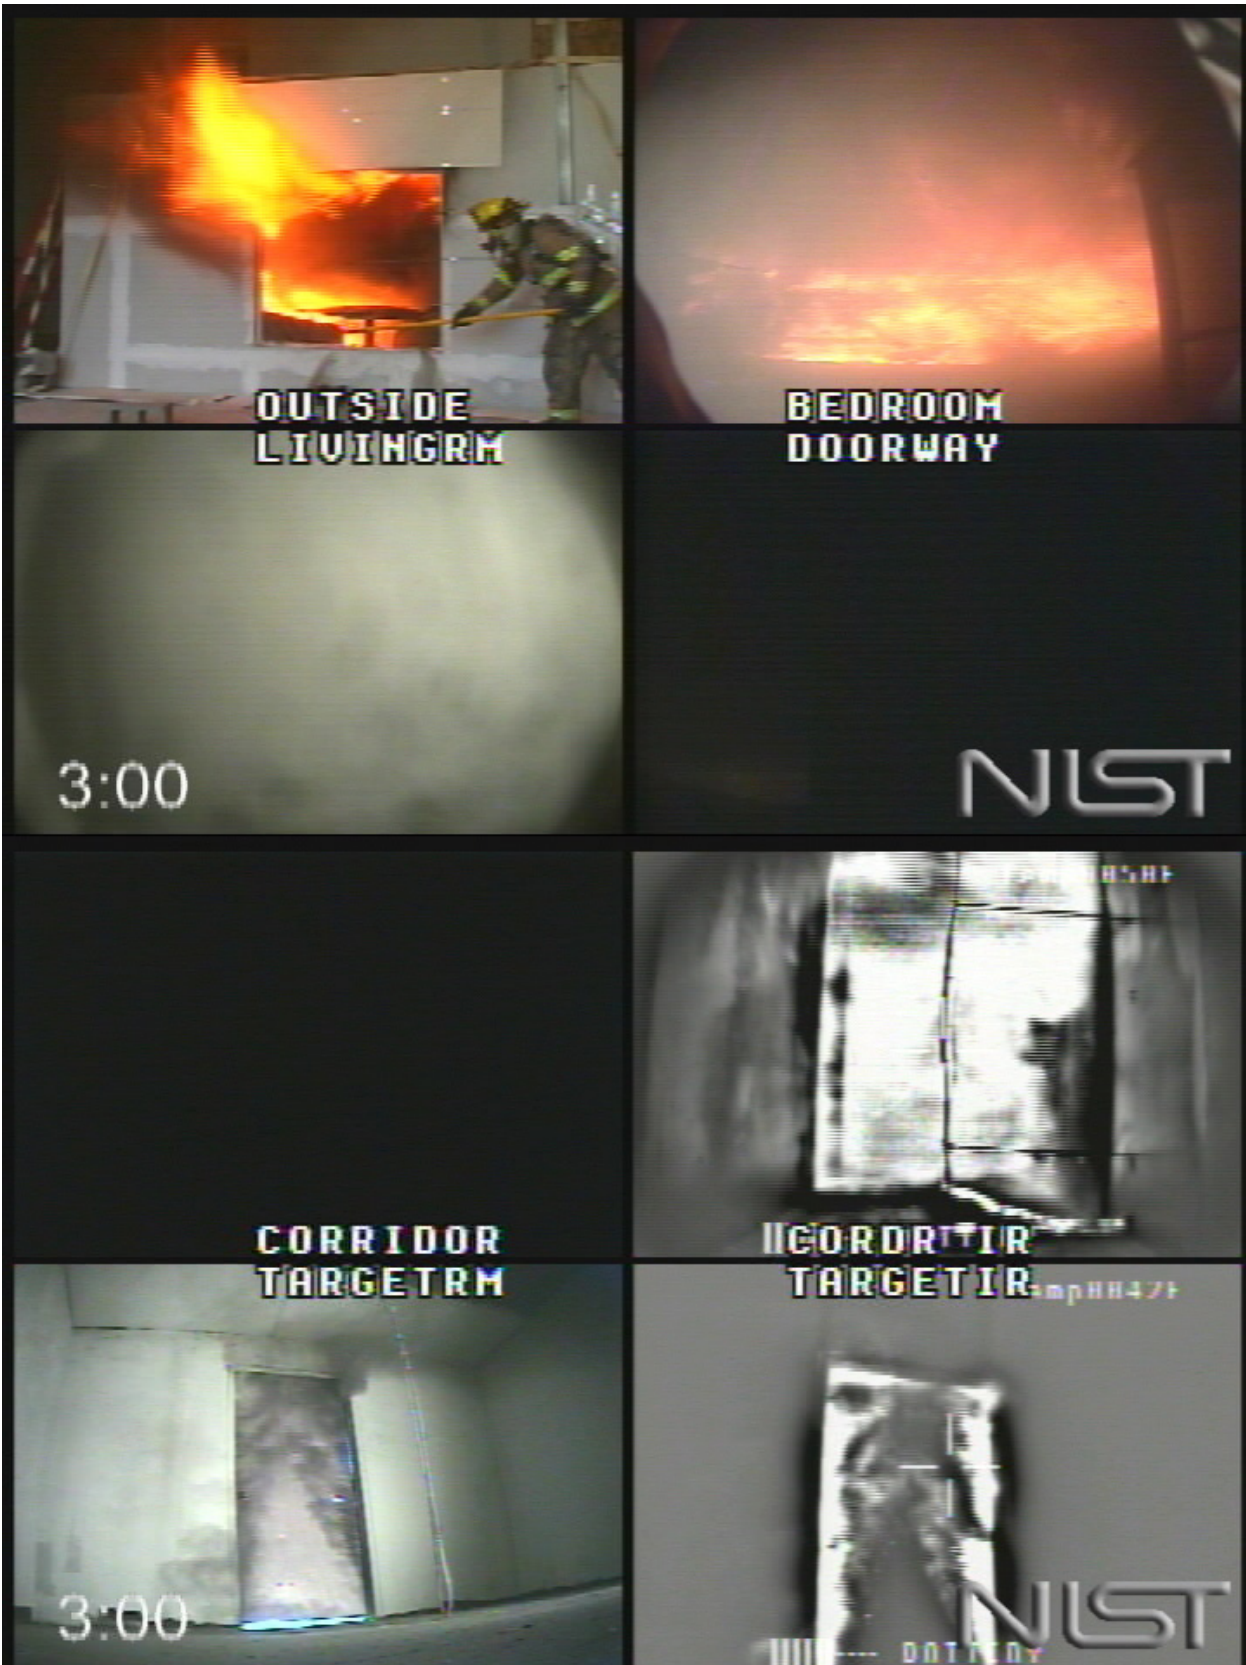
Figure 5.2.1-4. Experiment 2, 180 s after ignition.
