NIST Technical Note 1618

Fire Fighting Tactics Under Wind Driven Conditions: Laboratory Experiments

Daniel Madrzykowski
Stephen Kerber

January 2009

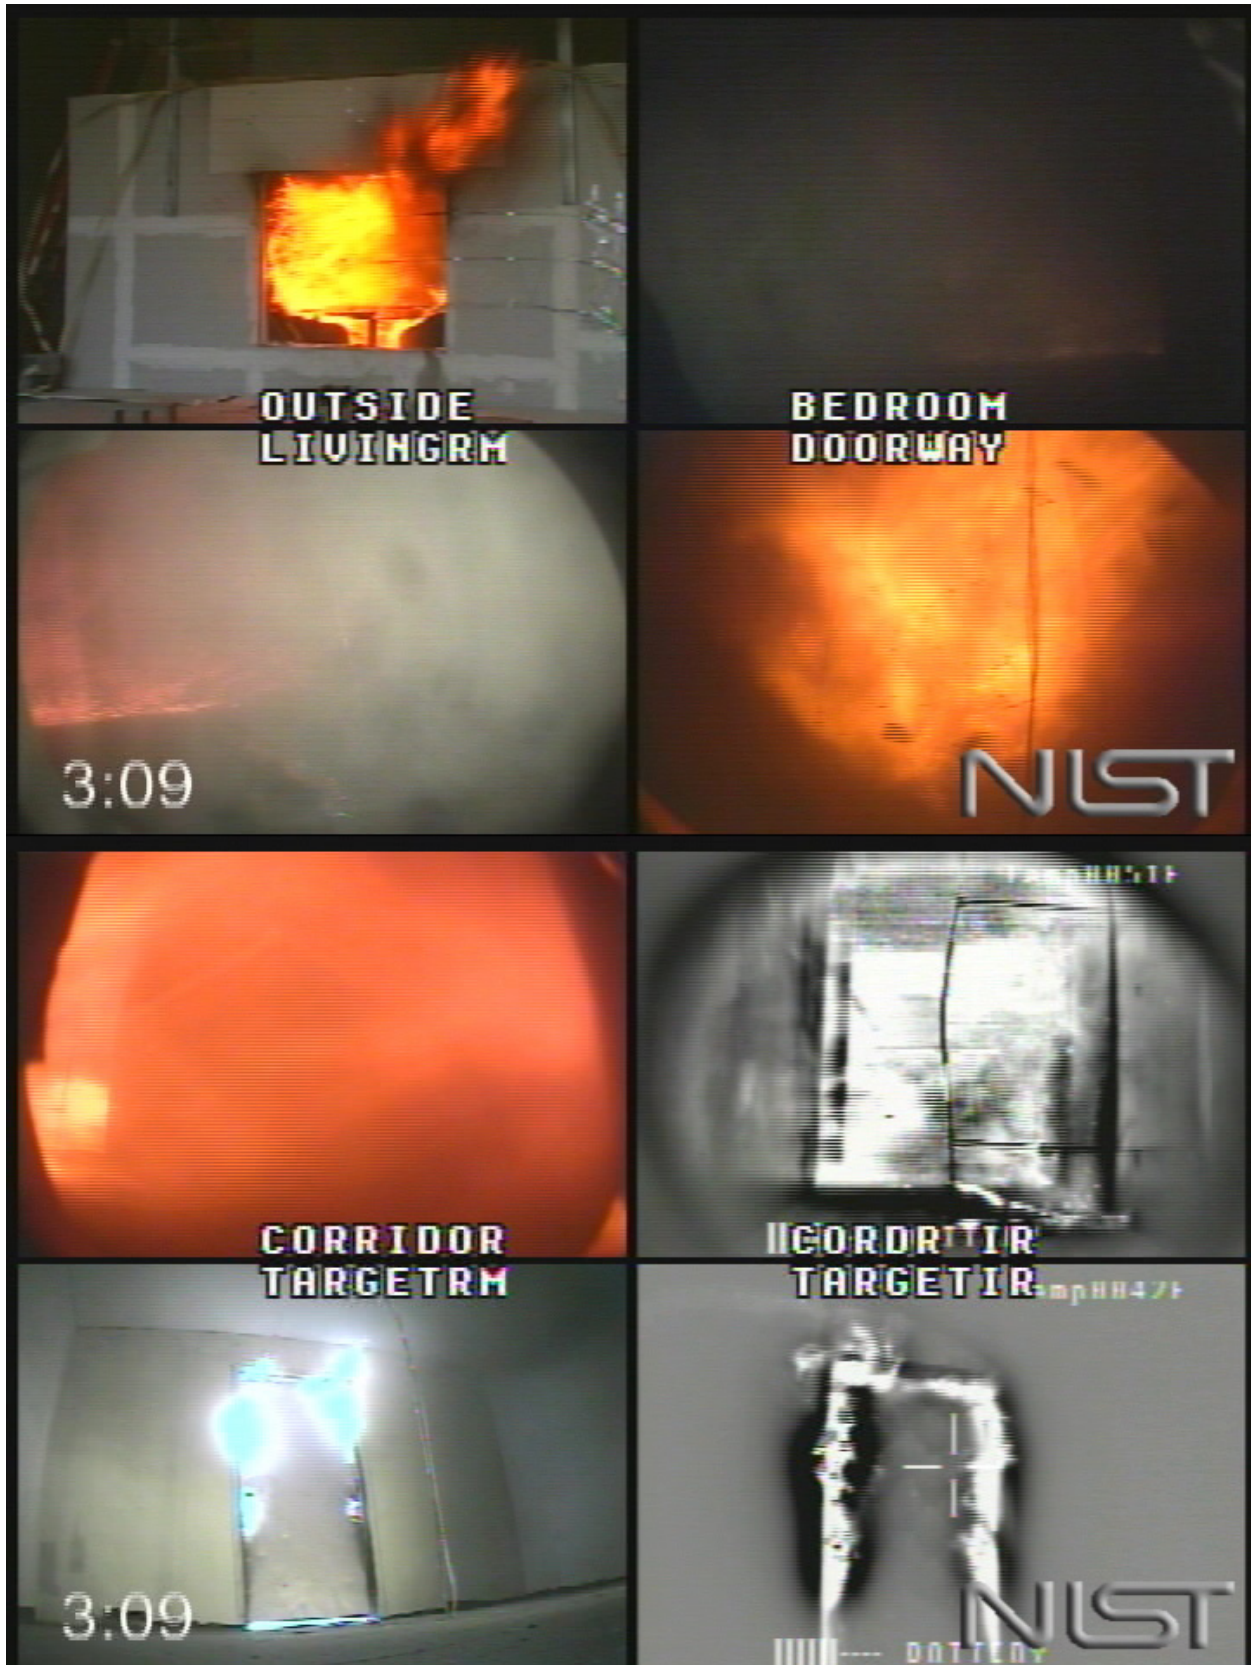
Figure 5.2.1-5. Experiment 2, corridor flames, 189 s after ignition.

Figure 5.2.1-5 shows the conditions at 189 s after ignition. Flames are still flowing out of the top of the window opening. Only a glow could be seen in the bedroom. Horizontal flames are shown extending through the living room and out through the doorway into the corridor. Flames are shown around the top portion of the door and at the bottom edge of the door.

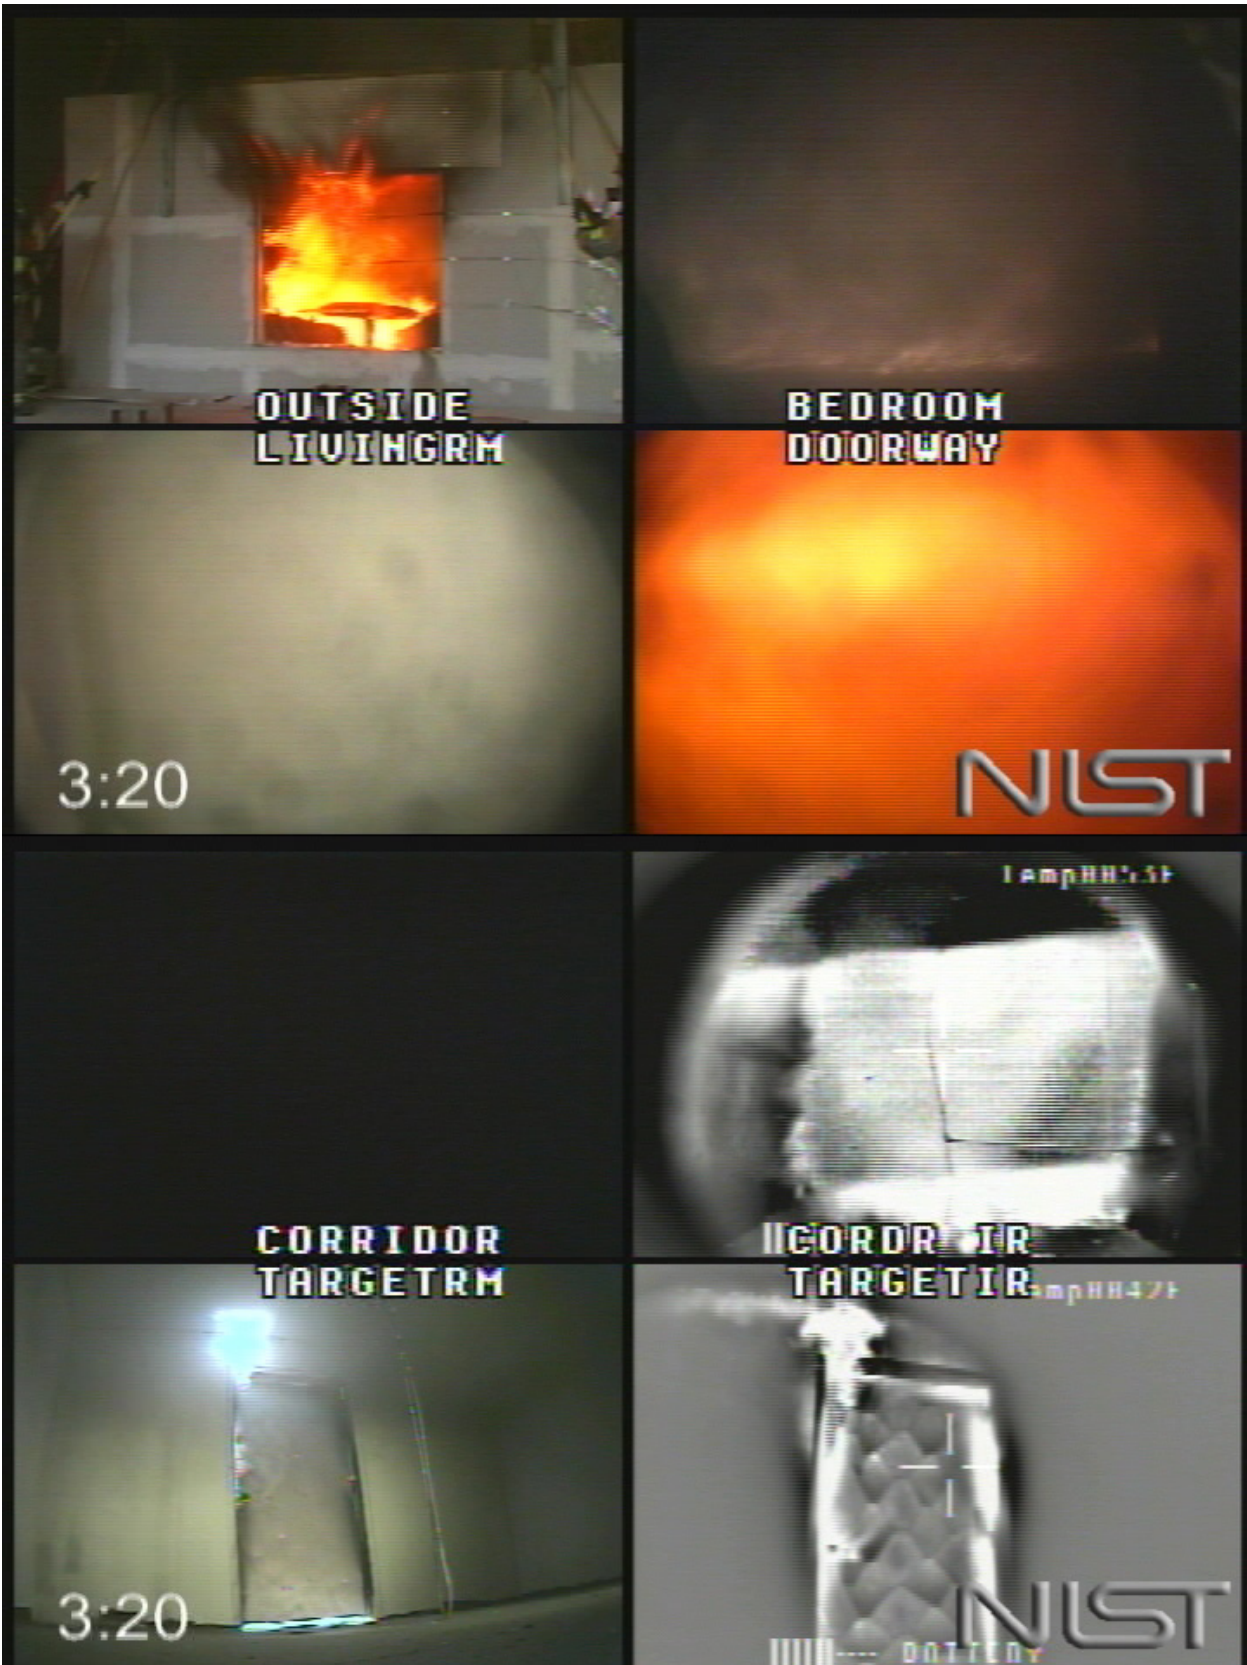
Figure 5.2.1-6. Experiment 2, WCD deployed, 200 s after ignition.

The images in Figure 5.2.1-6 were recorded at 200 s after ignition, just prior to the deployment of the large wind control device. The bedroom was fully involved with a post-flashover fire with some flames extending into the corridor. The thermal view of the corridor continued to show heat exiting the living room, filling the doorway from top to bottom, and at a high velocity. The thermal image was deteriorating due to the high thermal exposure. The target room video view showed less flame around the target room door, than the image from 11 s earlier. The thermal view shows the outlines of the reinforcing material inside the hollow core door, as the door had increased in temperature.

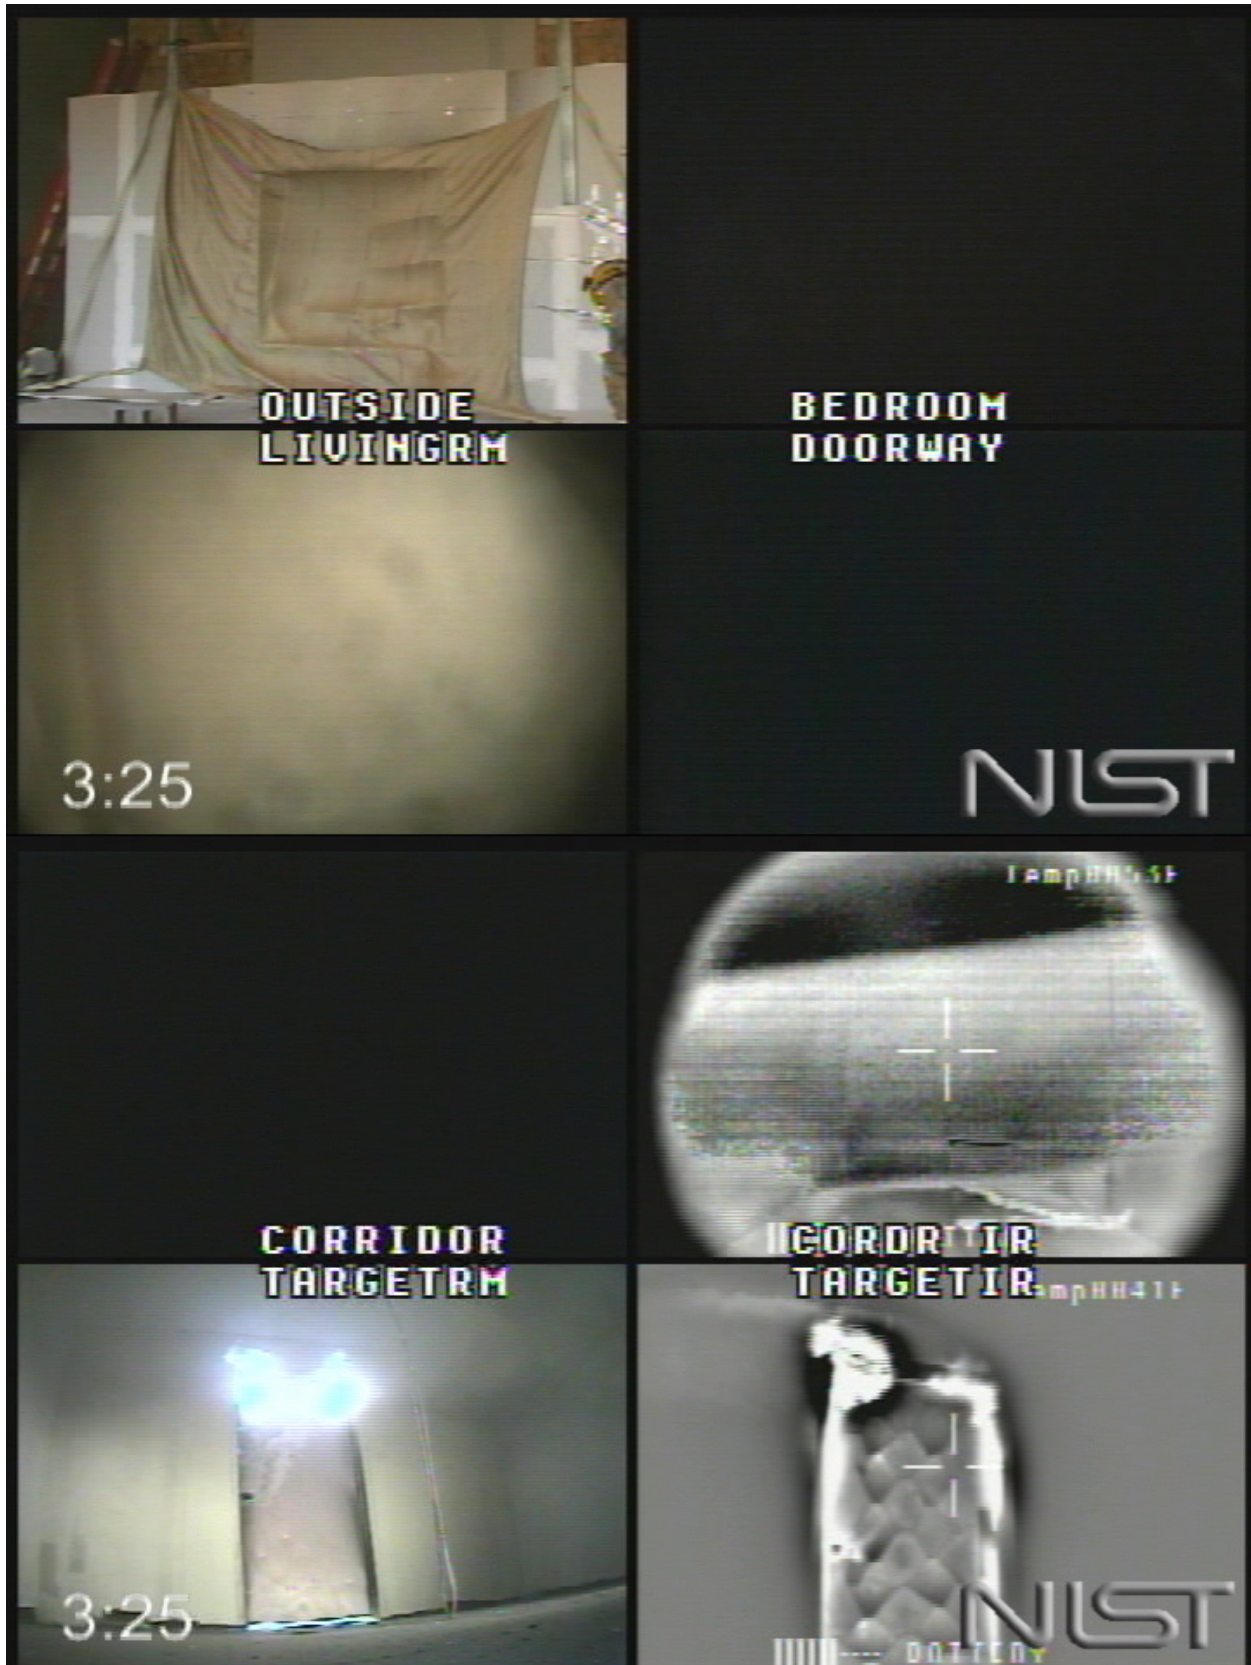
Figure 5.2.1-7. Experiment 2, WCD in place, 205 s after ignition.

At 205 s after ignition, the wind control device was deployed and in place as shown in the outside view of Figure 5.2.1-7. The interior video views were obscured by soot. The thermal view of the corridor no longer showed any hot gas flows, only a hot gas layer. Conditions in the target room did not appear to have changed significantly in the 5 s since the images in Figure 5.2.1-6.

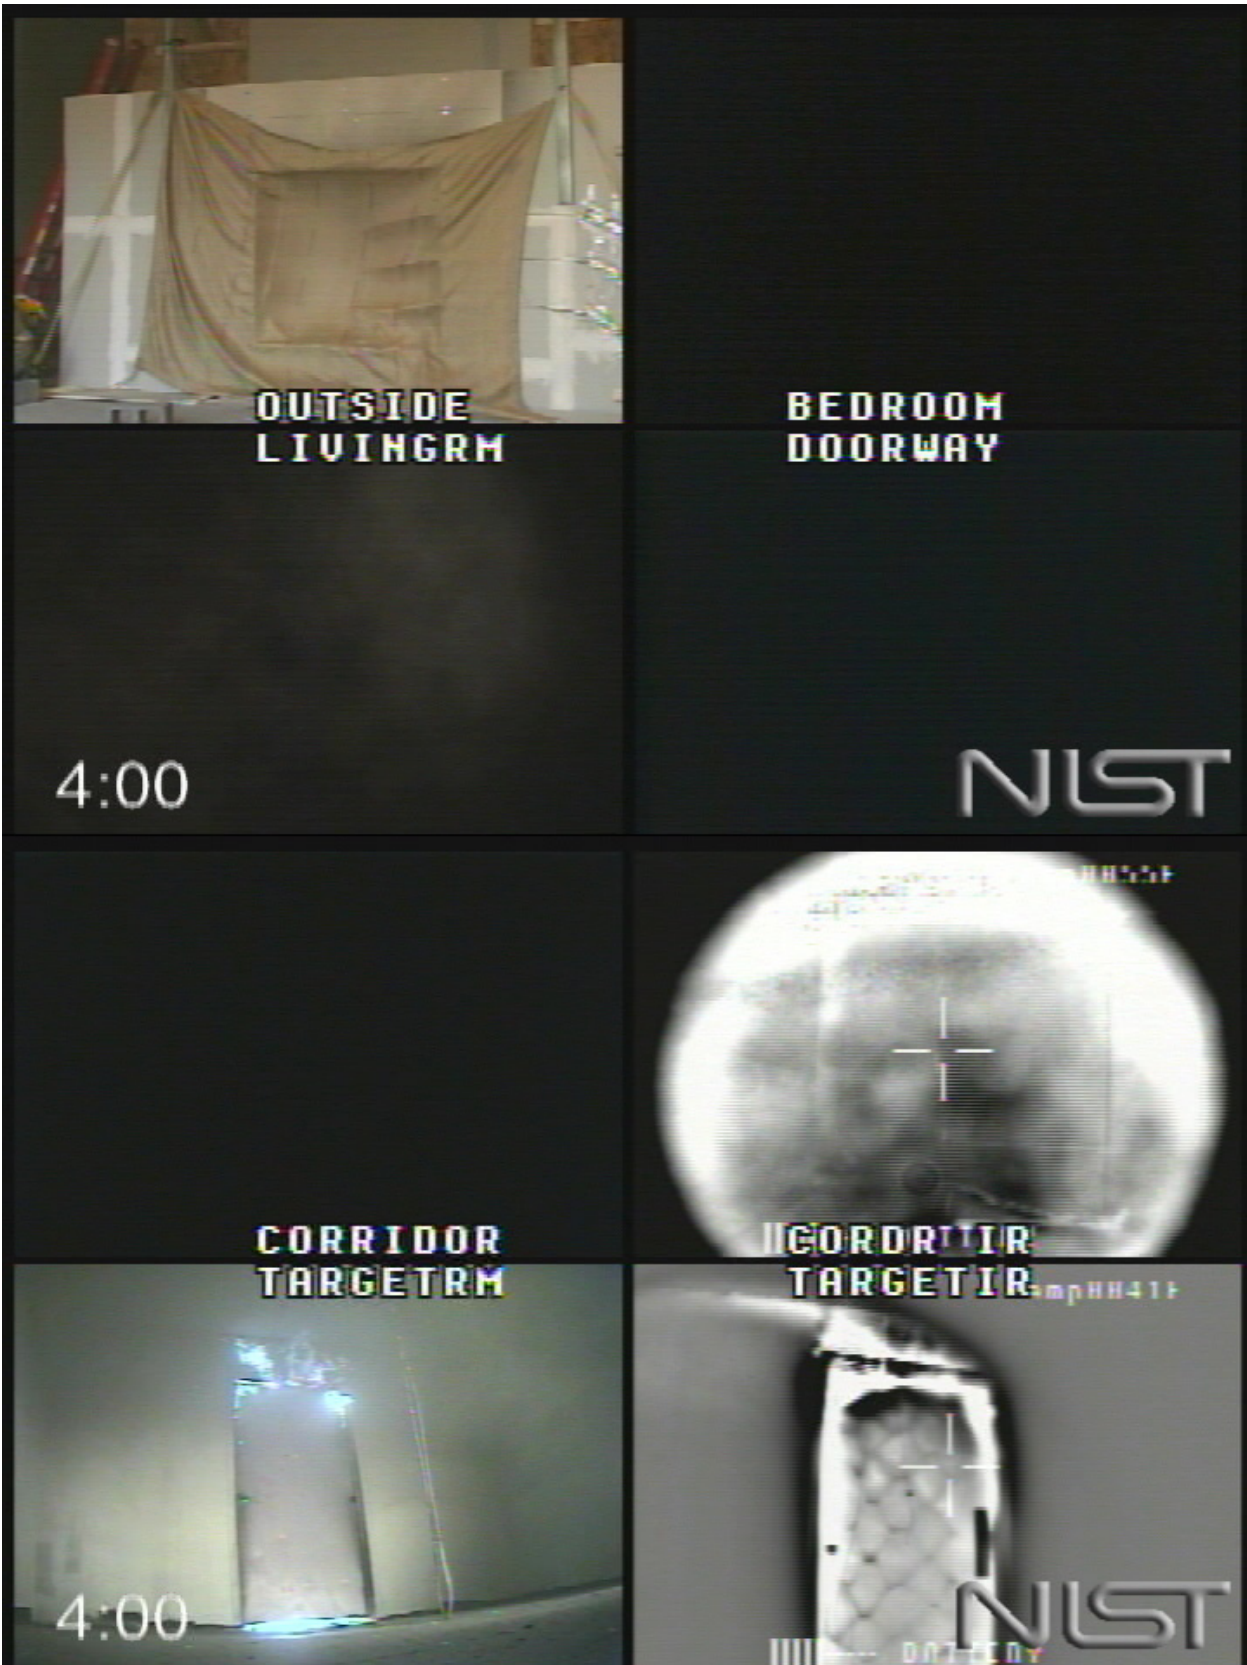
Figure 5.2.1-8. Experiment 2, 240 s after ignition.

Figure 5.2.1-8 shows the conditions at 240 s after ignition, or approximately 75 s since deployment of the wind control device. The interior video views were still obscured by soot. The thermal image from the corridor was still saturated with heat but started to improve in clarity. In the target room the top of the door continued to burn and the thermal image captured the increased heat level of the door.

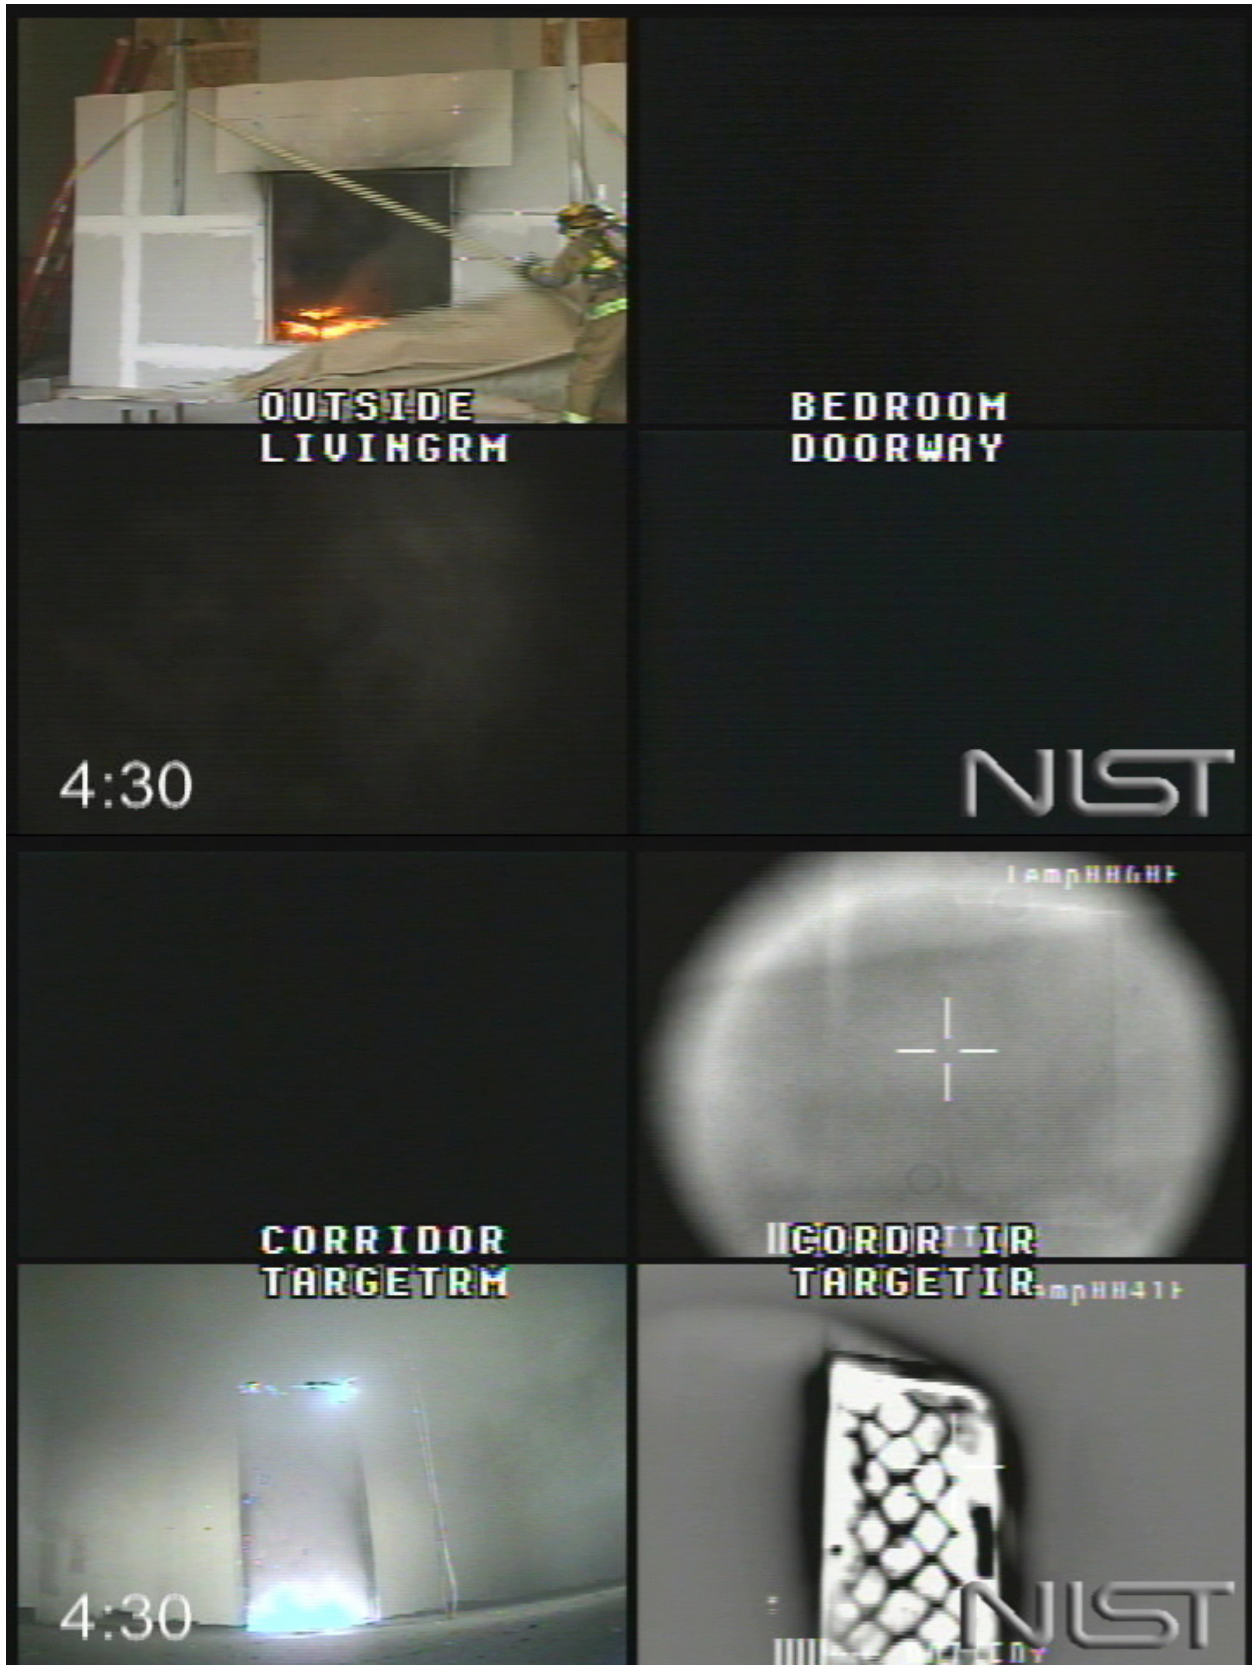
Figure 5.2.1-9. Experiment 2, WCD removed, 270 s after ignition.

Figure 5.2.1-9 shows the conditions at 270 s after ignition, which was about one second after the curtain was removed from the window opening.

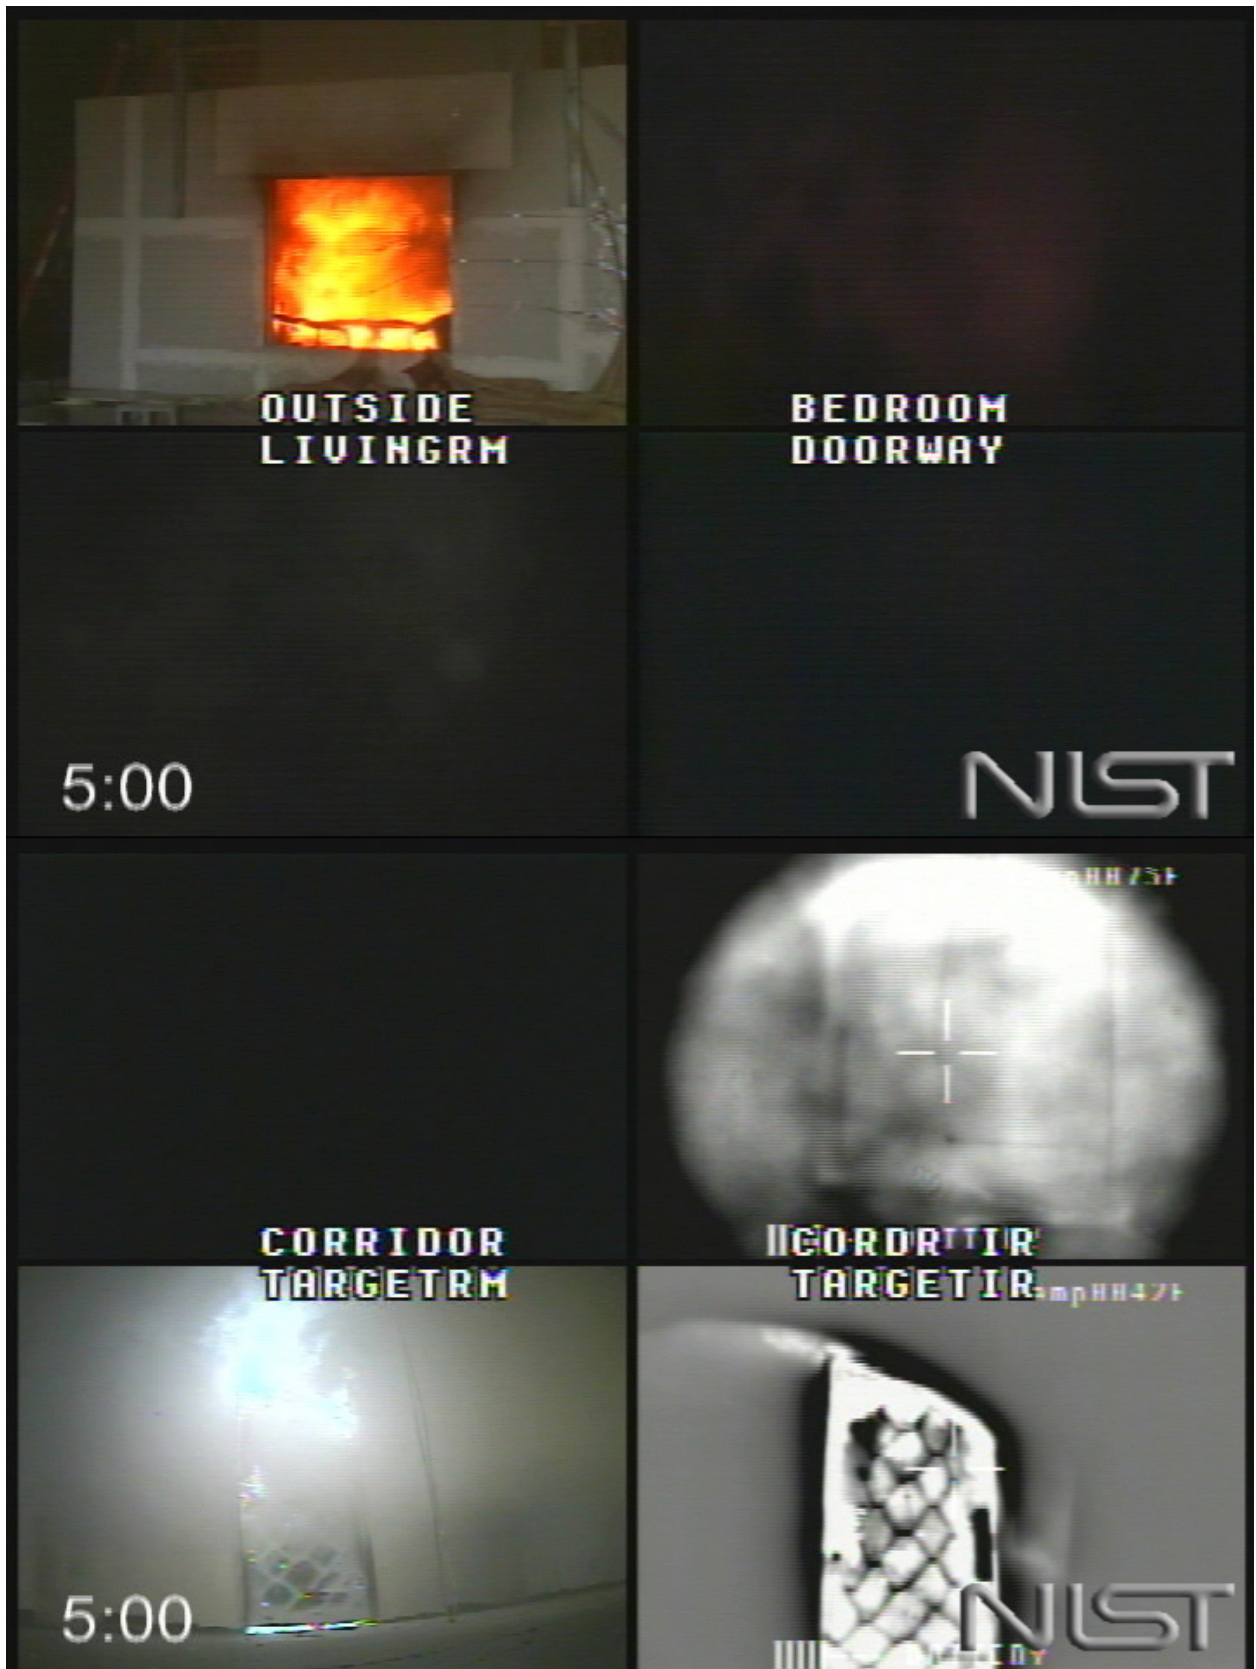
Figure 5.2.1-10. Experiment 2, 300 s after ignition.

The measurements from the thermocouple array in the center of the target room are given in Figure 5.2.3-12. A hot gas layer, 0.61 m (2.00 ft) thick, has formed within 200 s after ignition. During the time the WCD was in place, only the temperatures close to the ceiling increased as smoke and flames burned around the top edge of the door. After the WCD was removed, cool air pushed in through the gap at the top of the door, which caused the upper thermocouples to cool. This was followed by increased flames coming from the door and the opening as it burned away, visible in Figure 5.2.1-10, which resulted in increased temperatures.

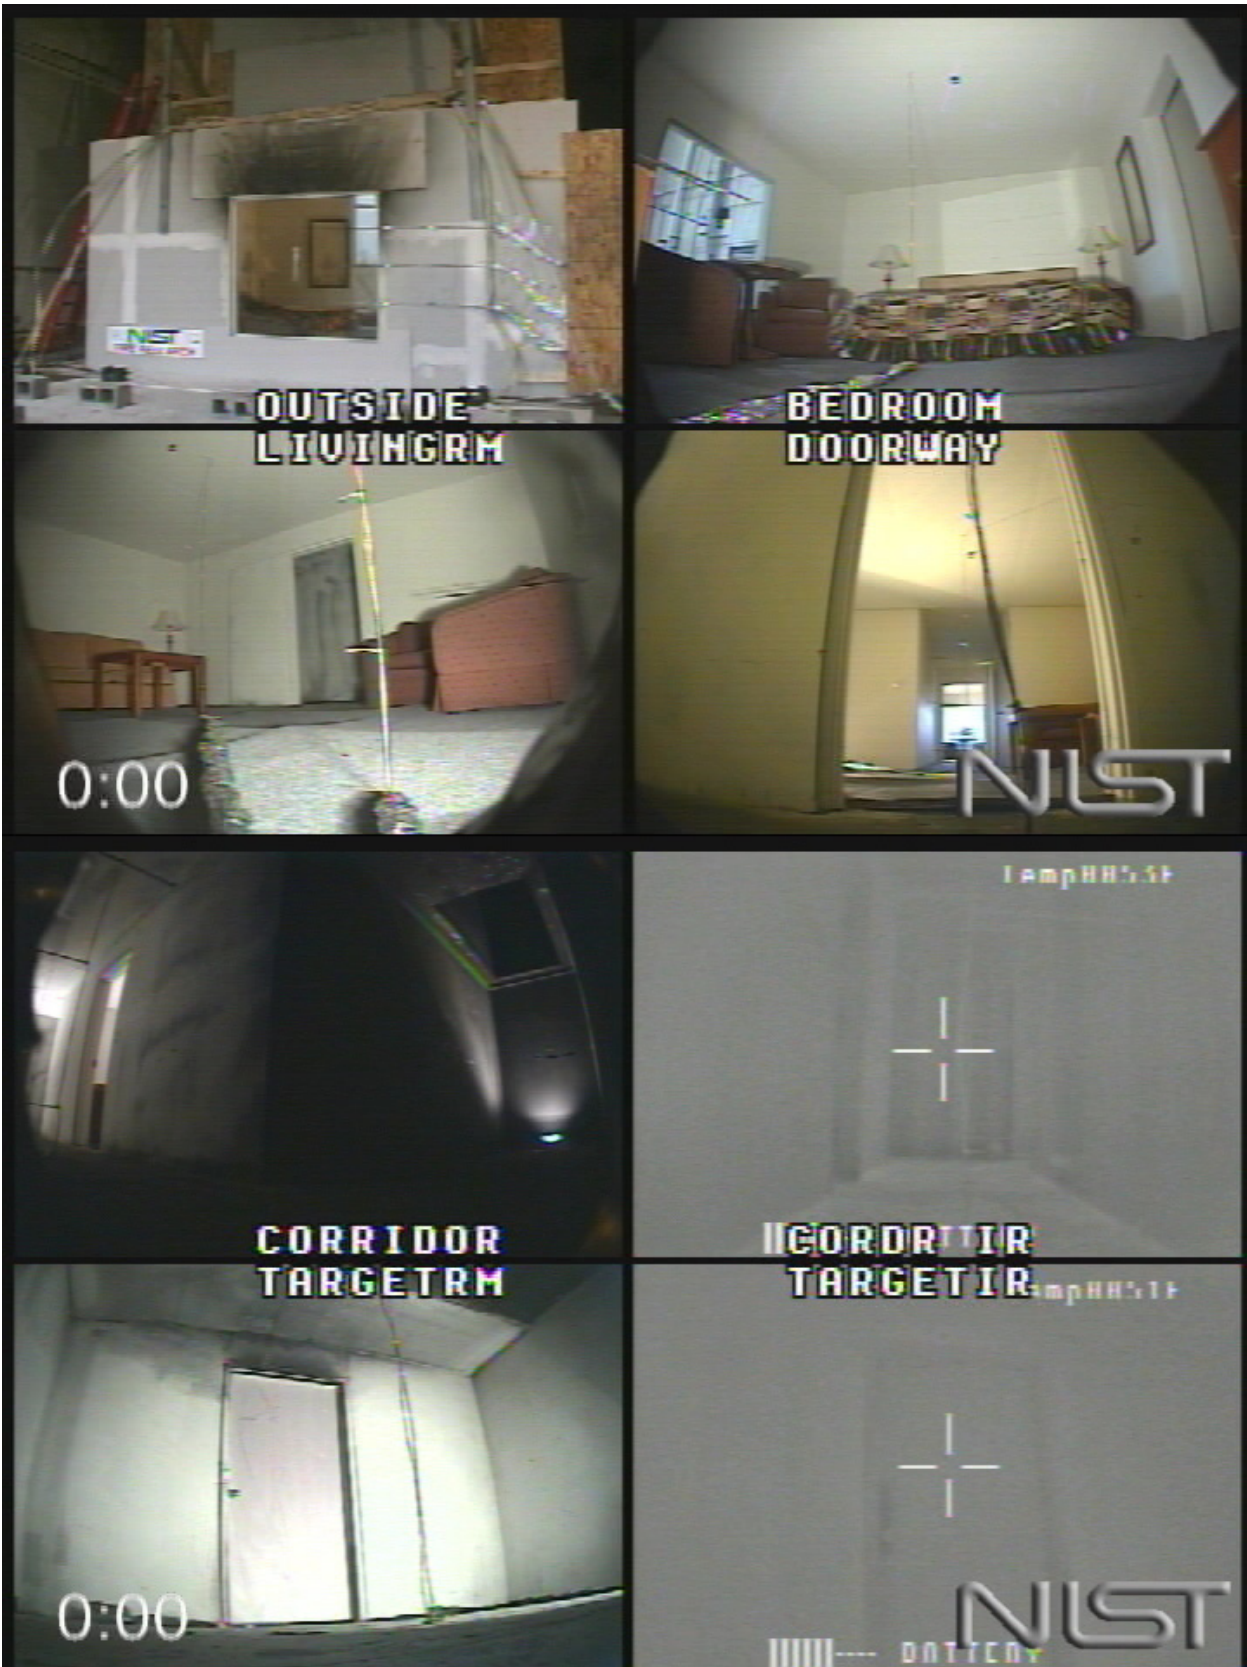
Figure 5.3.1-1. Experiment 3, ignition.

Figure 5.3.1-1 shows the conditions at the time of ignition. At this point, the six video views are clear and unobstructed. However, the thermal images provide limited thermal contrast because the surfaces in the view were at nearly equal temperature.

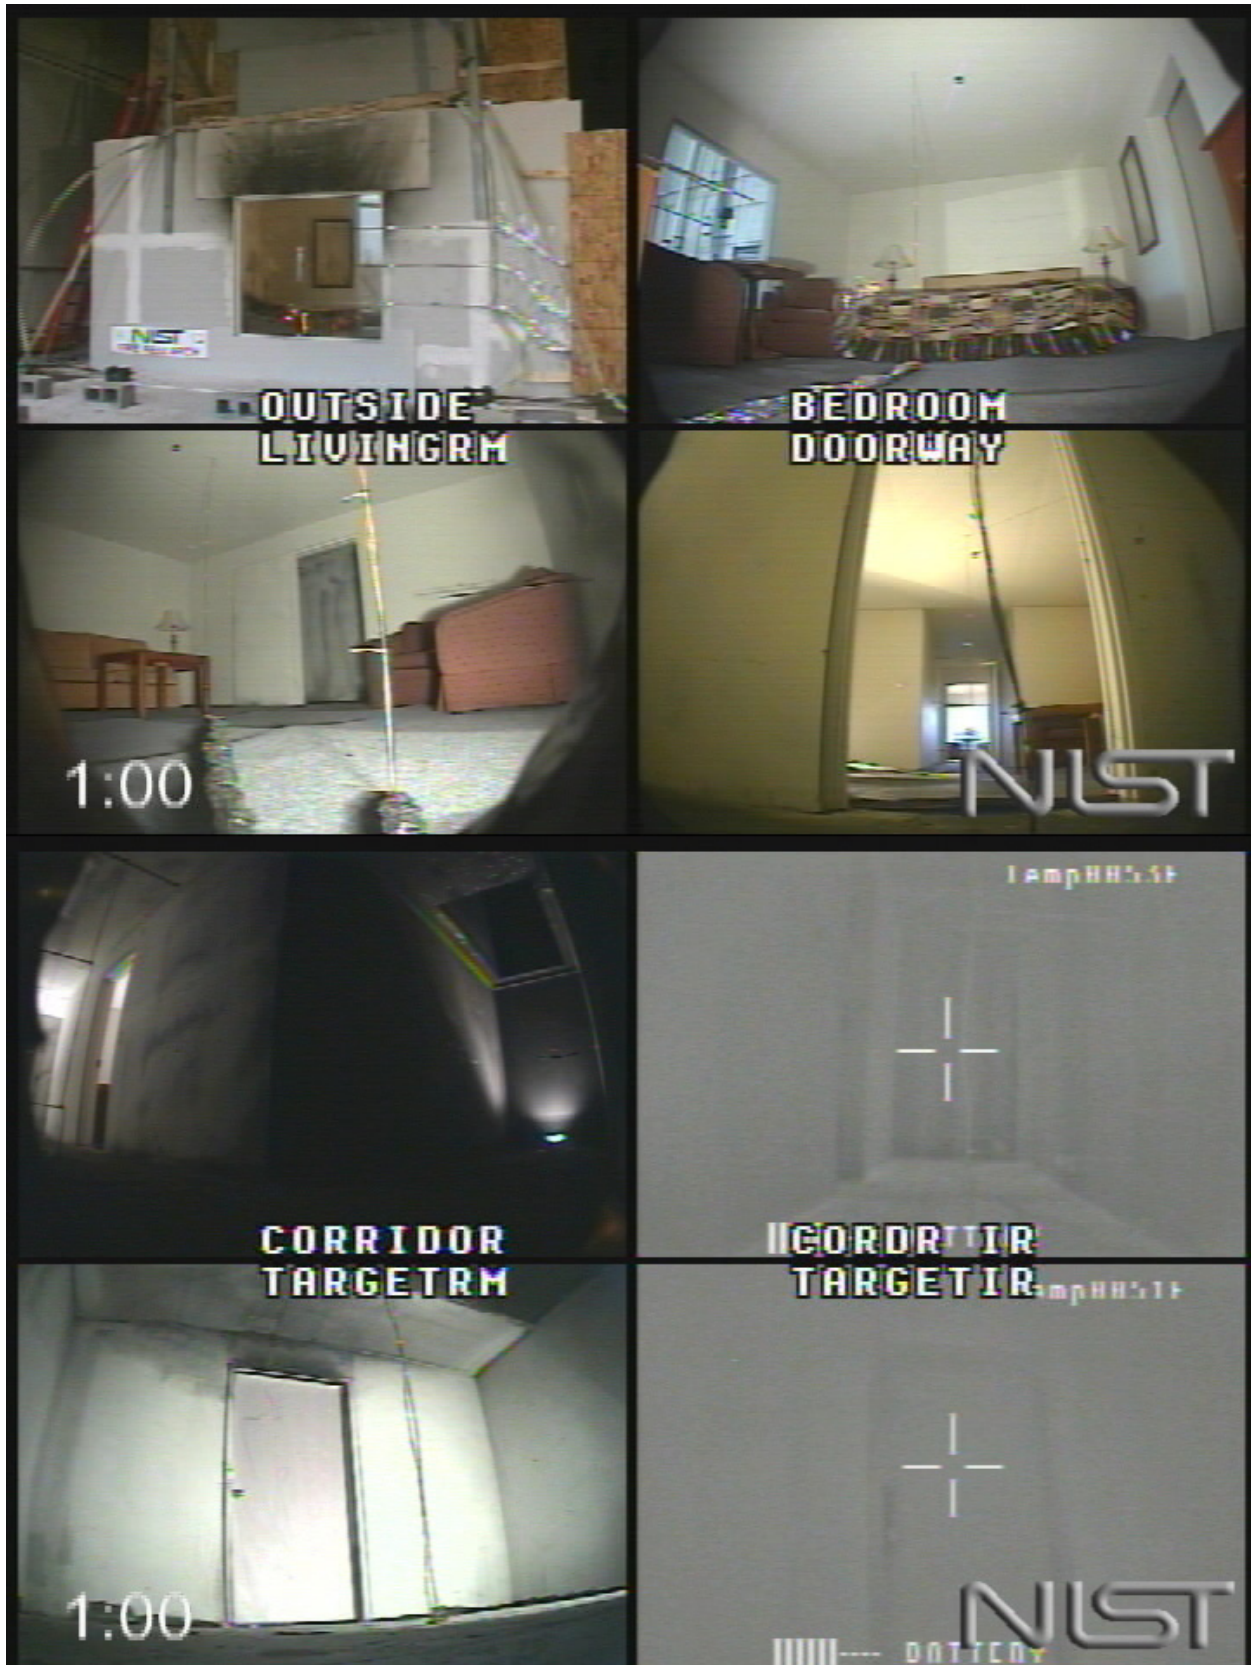
Figure 5.3.1-2. Experiment 3, 60 s after ignition.

The images in Figure 5.3.1-2 were captured 60 s after ignition. The fire from the trash container began to spread to the bed. There was very little smoke being produced and a layer has yet to develop. There was also no smoke or change in thermal condition in the living room, target room or corridor at this time.

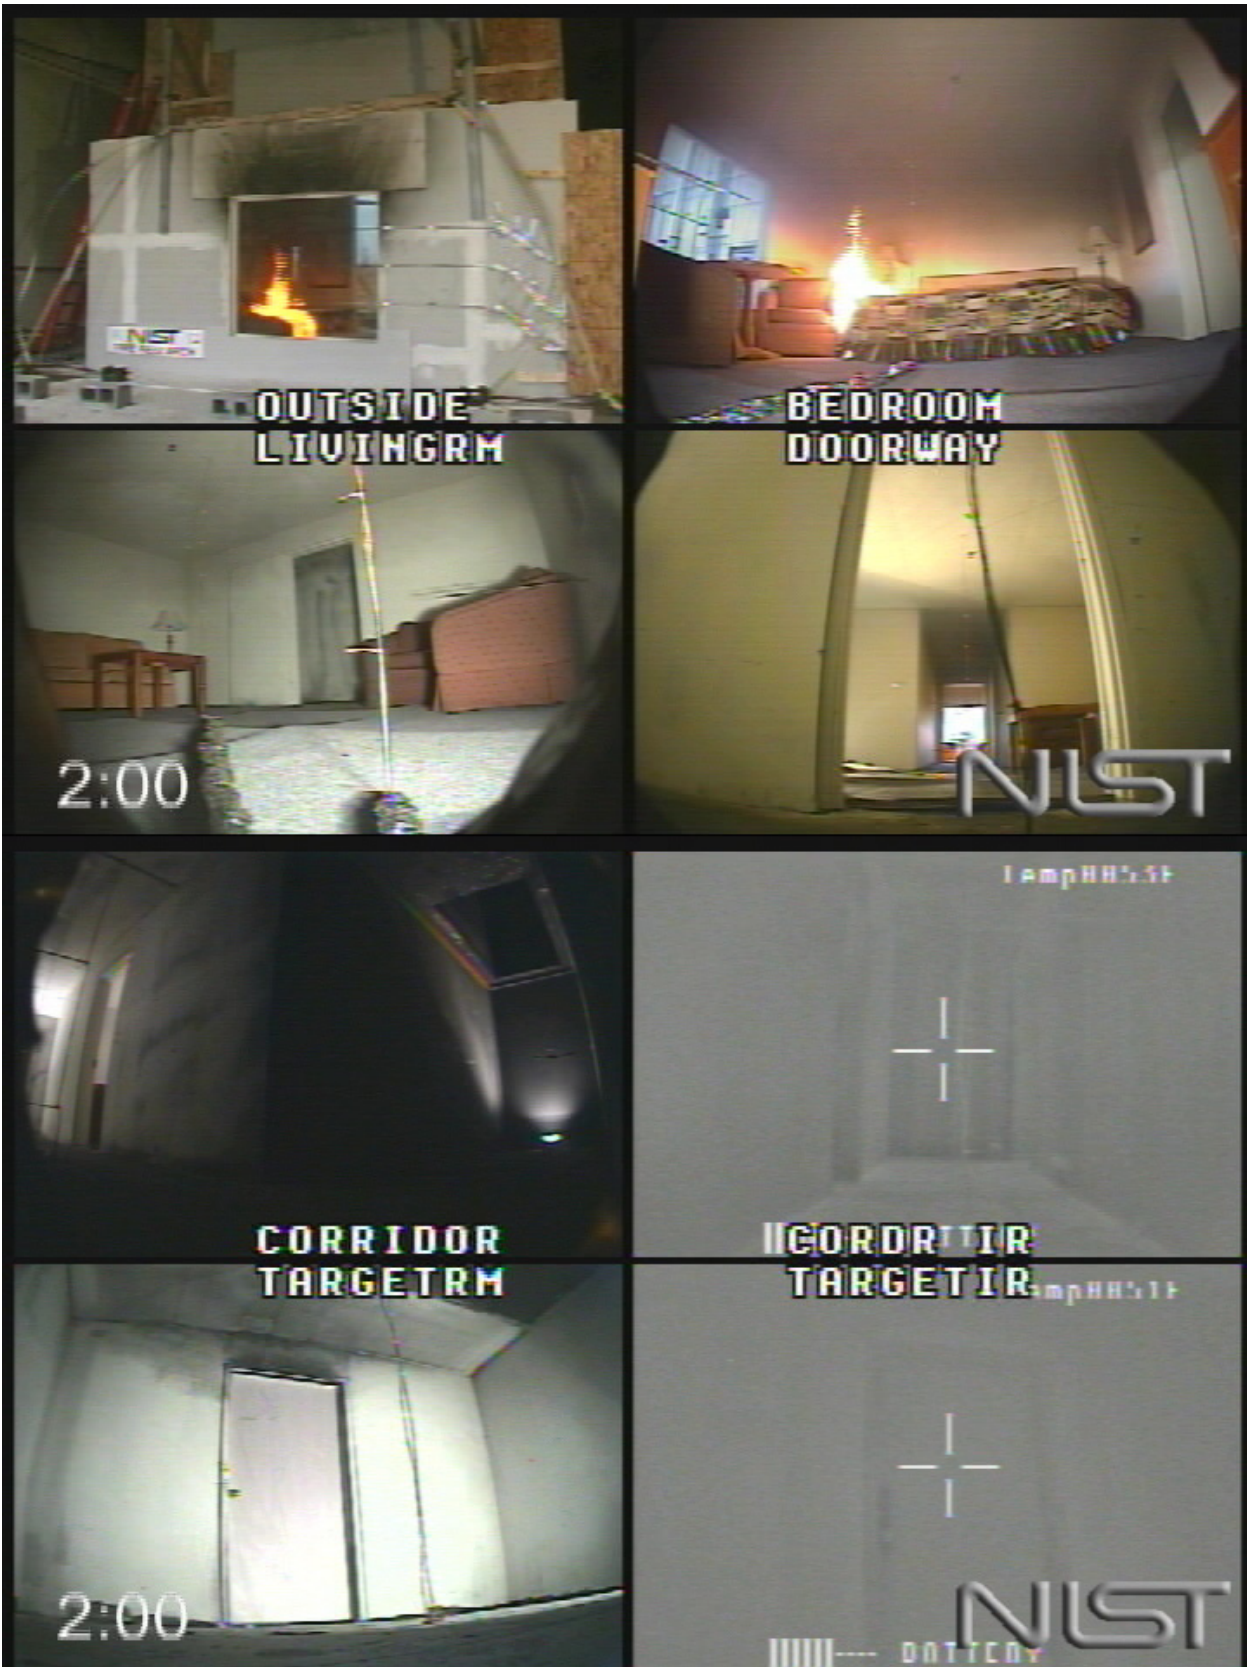
Figure 5.3.1-3. Experiment 3, 120 s after ignition.

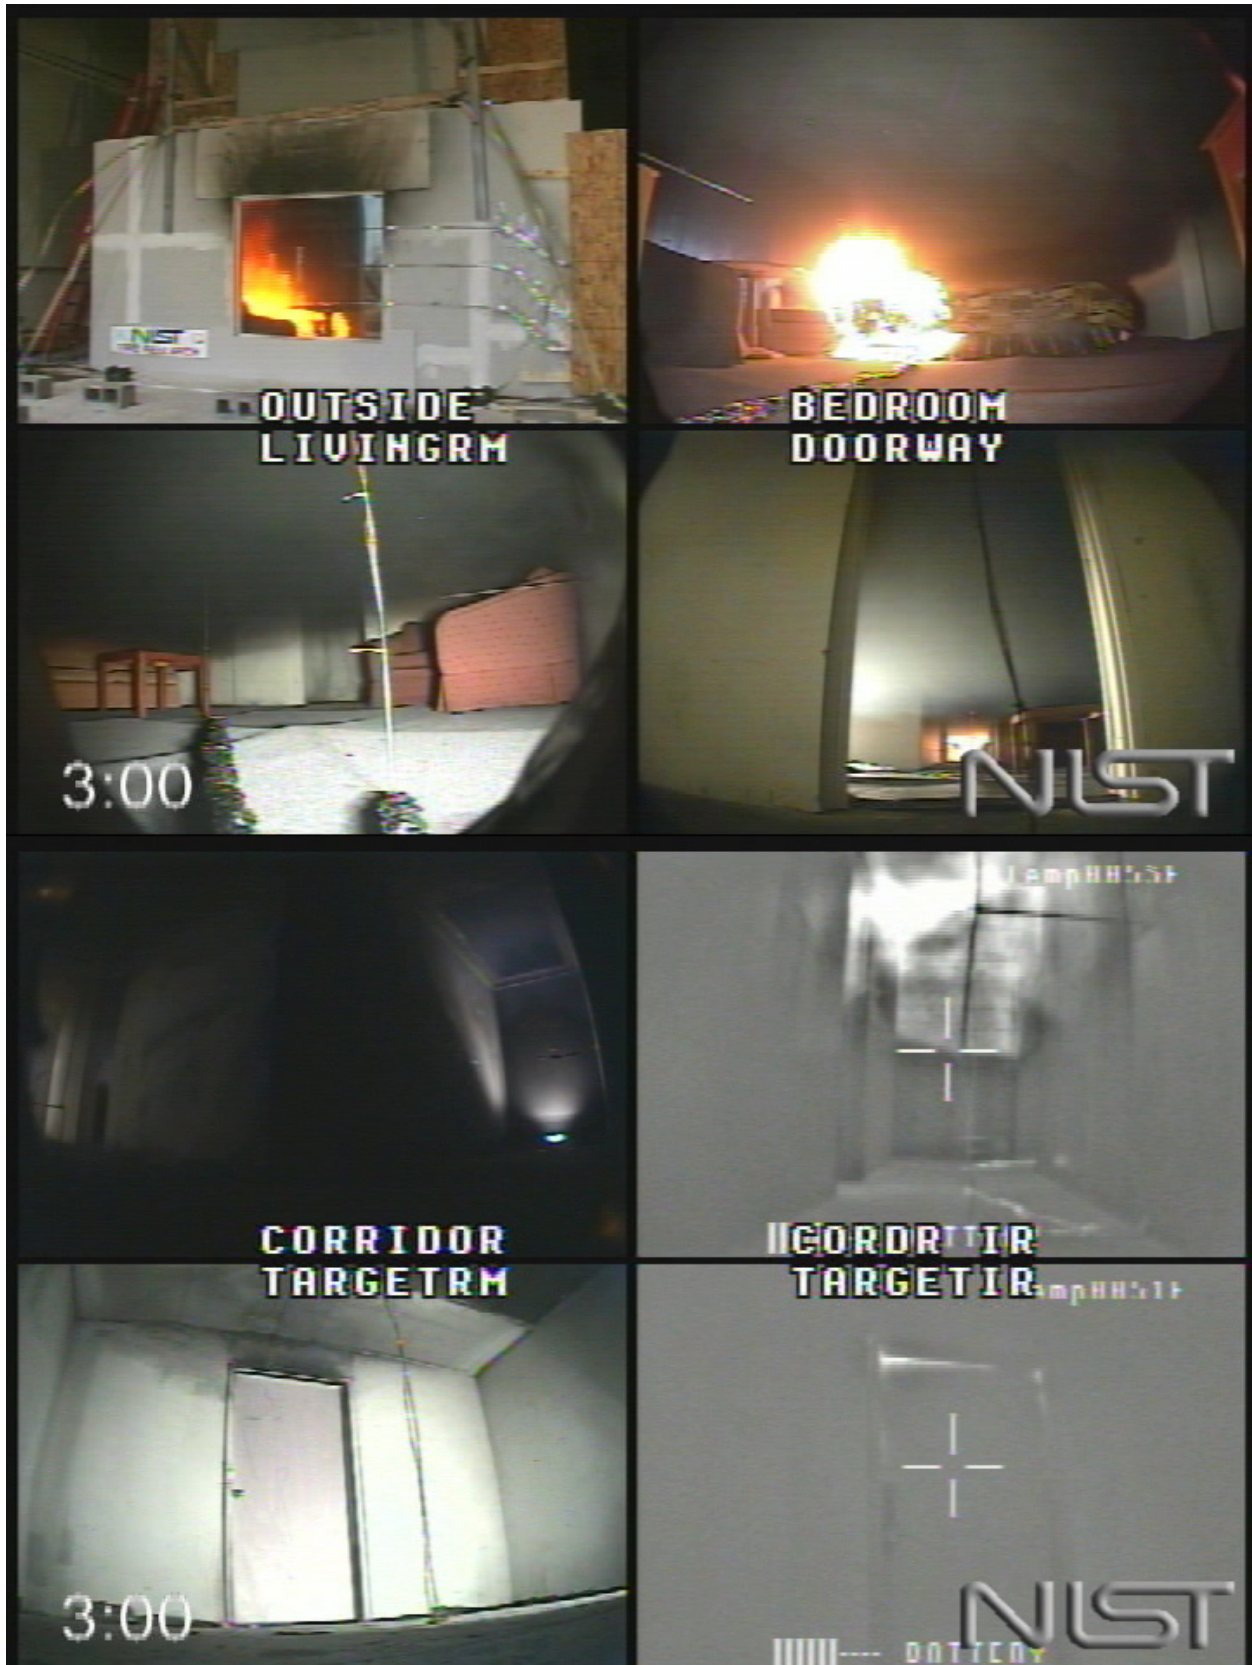
Figure 5.3.1-4. Experiment 3, 180 s after ignition.
