NIST Technical Note 1618

Fire Fighting Tactics Under Wind Driven Conditions: Laboratory Experiments

Daniel Madrzykowski
Stephen Kerber

January 2009

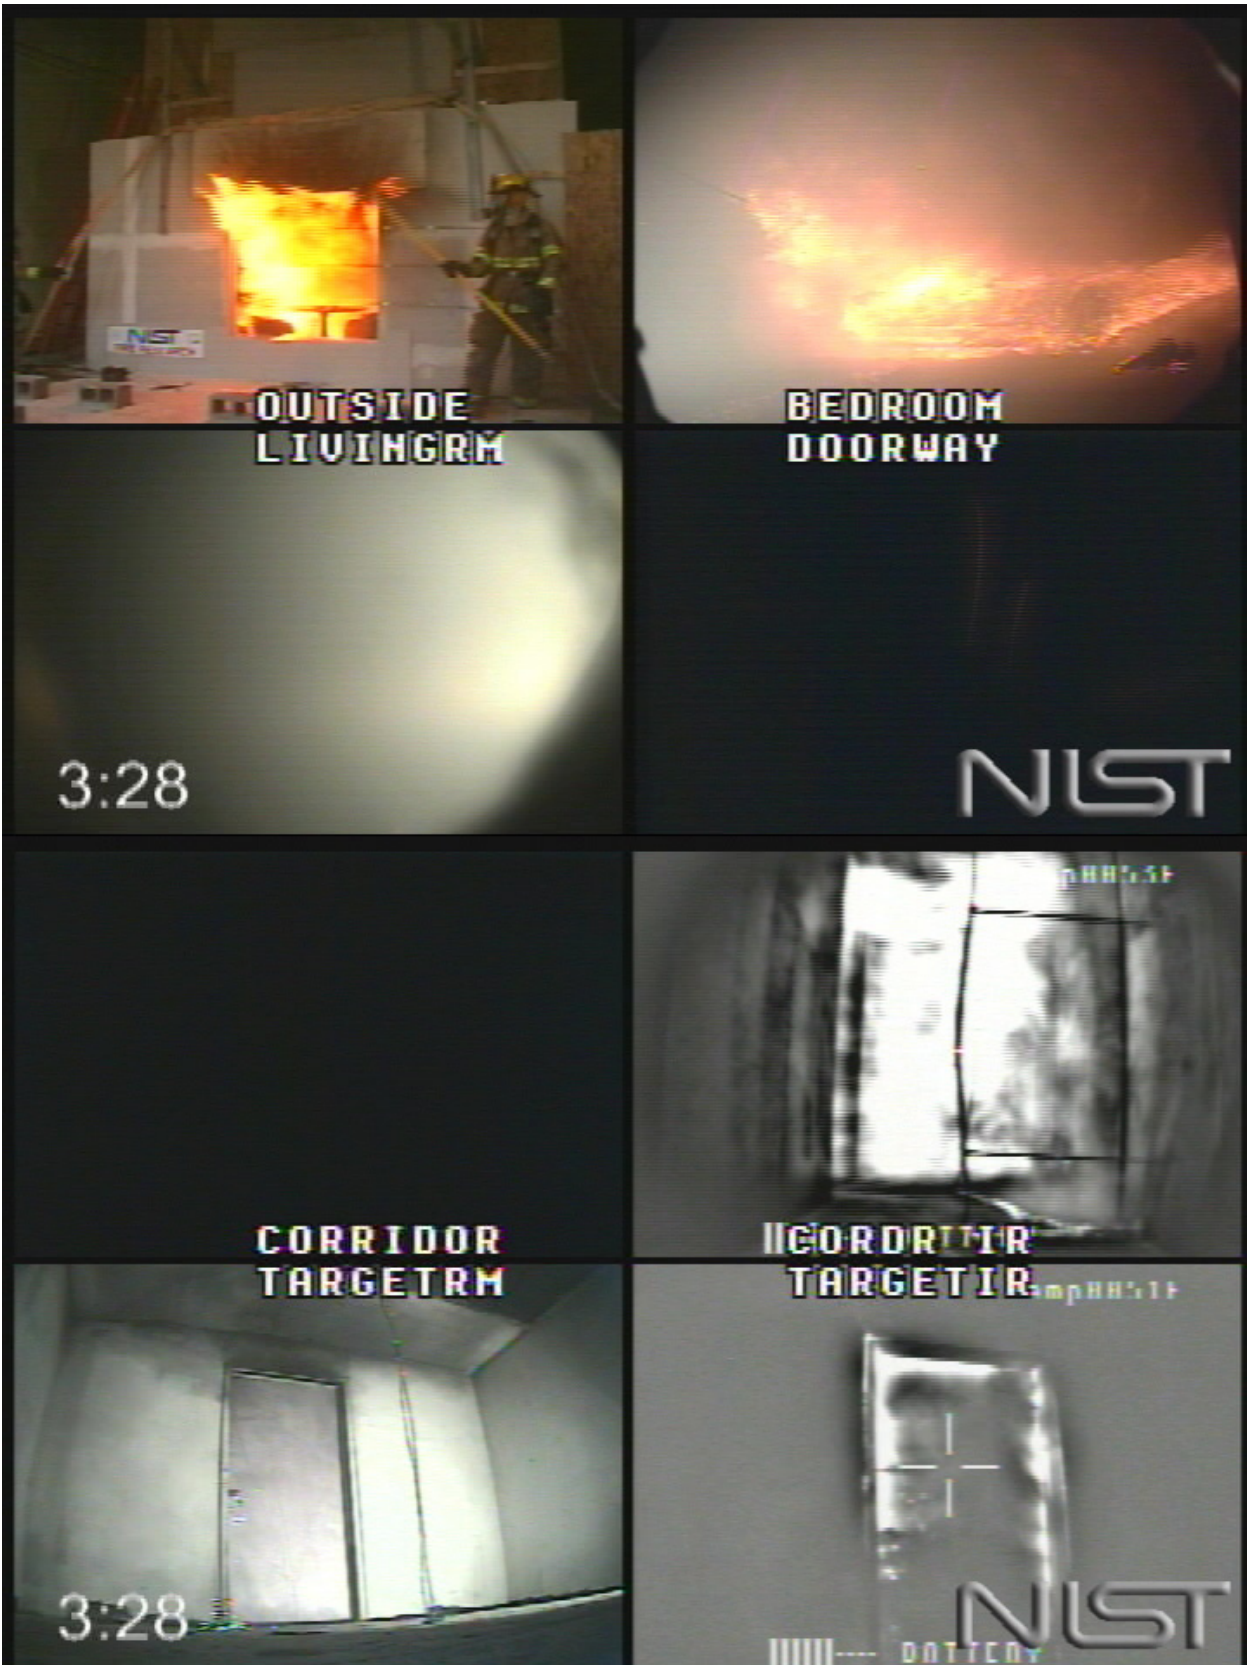
Figure 5.3.1-5. Experiment 3, window fully vented, 208 s after ignition.

Figure 5.3.1-5 shows the conditions at 208 s after ignition. The flames had touched the window at 200 s and a majority of the glass fell out of the frame. The image shows the conditions just after the window was manually cleared. Flames are seen moving across the floor level in the bedroom and the camera views in the living room, hallway and corridor are obscured by smoke. The image from the corridor IR camera shows hot gases exiting the living room, filling the doorway top to bottom and impinging on the east wall of the corridor. Heat was flowing around the entire perimeter of the hall door into the target room, as shown in the thermal image of the target room.

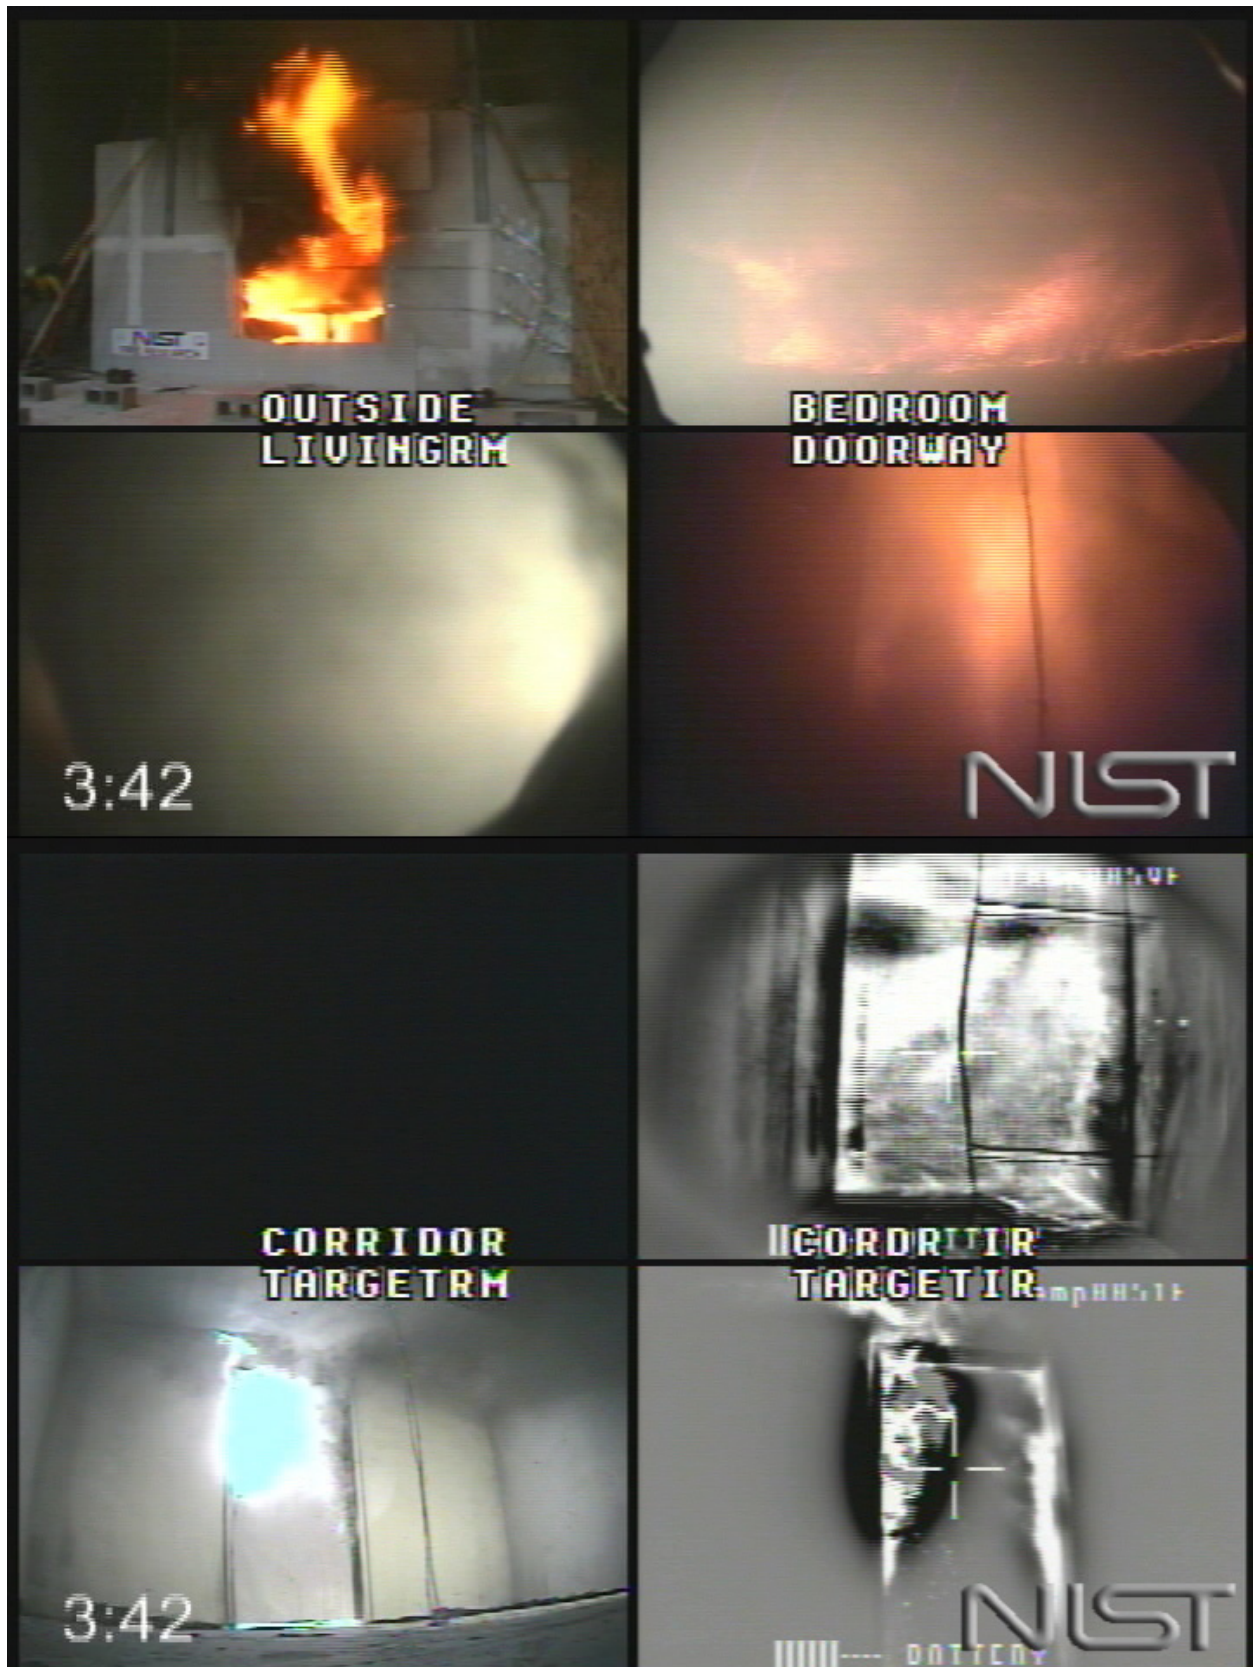
Figure 5.3.1-6. Experiment 3, corridor flames, 222 s after ignition.

Figure 5.3.1-6 was captured at 222 s after ignition. Flames were flowing out of the top of the window opening. Flames can be seen in the bedroom at the floor level and flames are shown extending out through the doorway into the corridor. No flames were visible in the living room as the camera was obscured by smoke. The wood door to the target room was failing, flames were breaching the top corners of the door and a smoke layer was beginning to form in the target room.

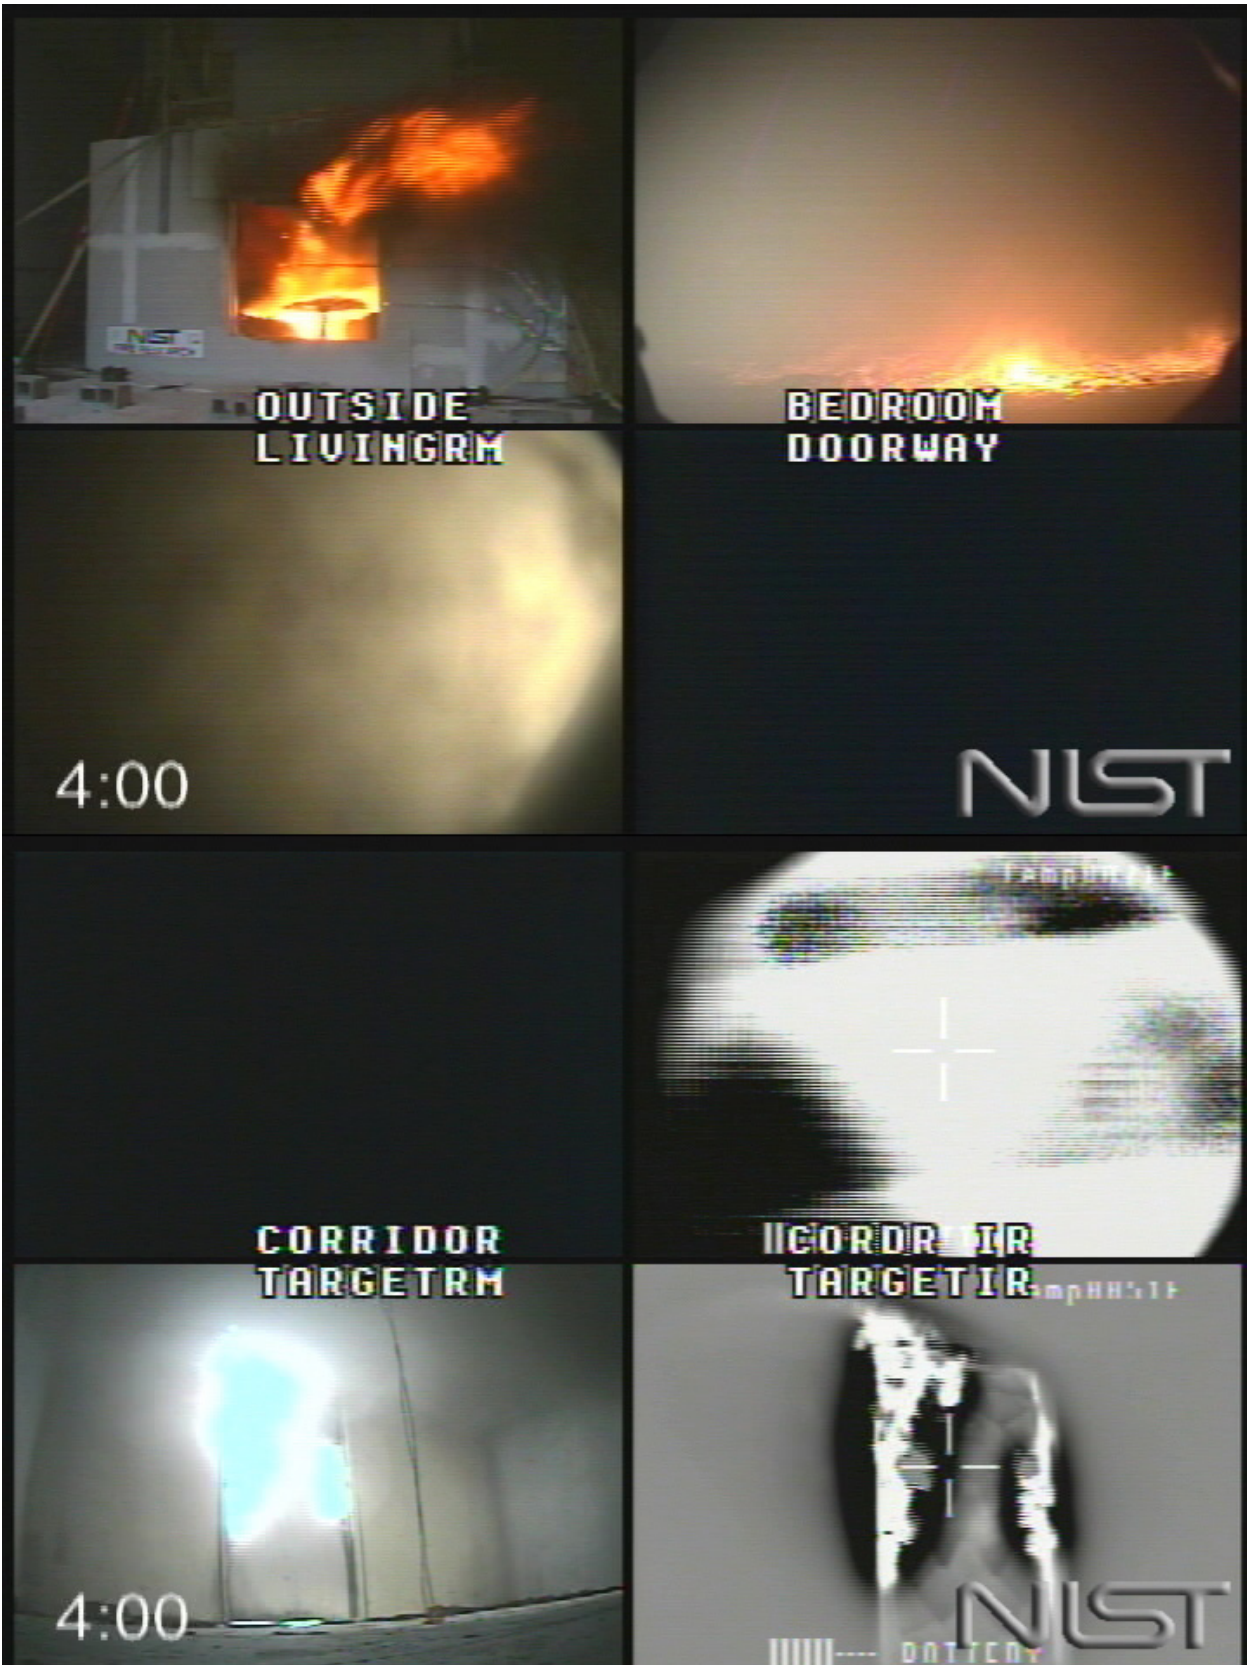
Figure 5.3.1-7. Experiment 3, 240 s after ignition.

Figure 5.3.1-7 shows the conditions at 240 s after ignition. Flames were pulsing out of the top right corner of the window opening. Flames were still visible at the floor level in the bedroom but smoke was obscuring the views in the living room and corridor. The amount of heat entering the hallway has caused the image from the corridor IR camera to deteriorate substantially. The visual image in the target room showed flames consuming both sides of the door and beginning to come under the door. The visibility at the lower layer in the target room remained good.

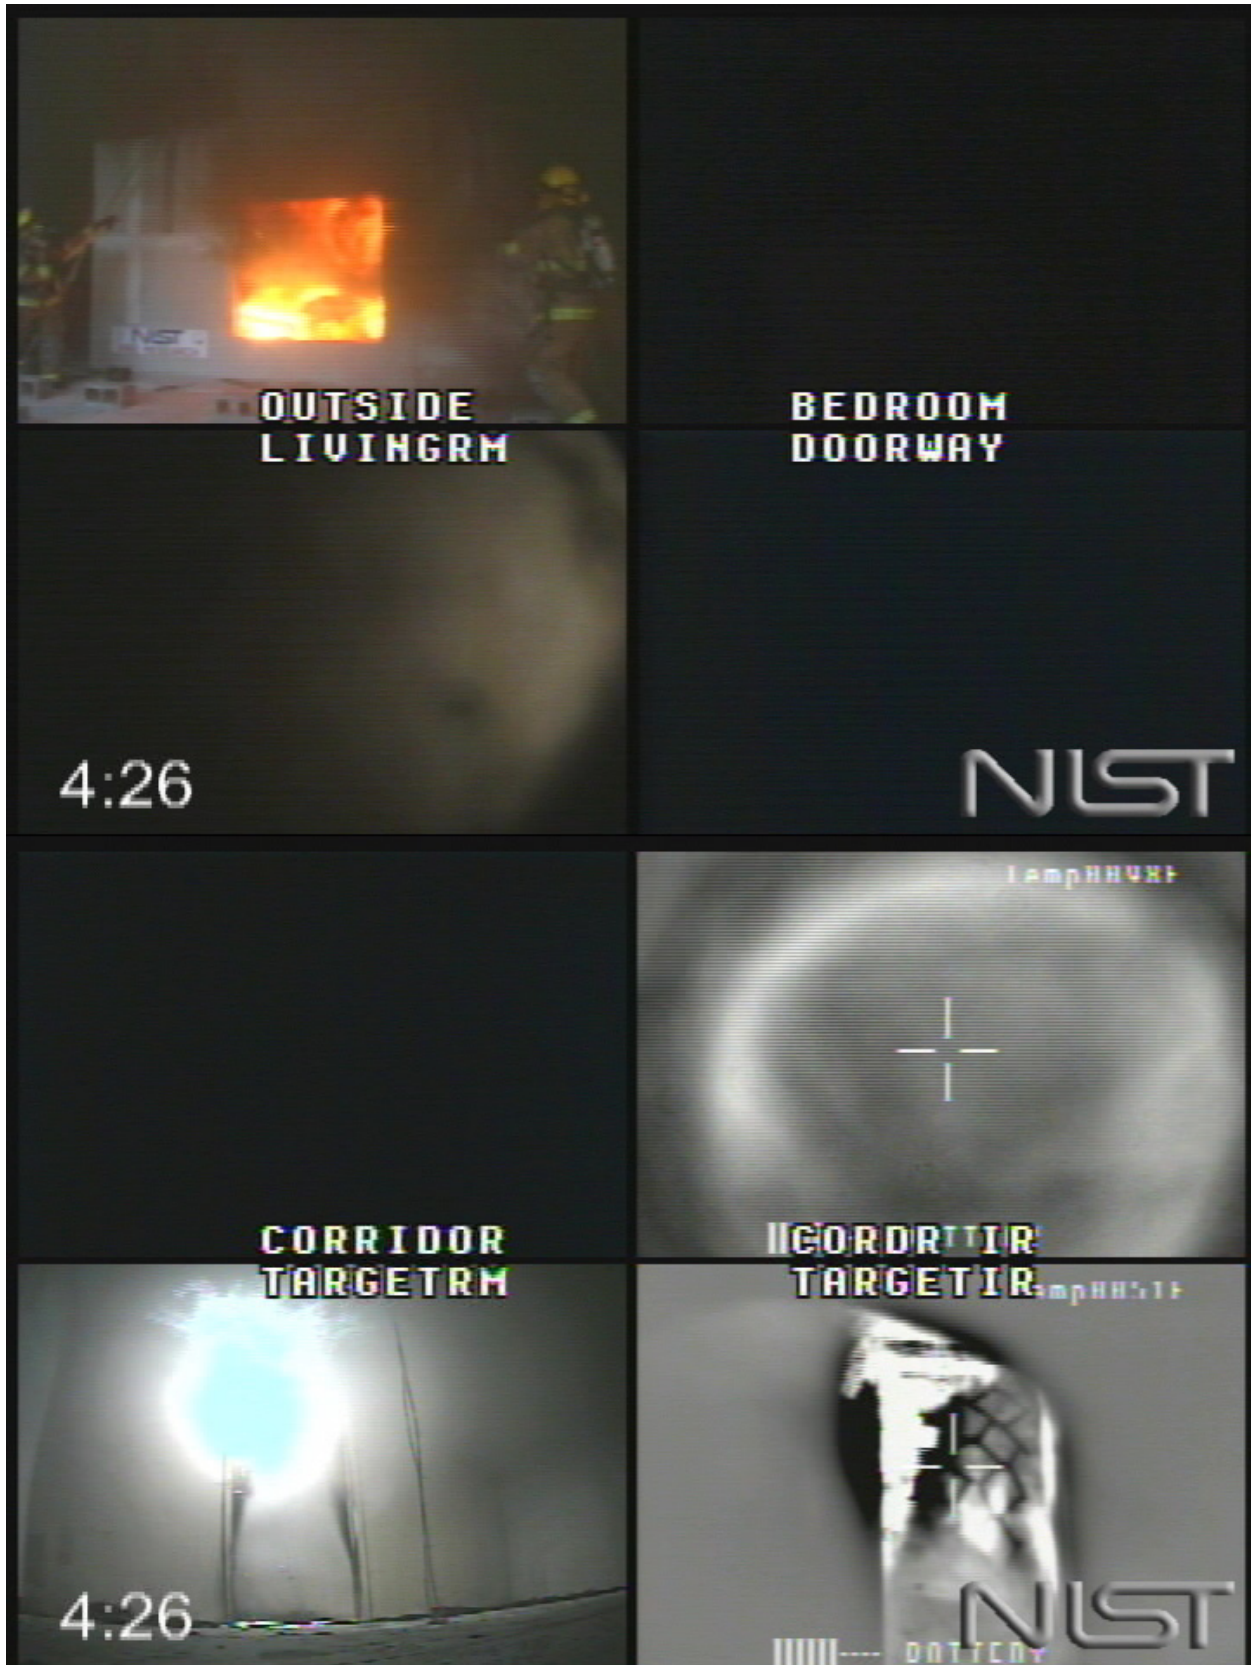
Figure 5.3.1-8. Experiment 3, WCD deployed, 266 s after ignition.

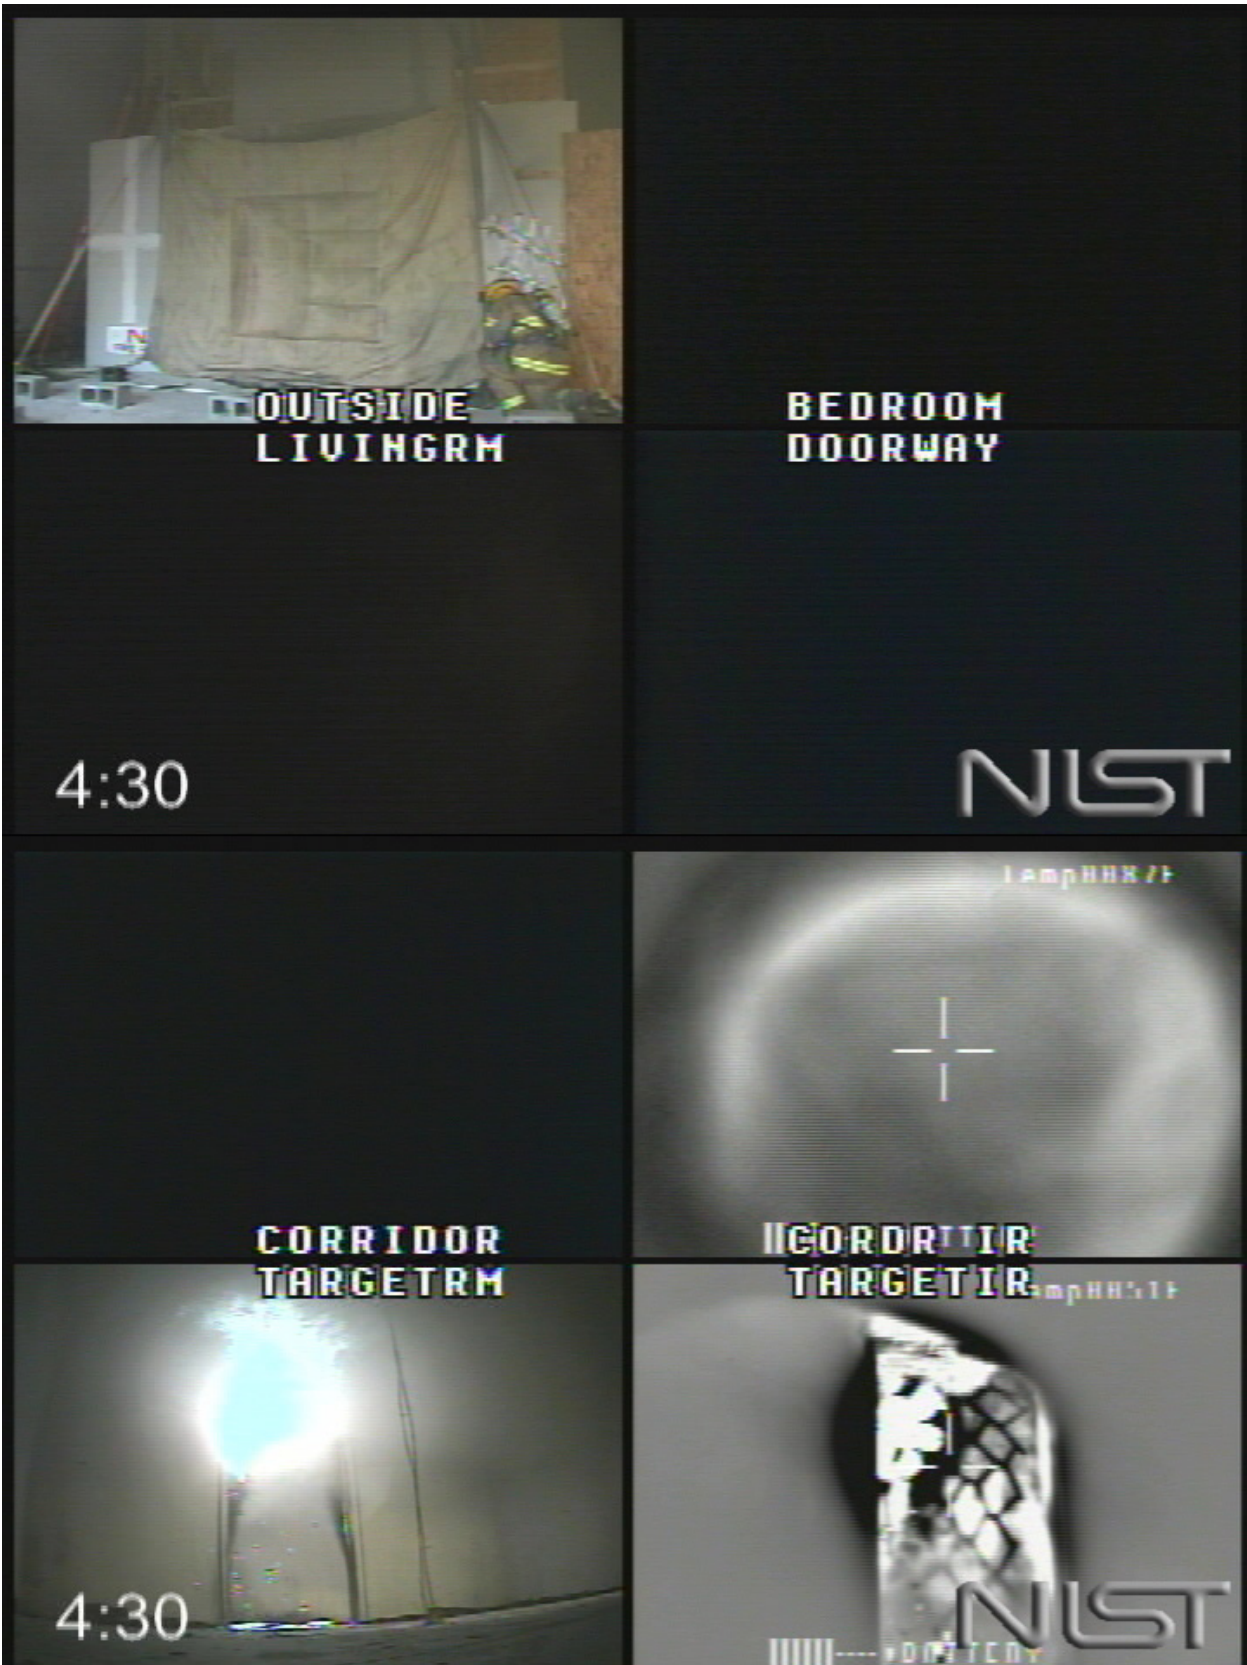
Figure 5.3.1-9. Experiment 3, WCD in place, 270 s after ignition.

At 270 s after ignition, the wind control device was deployed and in place as shown in the outside view of Figure 5.3.1-9. The interior video views were obscured by soot. The thermal view of the corridor no longer showed any hot gas flows, only a hot gas atmosphere. Conditions in the target room did not appear to have changed significantly in the 4 s since the images in Figure 5.3.1-8.

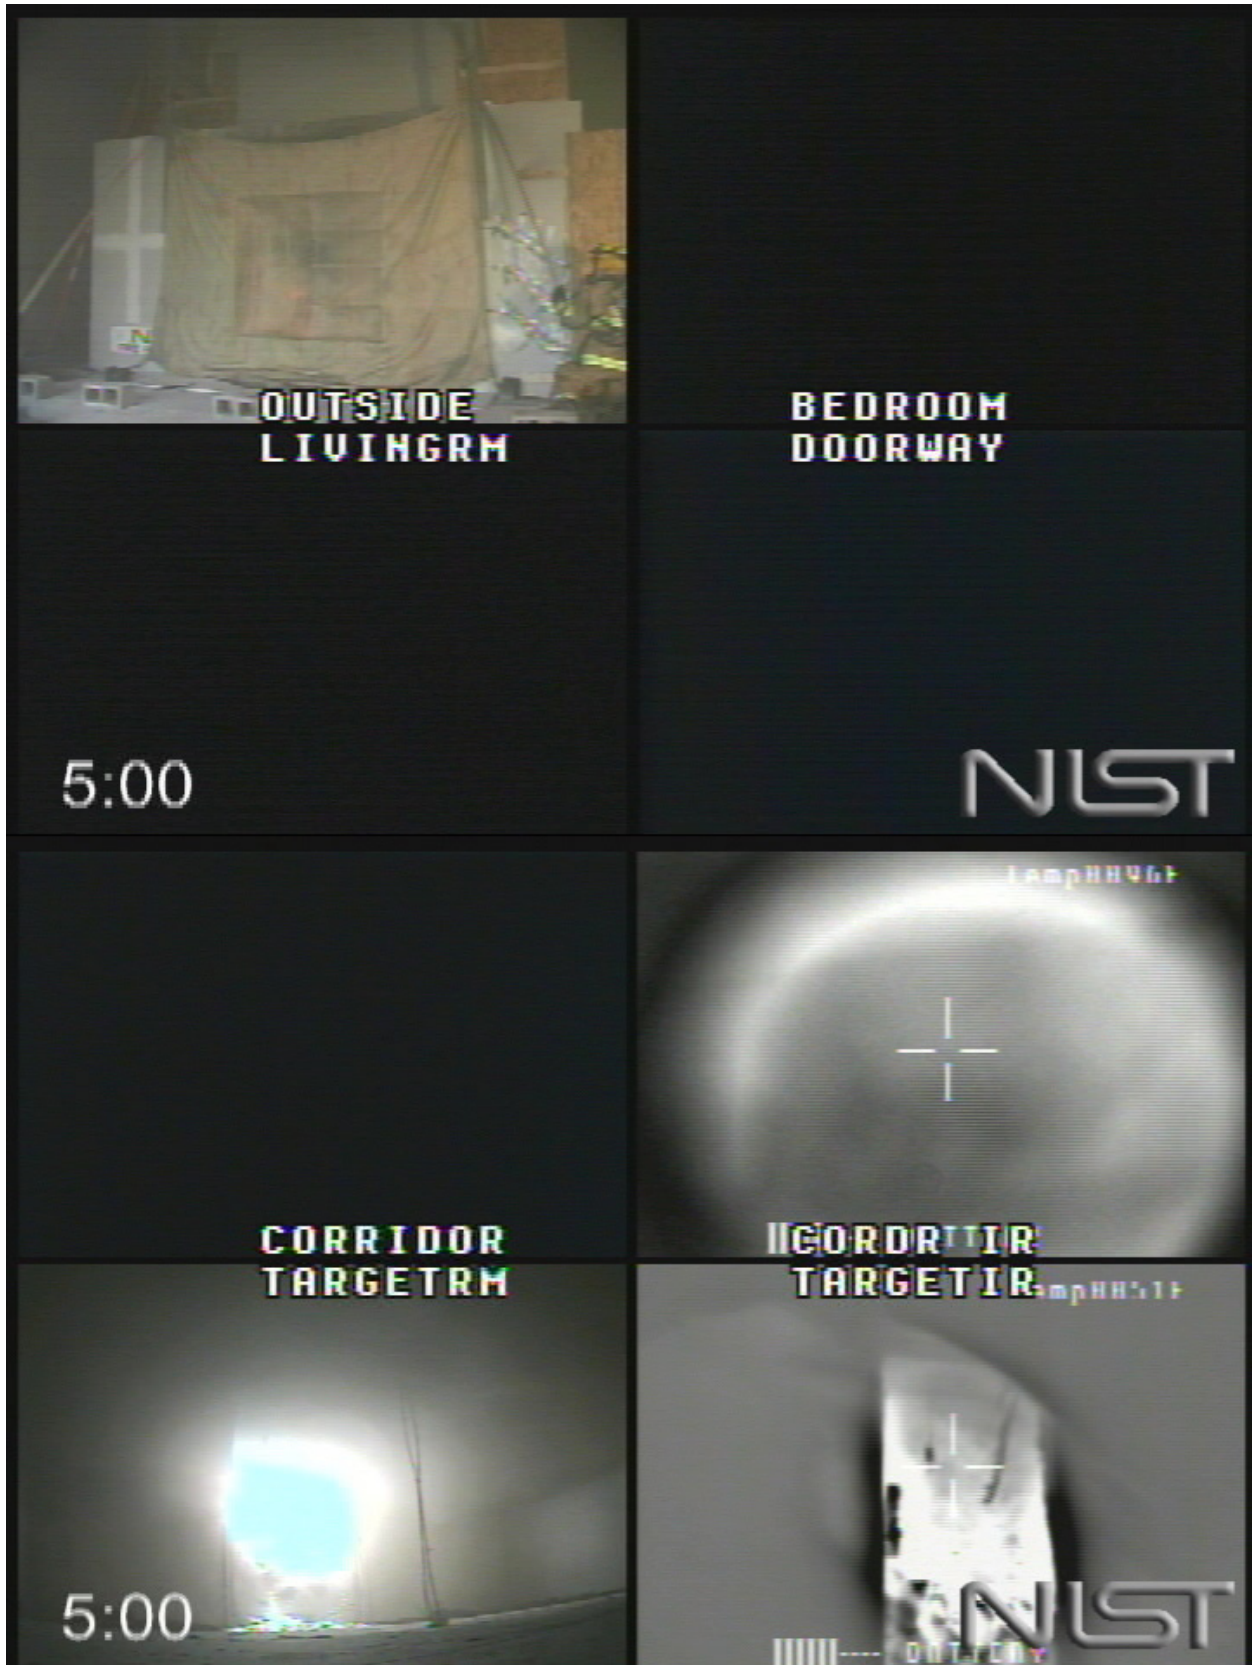
Figure 5.3.1-10. Experiment 3, 300 s after ignition.

Figure 5.3.1-10 shows the conditions at 300 s after ignition, or approximately 30 s since deployment of the wind control device. The interior video views were still obscured by soot. The thermal image from the corridor was still saturated with heat but started to improve in clarity. In the target room the top of the door continued to burn and the thermal image captured the increased heat and the absence of the top half of the door. Although the top half of the door was missing a two layer environment still remained in the target room.

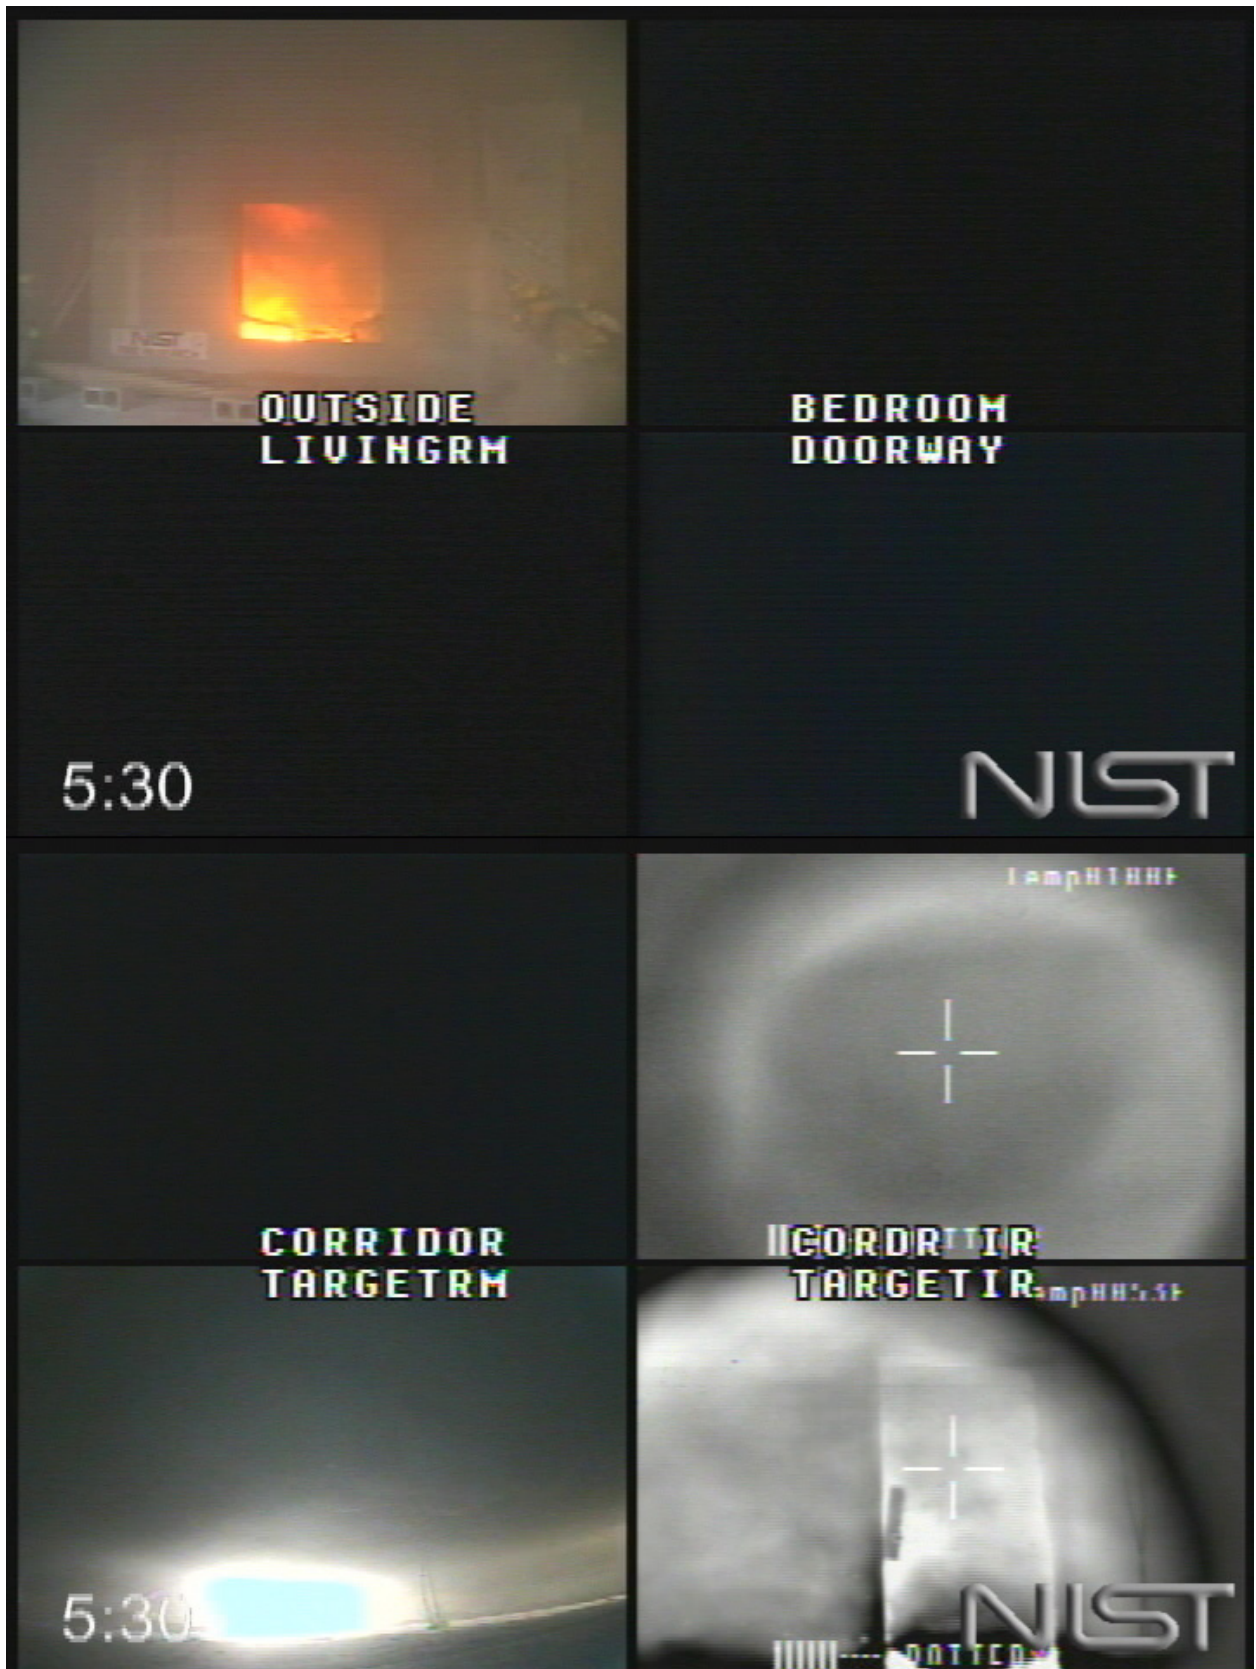
Figure 5.3.1-11. Experiment 3, WCD removed, 330 s after ignition.

Figure 5.3.1-11 shows the conditions at 330 s after ignition, which was about 4 s after the curtain was removed from the window opening. There were flames visible in the bedroom from the outside camera view. The interior video views were still obscured by soot. The target room visual camera shows the smoke layer has descended toward the floor and thermal image shows the heat is mixing throughout the room.

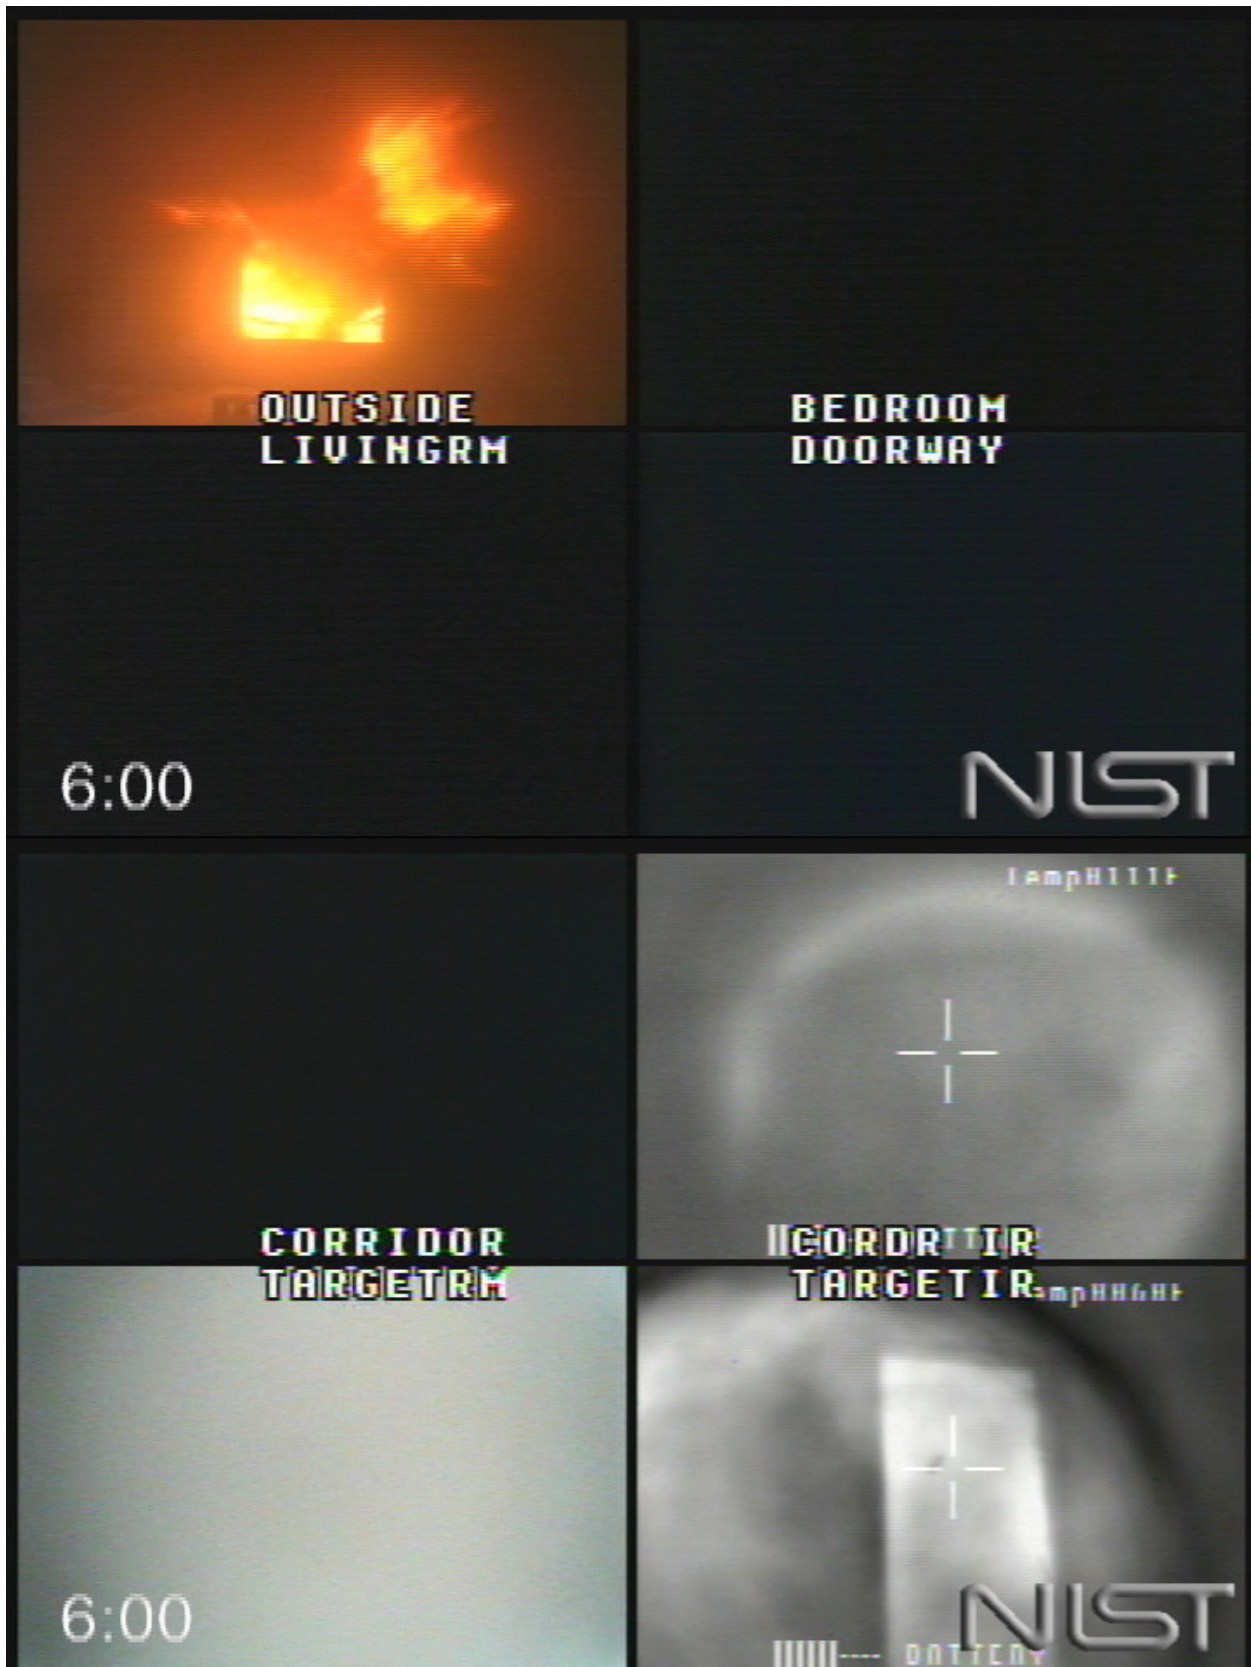
Figure 5.3.1-12. Experiment 3, 360 s after ignition.

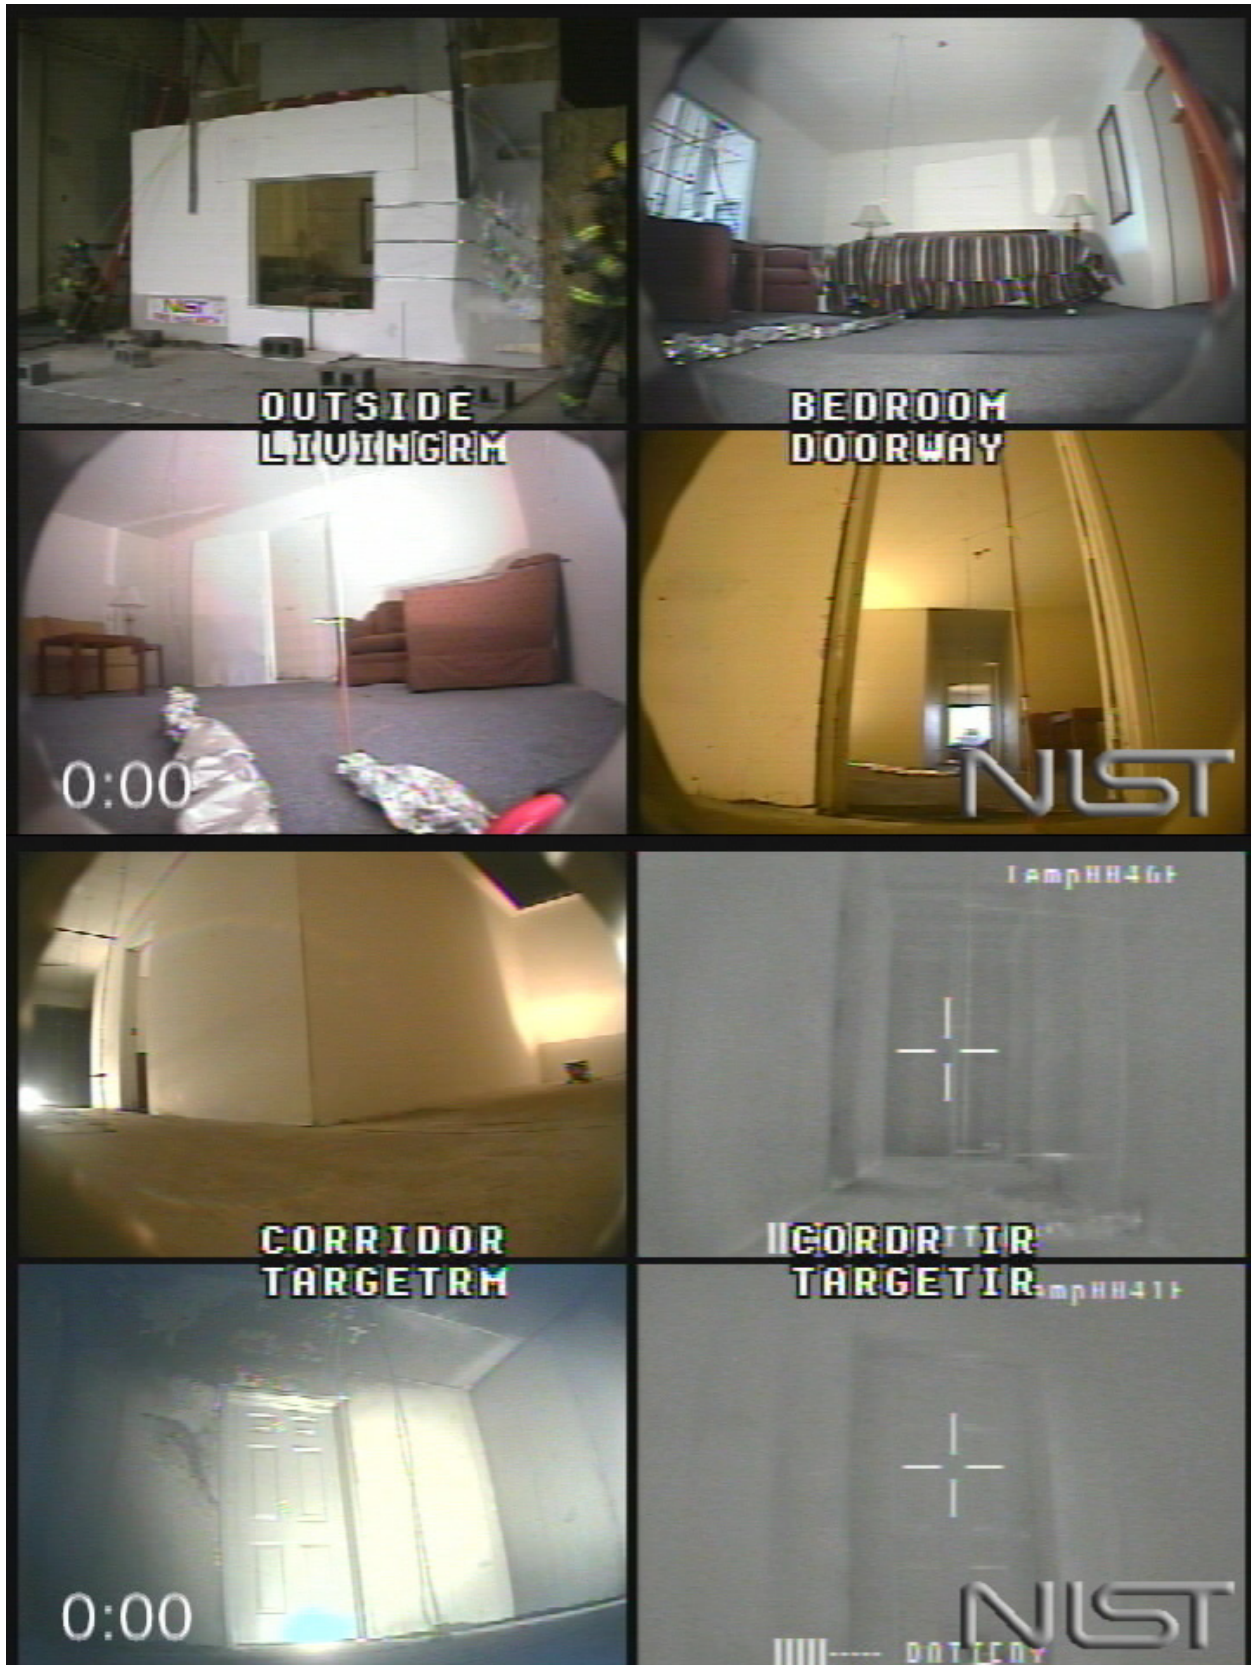
Figure 5.4.1-1. Experiment 4, ignition.

Figure 5.4.1-1 shows the conditions at the time of ignition. At this point, the six video views are clear and unobstructed. The thermal images provide limited thermal contrast because the surfaces in the view are at similar temperatures.

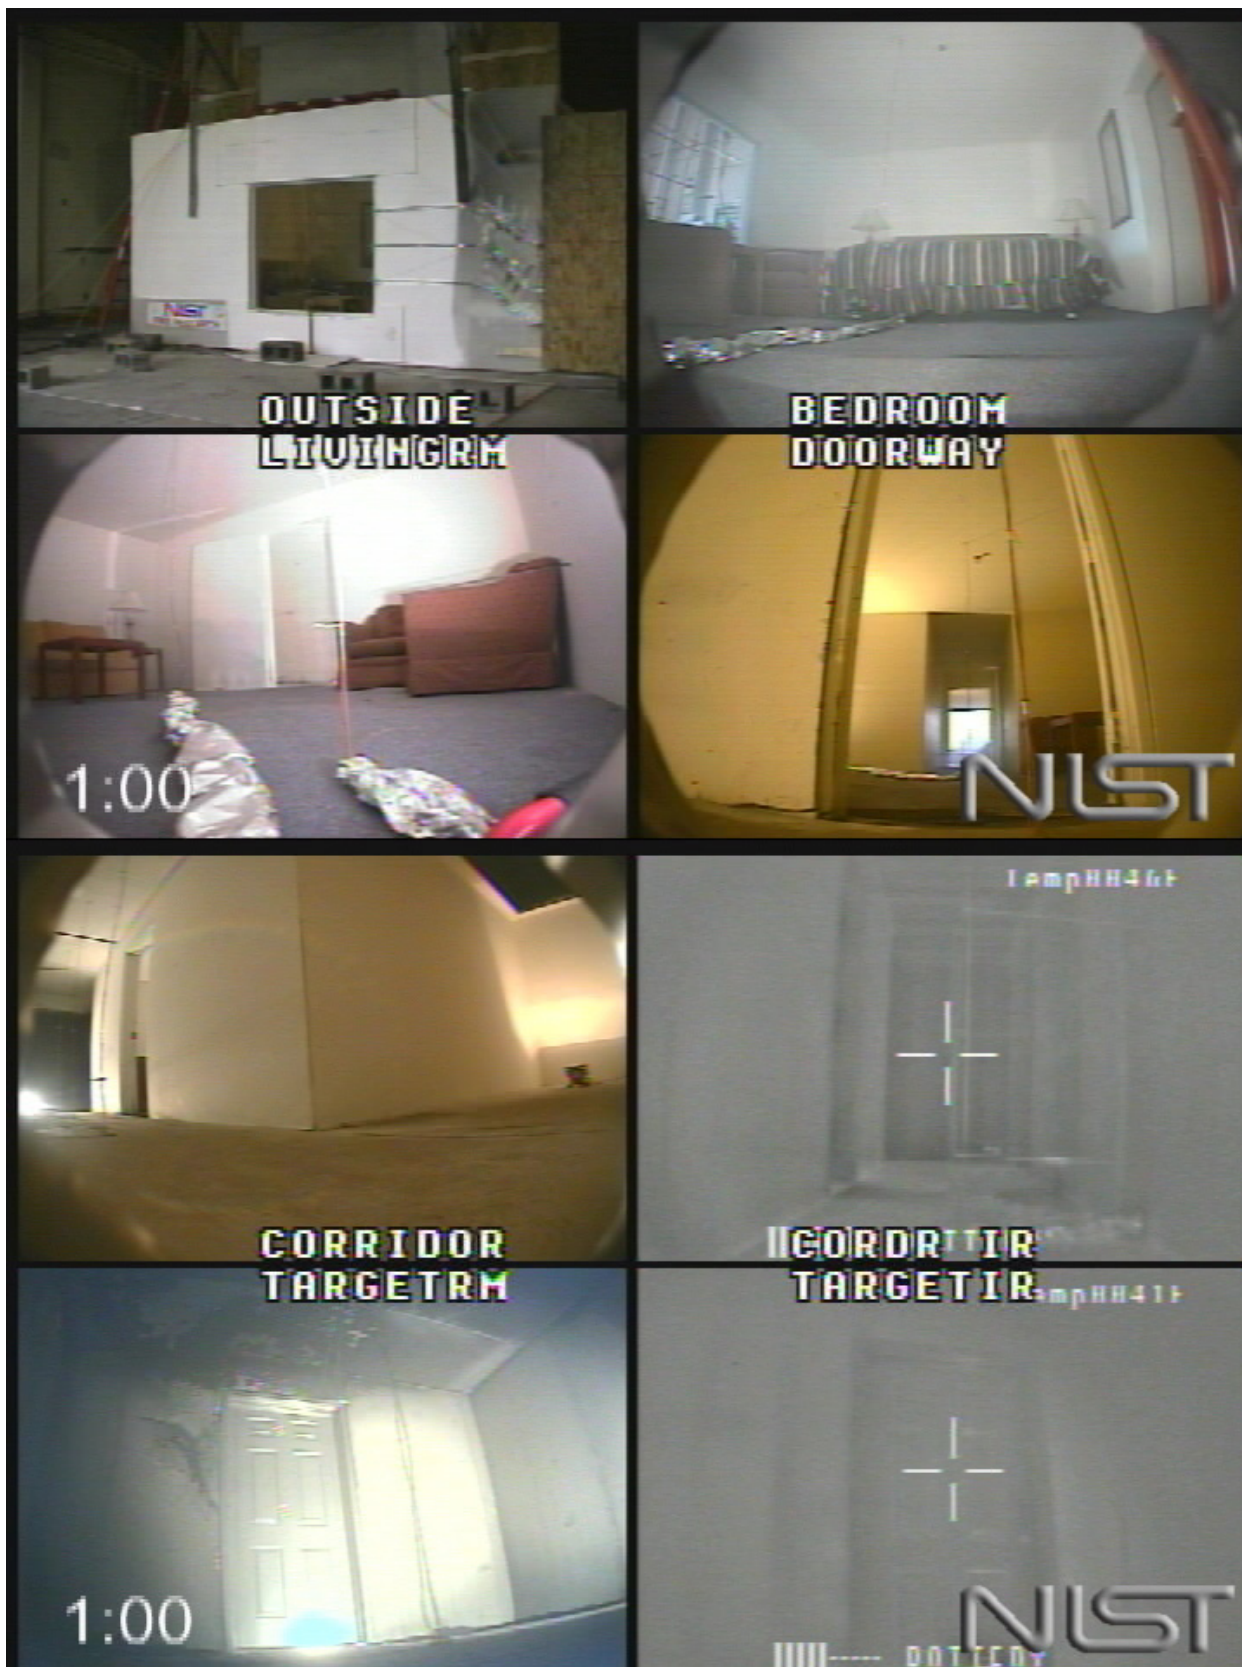
Figure 5.4.1-2. Experiment 4, 60 s after ignition.

The images in Figure 5.4.1-2 were captured 60 s after ignition. At this point the fire is still limited to the trash container fuel package. The fire development in this experiment was slower than in the previous experiments. There is a thin, light smoke layer formed in the bedroom. There was no smoke or change in thermal condition in the living room, target room or corridor at this time.
