NIST Technical Note 1618

Fire Fighting Tactics Under Wind Driven Conditions: Laboratory Experiments

Daniel Madrzykowski
Stephen Kerber

January 2009

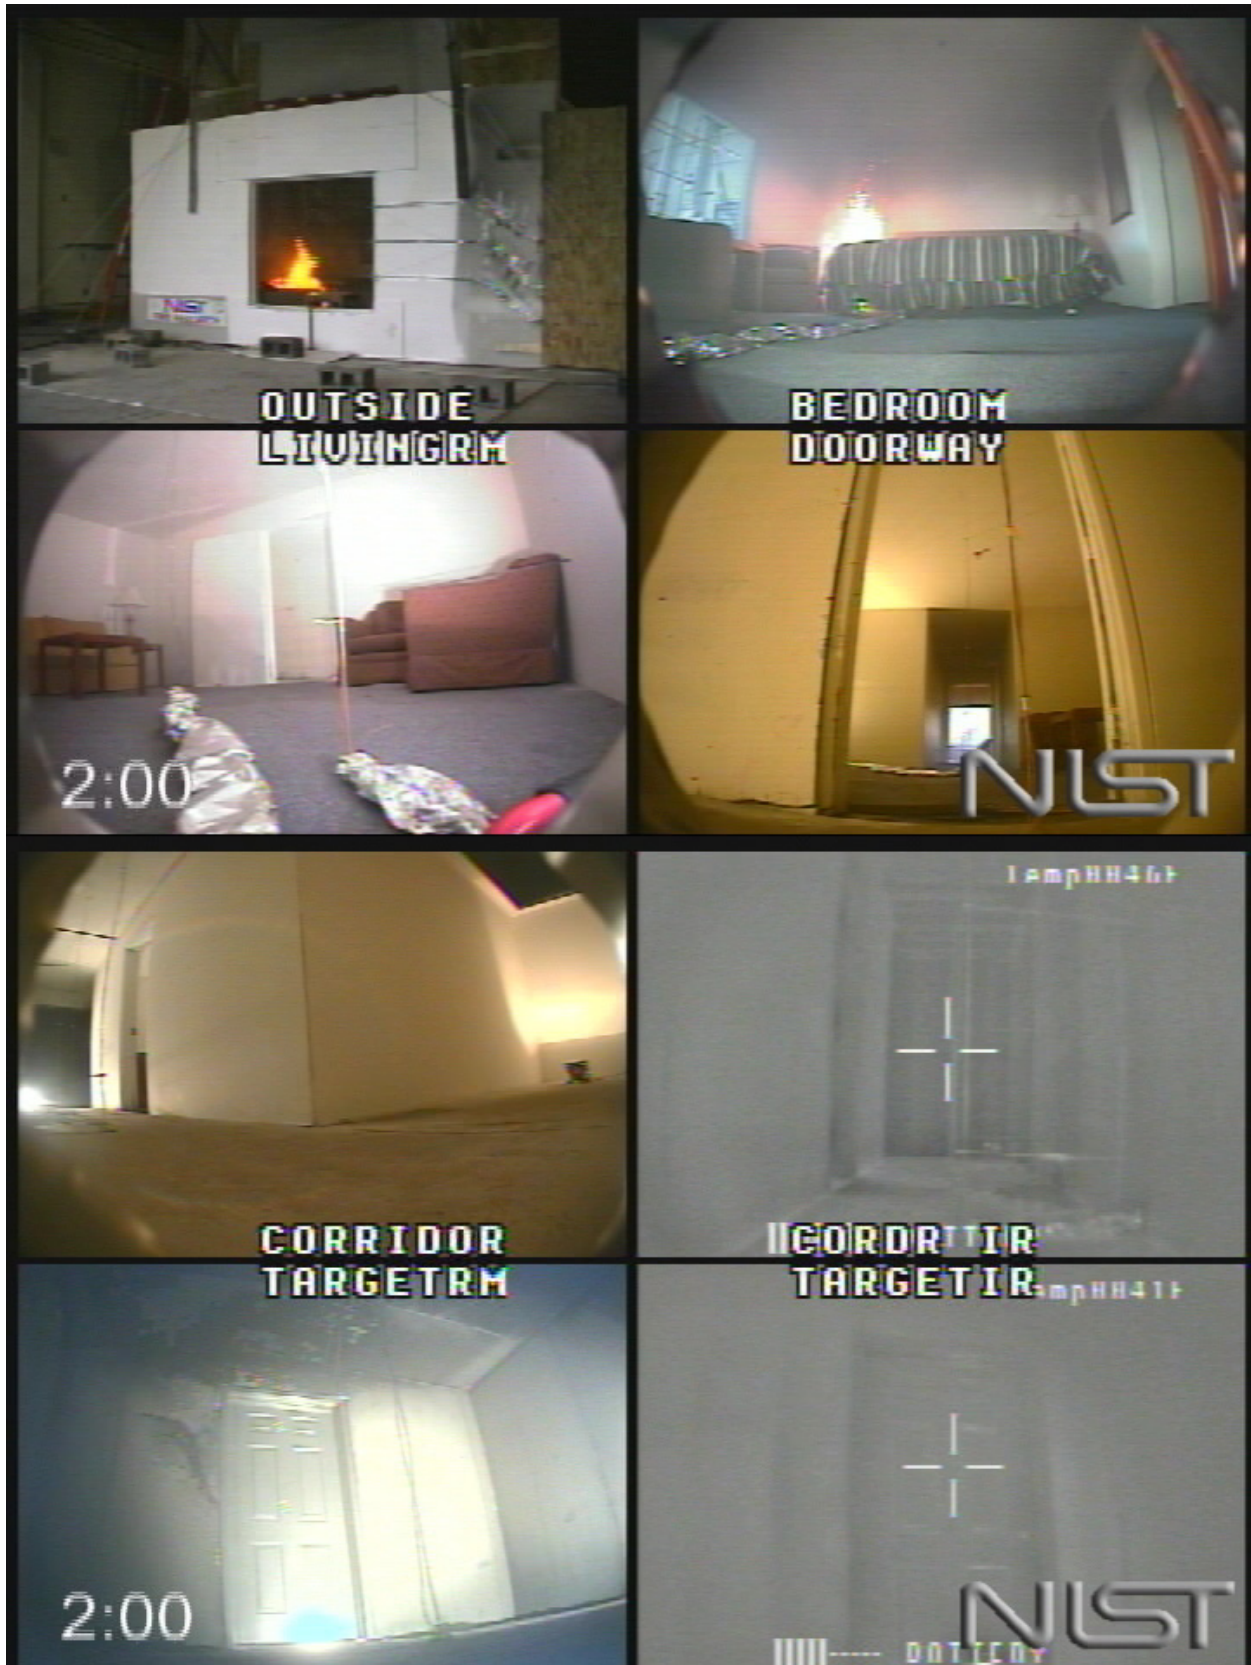
Figure 5.4.1-3. Experiment 4, 120 s after ignition.

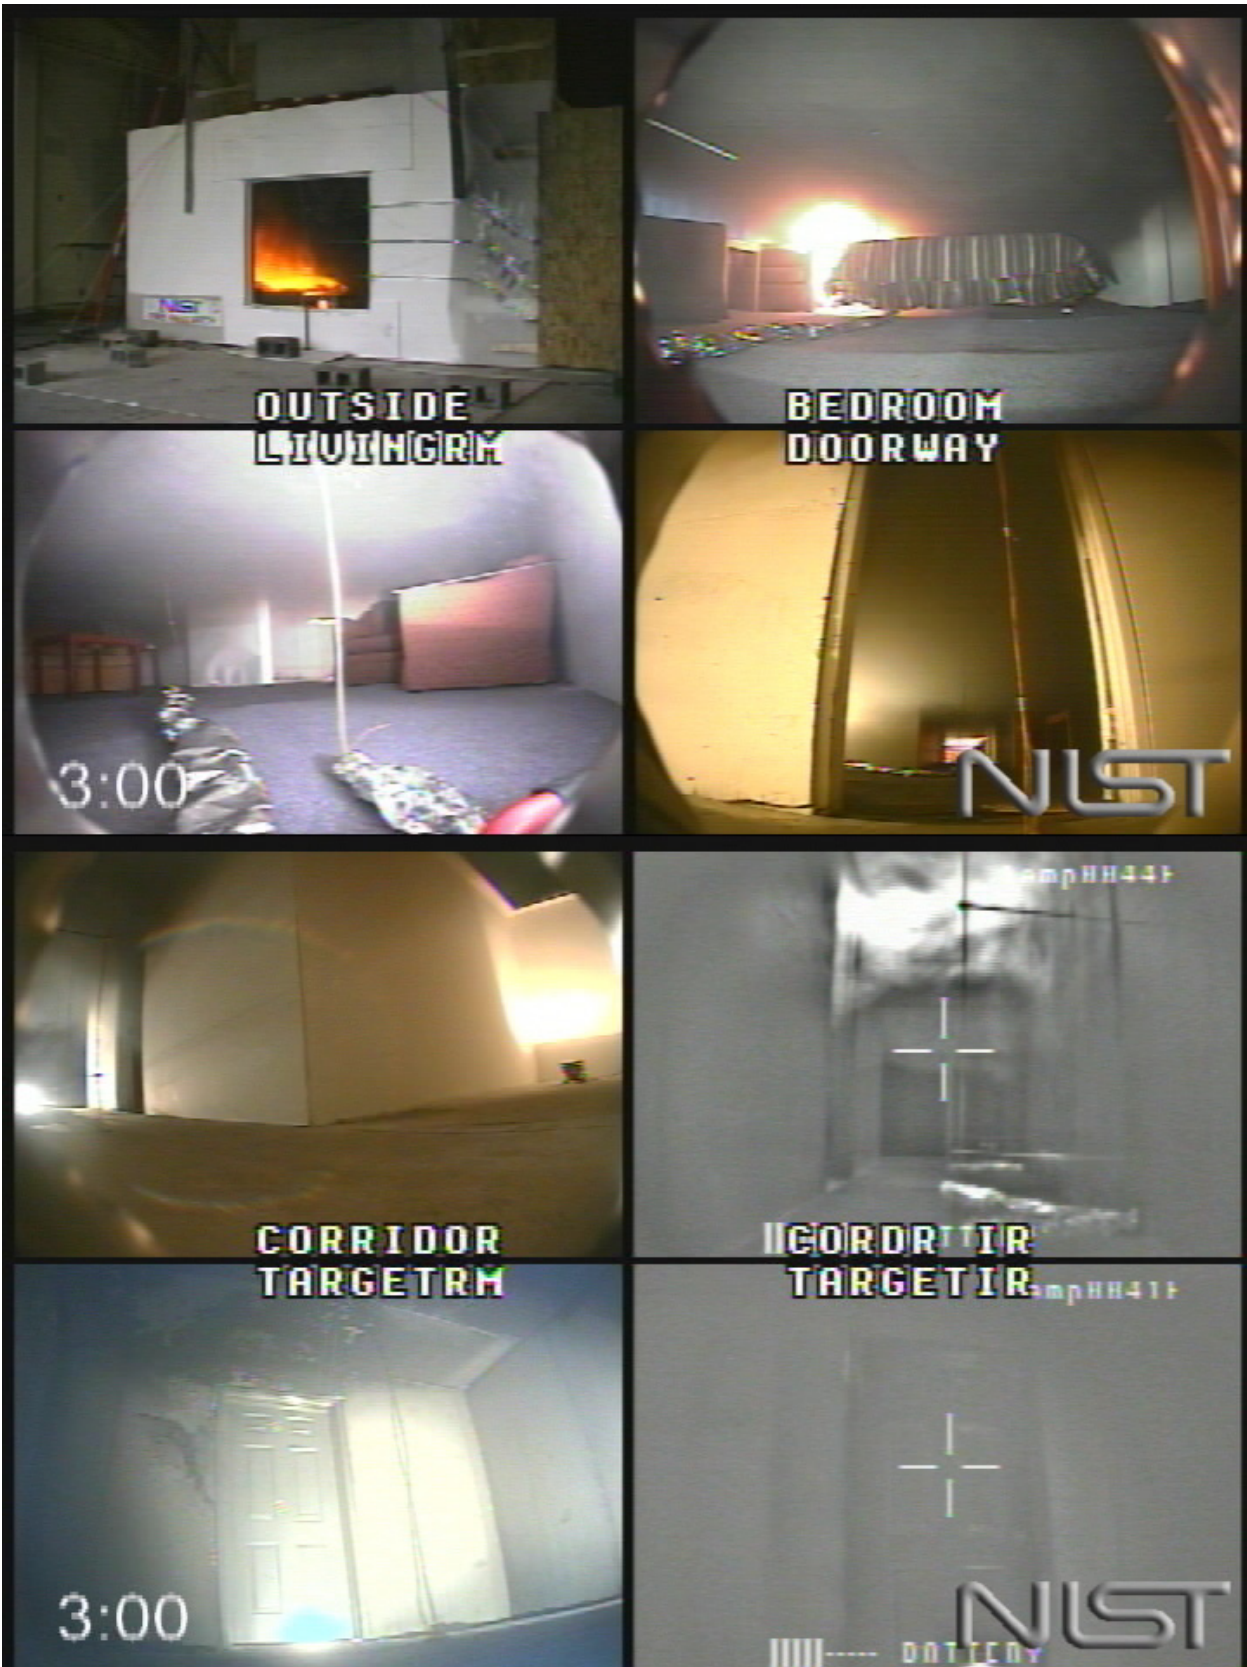
Figure 5.4.1-4. Experiment 4, 180 s after ignition.

Figure 5.4.1-4 shows the images recorded 60 s later at 180 s after ignition. The volume involved in fire has increased. The hot gas layer in the bedroom has become thicker, extending down 1.52 m (5 .00ft) from the ceiling. A hot gas layer has also formed in the living room. It is also approximately 1.52 m (5 .00ft) thick. Smoke and heat are shown flowing into the corridor. The target room appears clear of smoke and thermal view of target room does not show any noticeable heat infiltration.

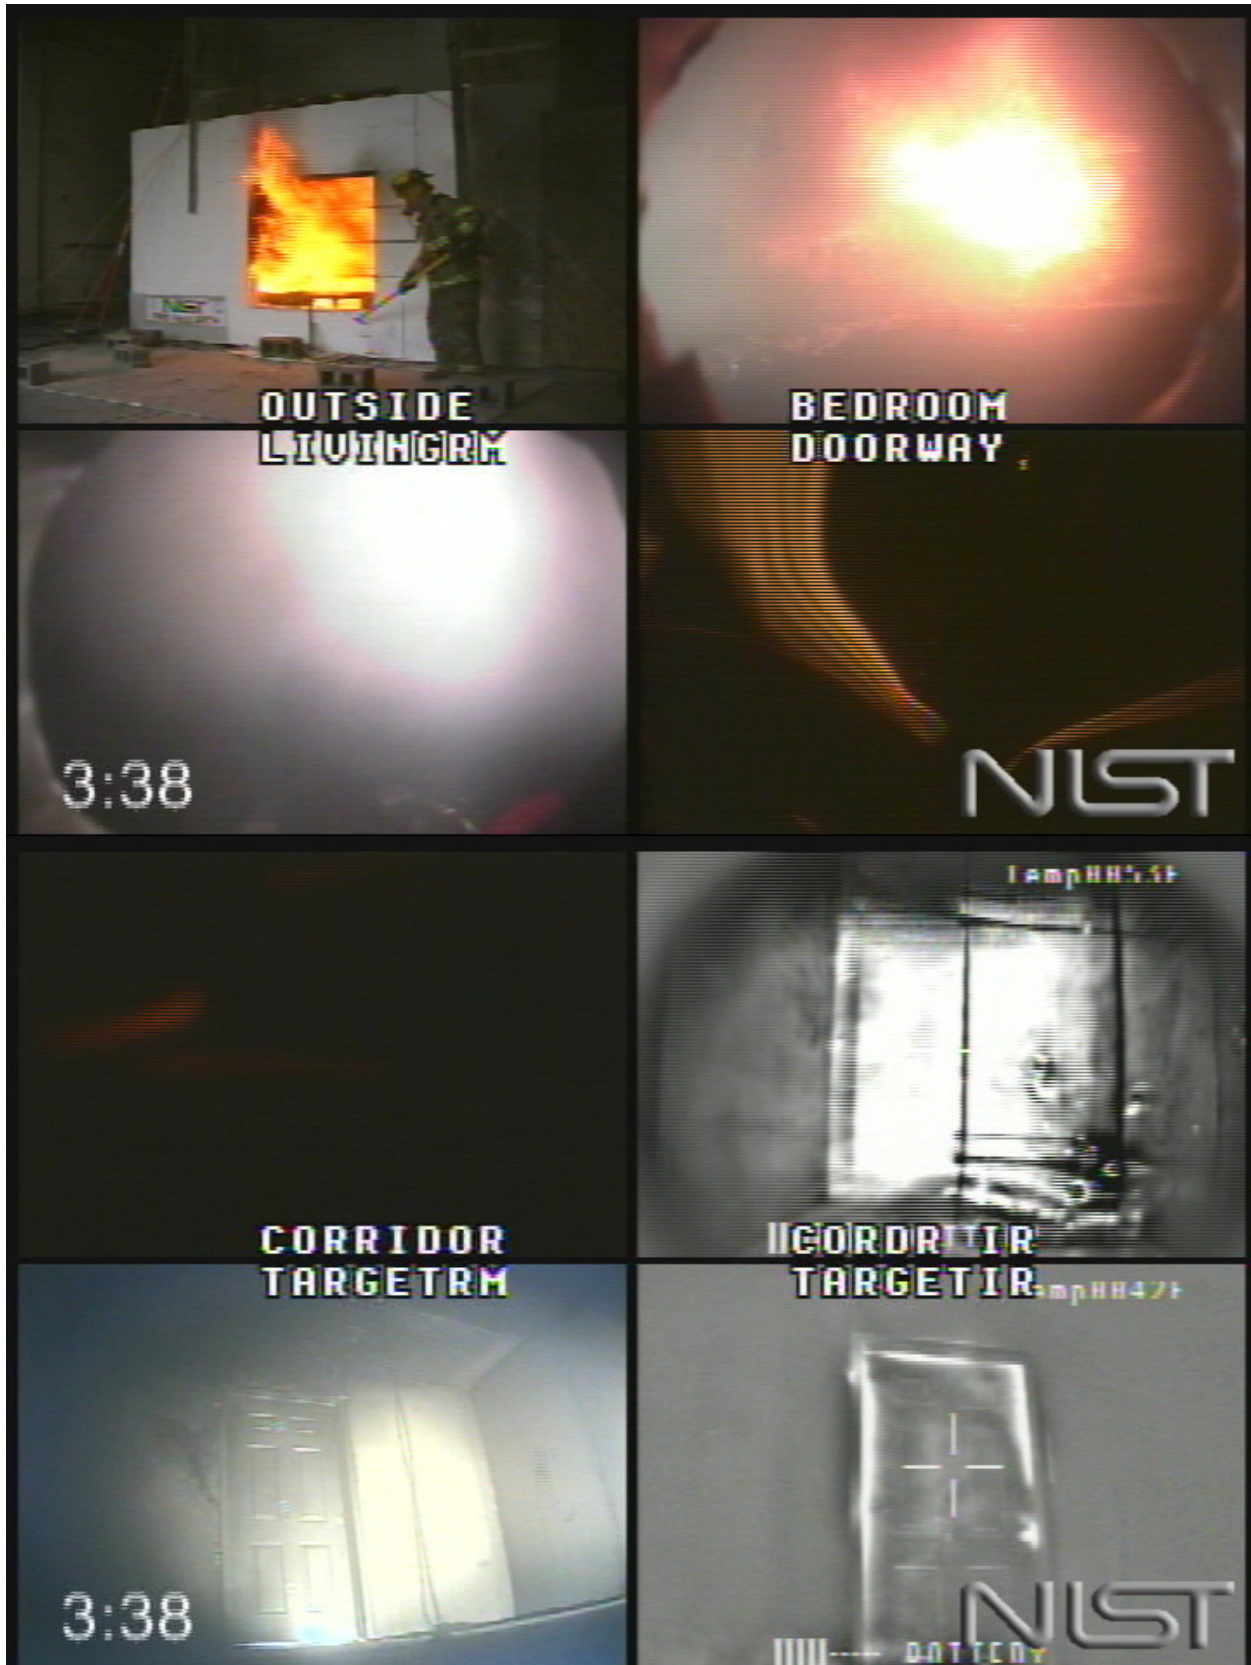
Figure 5.4.1-5. Experiment 4, window fully vented, 218 s after ignition.

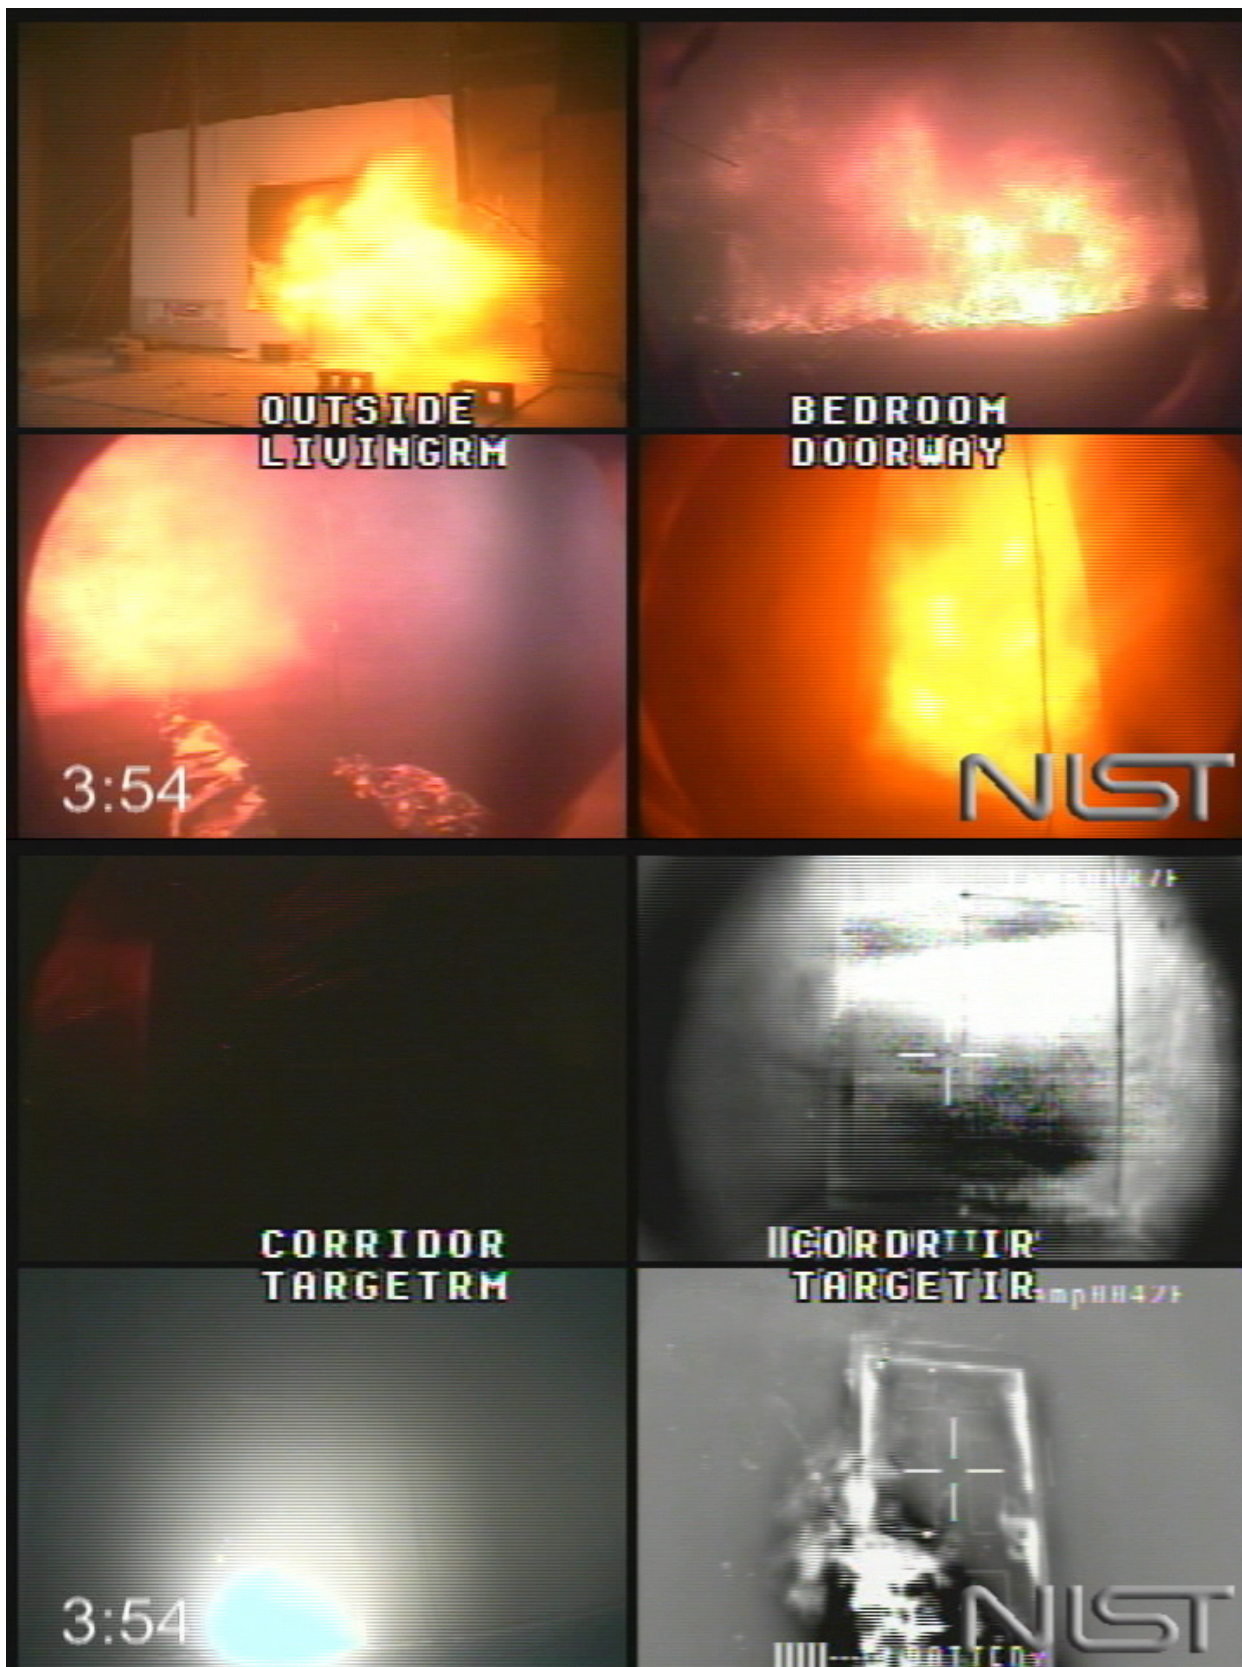
Figure 5.4.1-6. Experiment 4, corridor flames, 234 s after ignition.

Figure 5.4.1-6 shows the conditions at 234 s after ignition. Flames can be seen rolling out of the entire window opening. Horizontal flames are shown extending from the bedroom through the living room and out through the doorway into the corridor. In the corridor video view, the flames that pushed out of the living doorway can barely be seen through the thick smoke. The thermal camera view of the corridor gives the sense of horizontal (jet flame) nature of the hot gases extending across the corridor. In the target room, flames are shown coming under the bottom of the door. The thermal image from the target room exhibits heat around the door edges and a thermal plume from the bottom of the door.

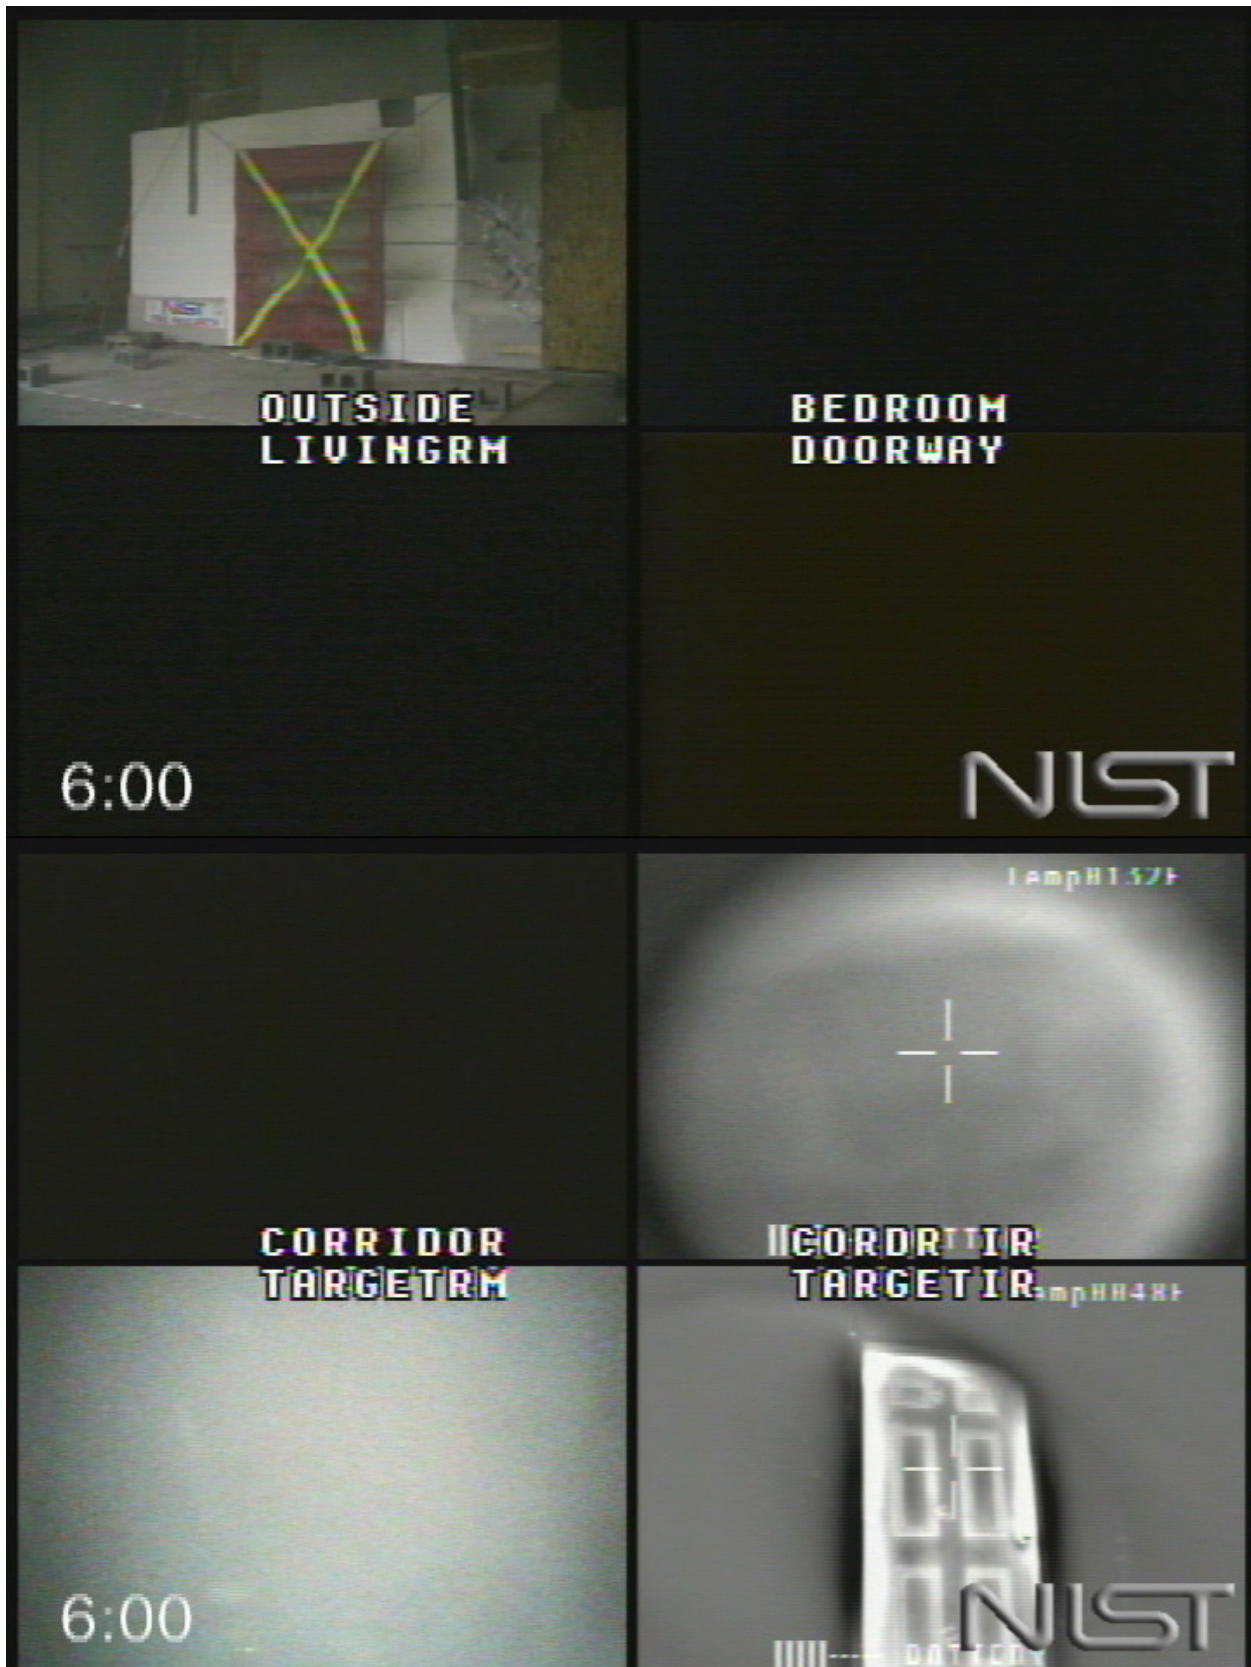
Figure 5.4.1-10. Experiment 4, 300 s after ignition.

Figure 5.4.1-10 shows the conditions at 300 s after ignition, or approximately 30 s since deployment of the wind control device. The interior video views were still obscured by soot. The thermal image from the corridor was still saturated with heat. In the target room the flames were still burning along portions of the edges and the bottom of the door. The thermal image of the target room door had not changed significantly since the previous image.

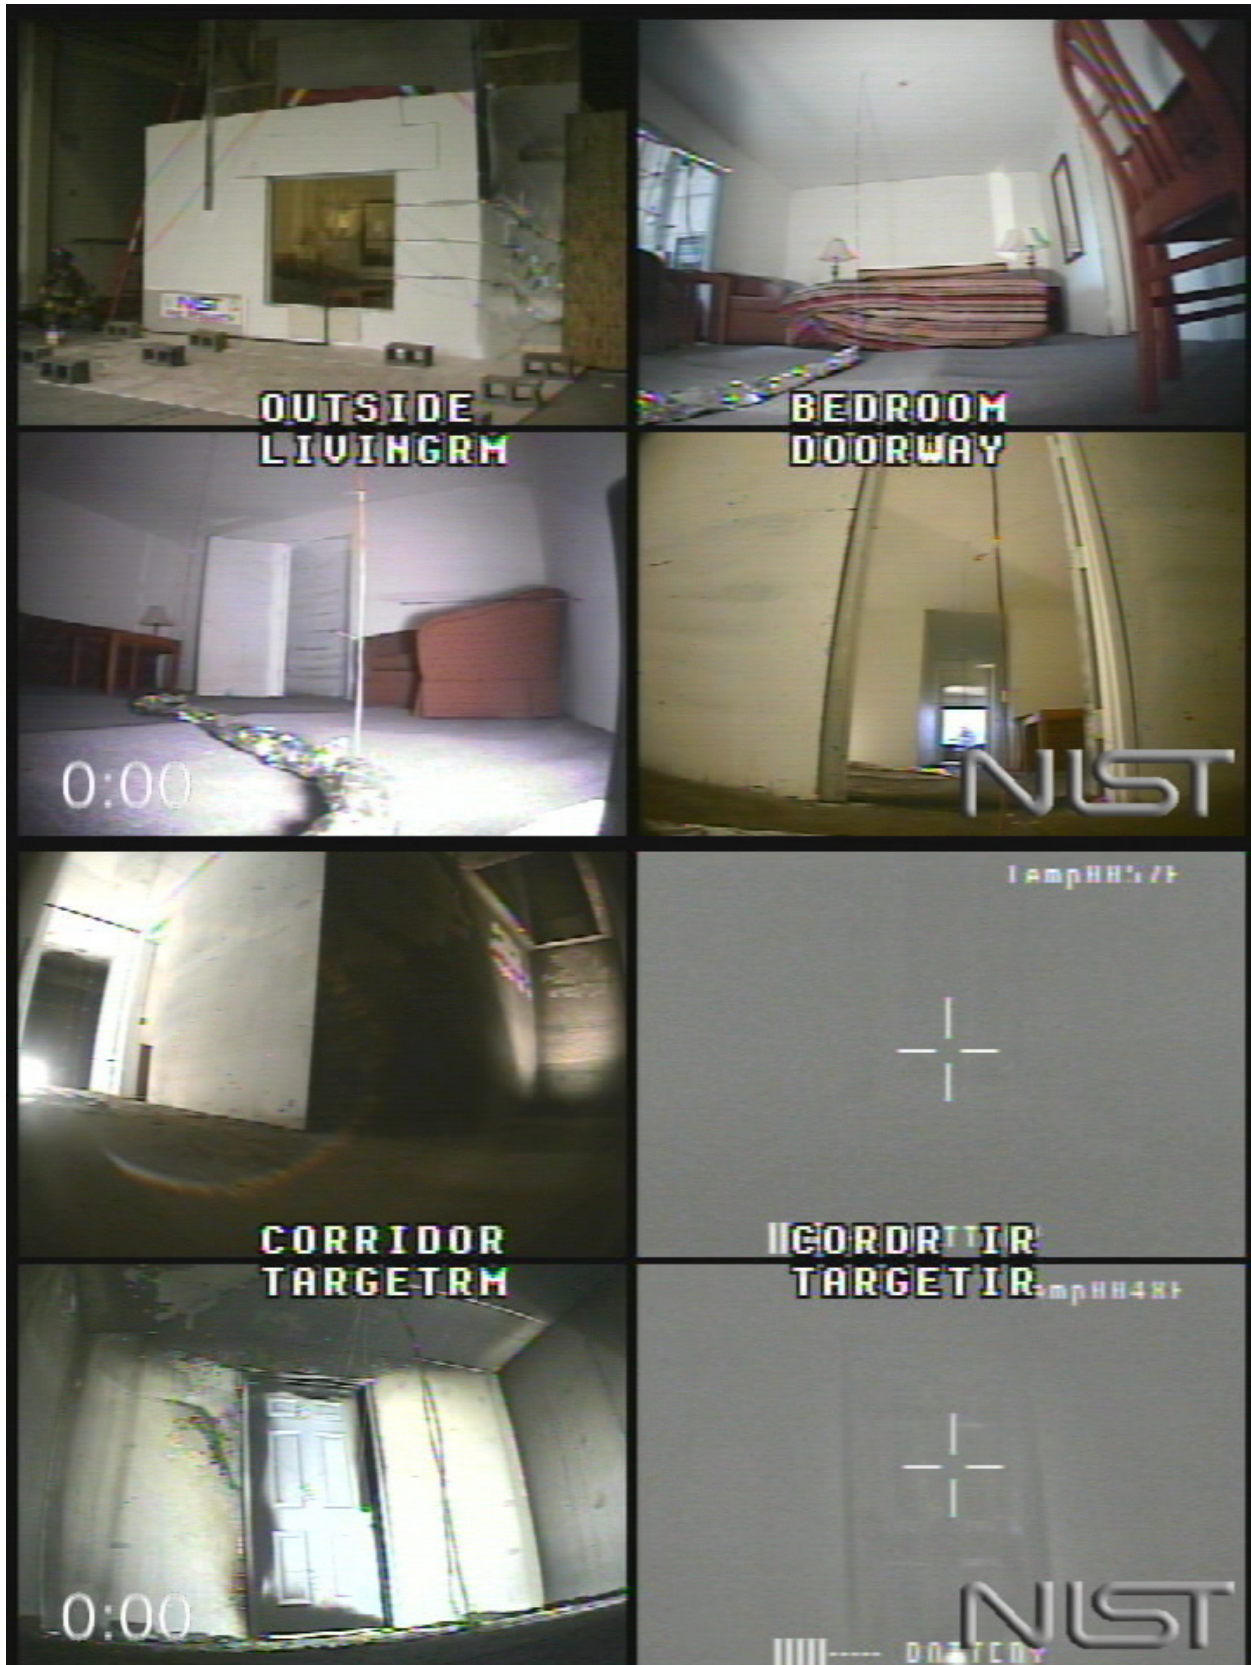
Figure 5.5.1-1. Experiment 5, ignition.

Figure 5.5.1-1 shows the conditions at the time of ignition. At this point, the six video views are clear and unobstructed. However, the thermal images provide limited thermal contrast because the surfaces in the view were at nearly equal temperature.

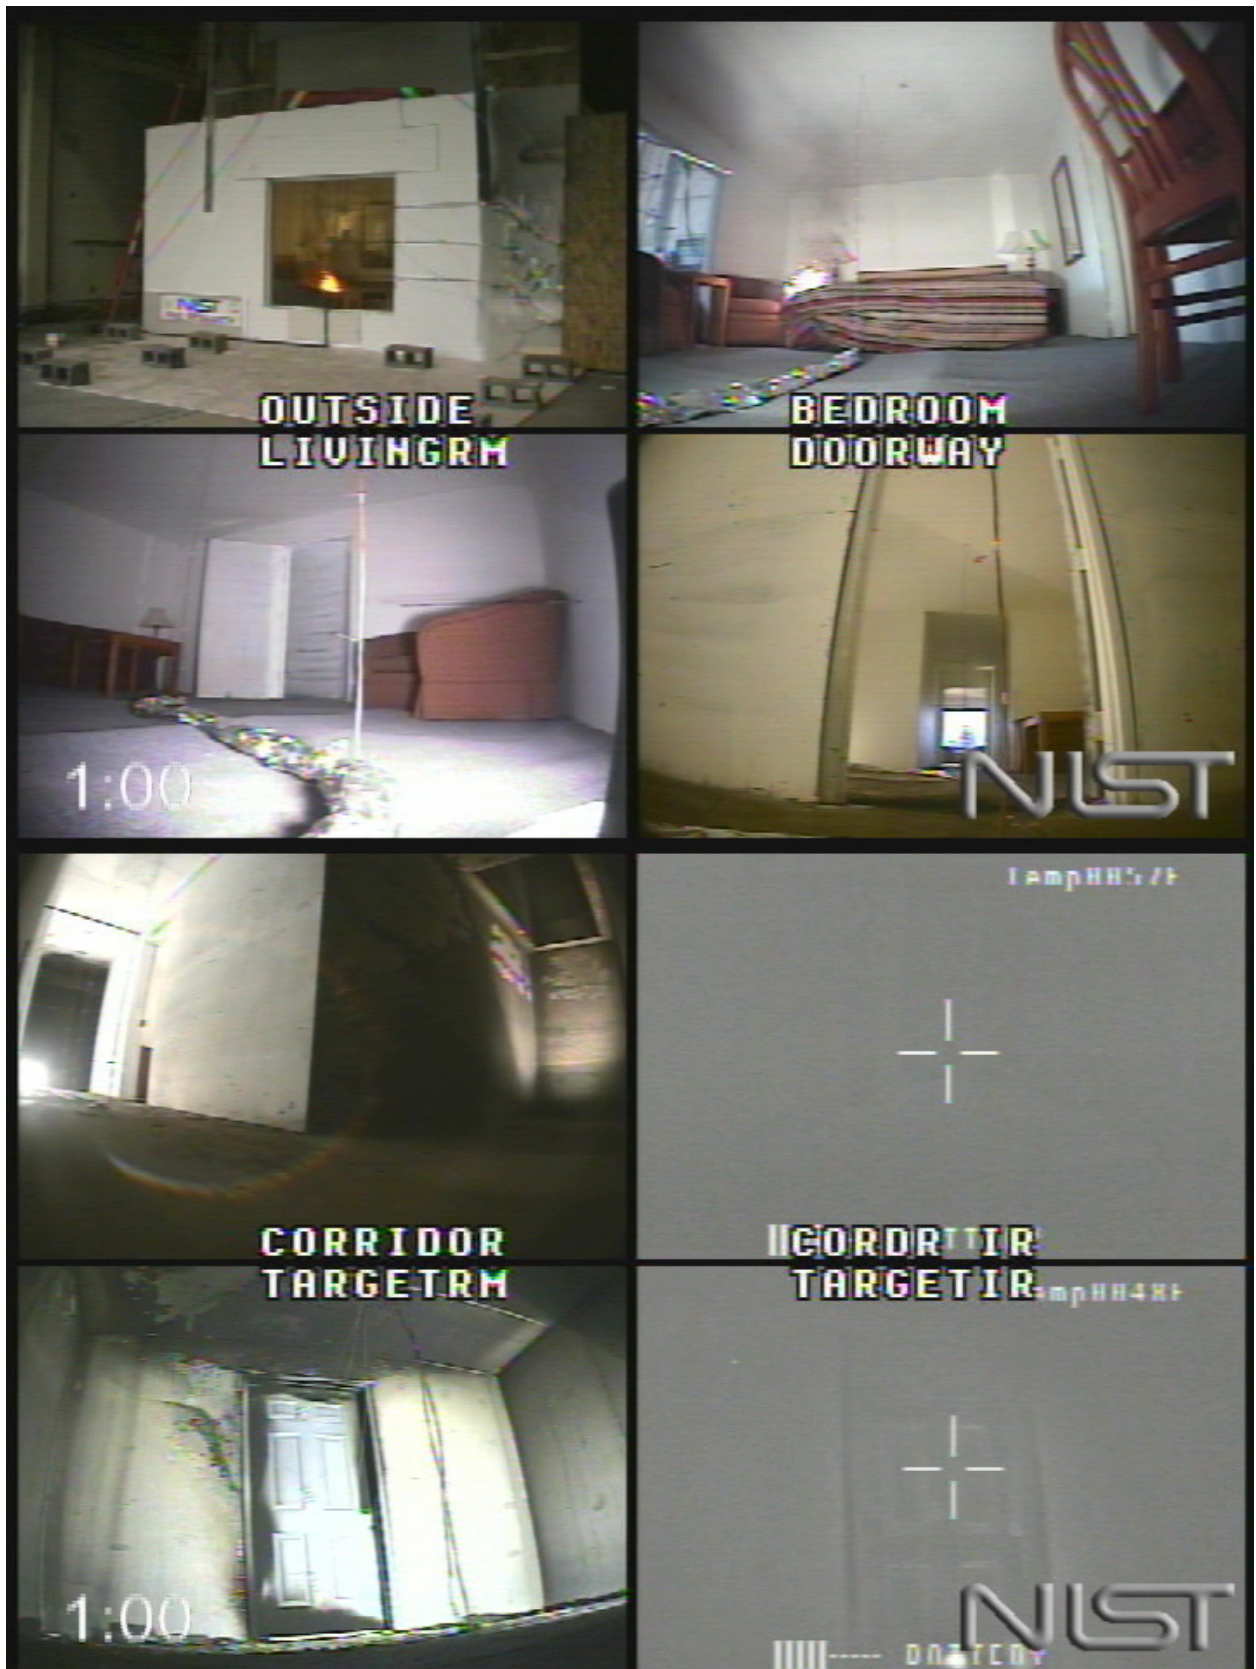
Figure 5.5.1-2. Experiment 5, 60 s after ignition.

The images in Figure 5.5.1-2 were captured 60 s after ignition. The fire from the trash container began to spread to the bed. There was very little smoke being produced and a layer has yet to develop. There was also no smoke or change in thermal condition in the living room, target room or corridor at this time.

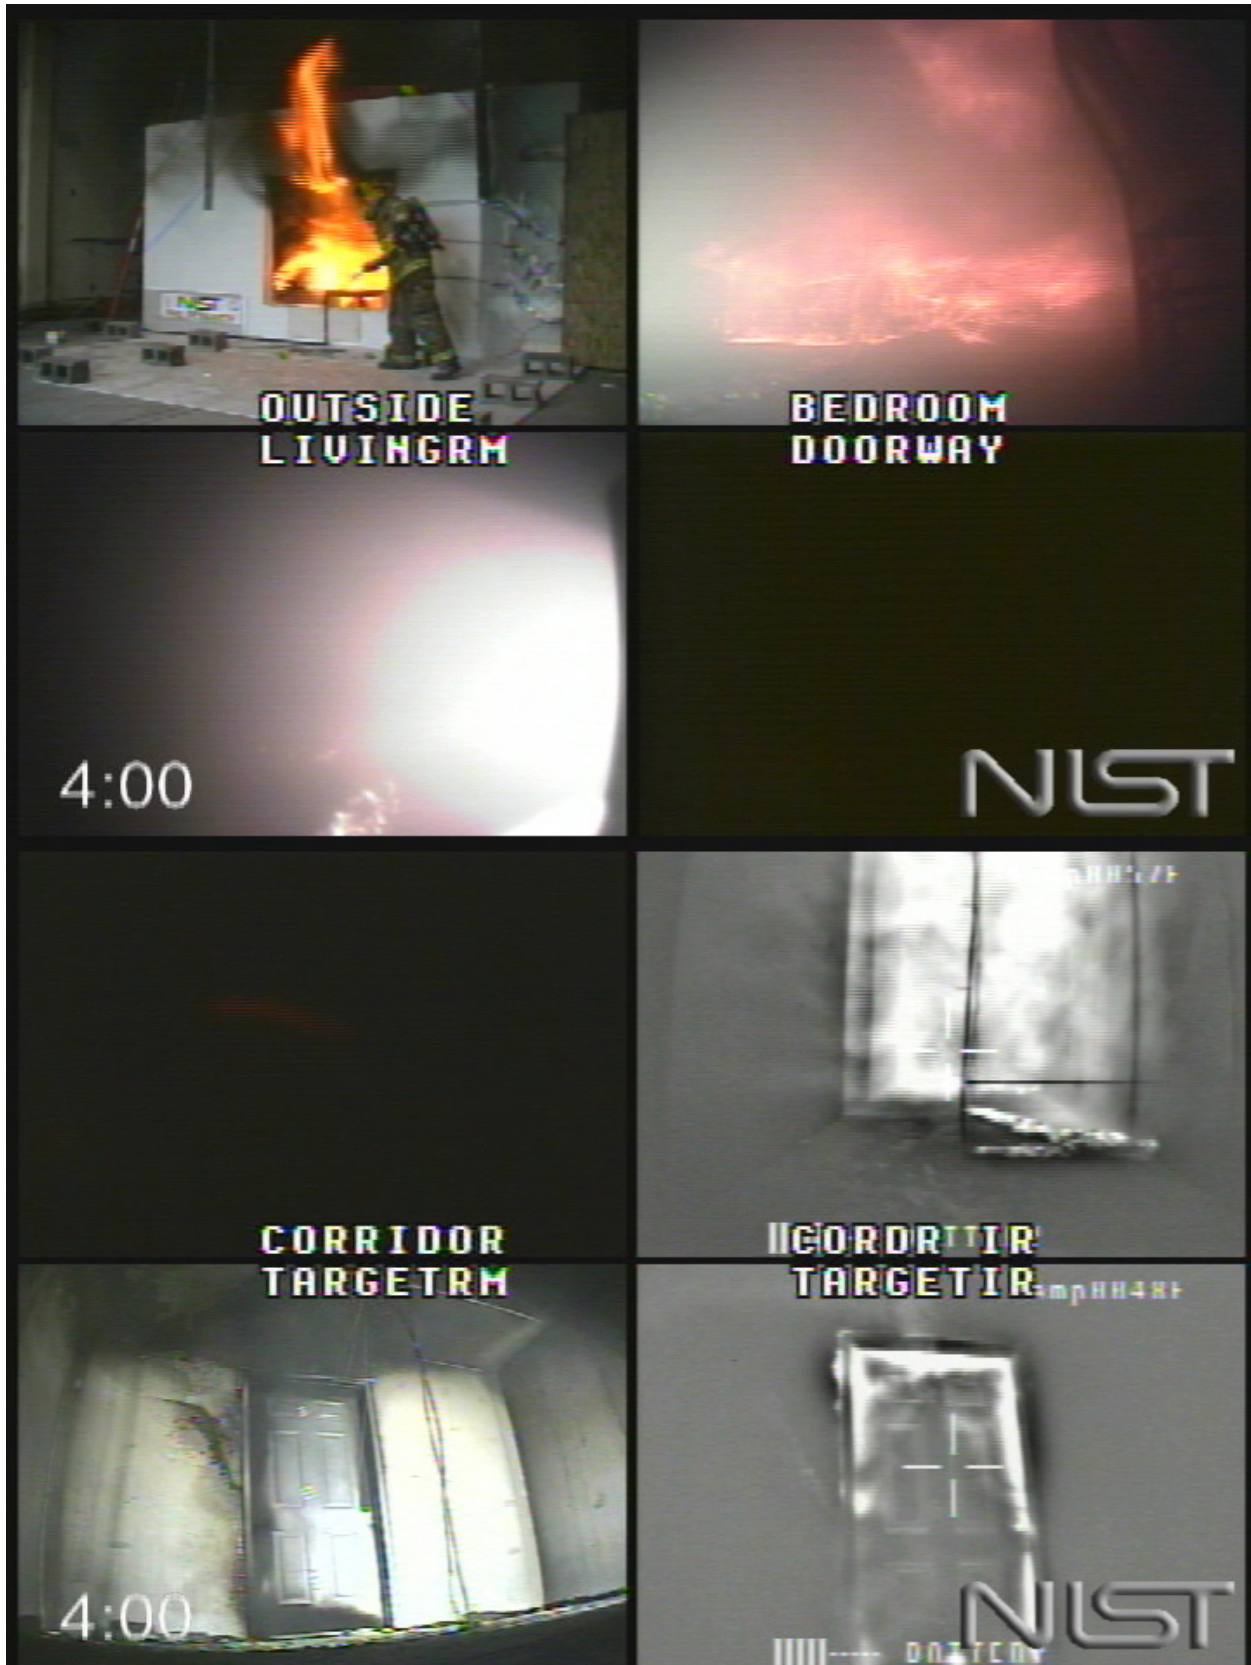
Figure 5.5.1-5. Experiment 5, 240 s after ignition.

Figure 5.5.1-5 shows the conditions at 240 s after ignition. The image shows the conditions just after the window was manually cleared. Flames are seen moving across the floor level in the bedroom and the camera views in the living room, hallway and corridor are obscured by smoke. The image from the corridor IR camera shows hot gases exiting the living room, filling the doorway top to bottom and impinging on the east wall of the corridor. Heat was flowing around the entire perimeter of the hall door into the target room, as shown in the thermal image of the target room.

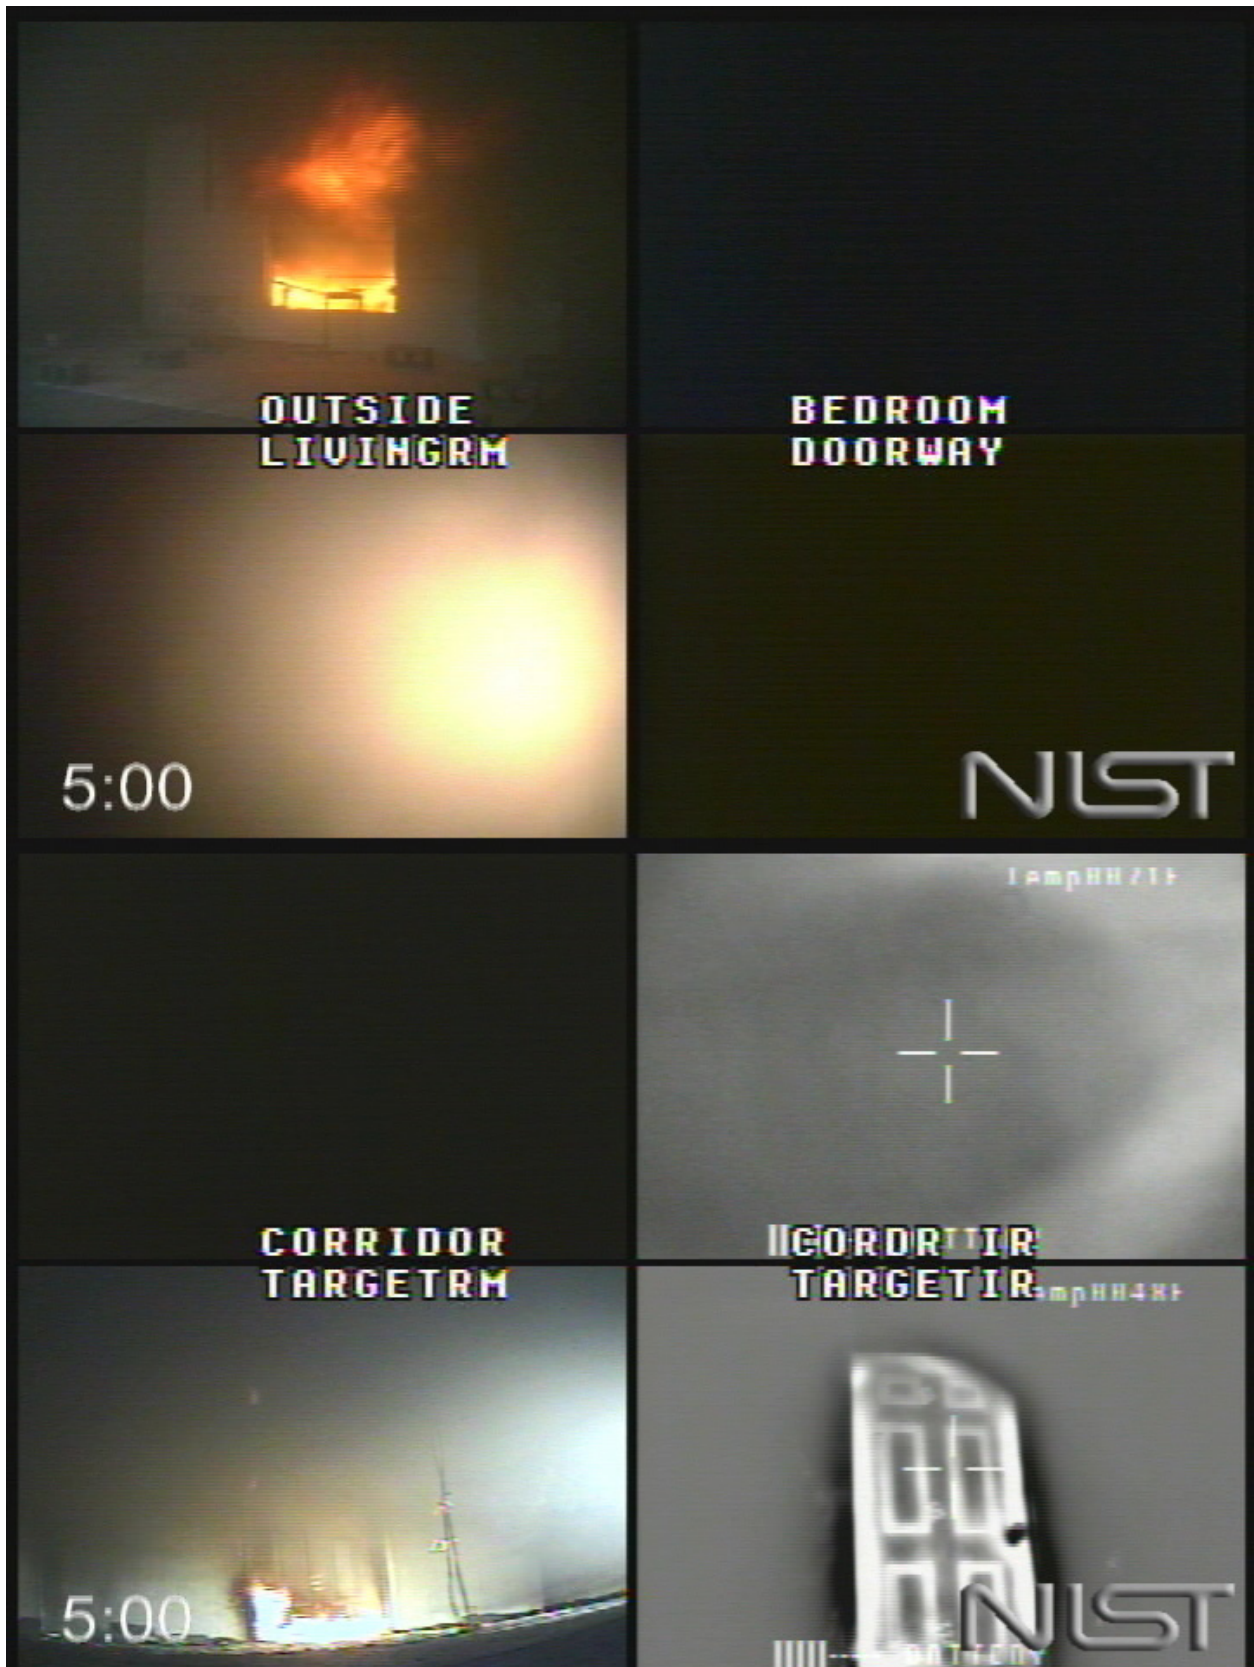
Figure 5.5.1-7. Experiment 5, 300 s after ignition.

Figure 5.5.1-7 shows the conditions at 300 s after ignition. Flames were pulsing out of the top of the window opening. Smoke was obscuring the views in the bedroom, living room and corridor. The amount of heat entering the hallway has caused the image from the corridor IR camera to deteriorate substantially. The visual image in the target room showed flames continuing to burn under the door. The visibility at the lower layer in the target room remained good.

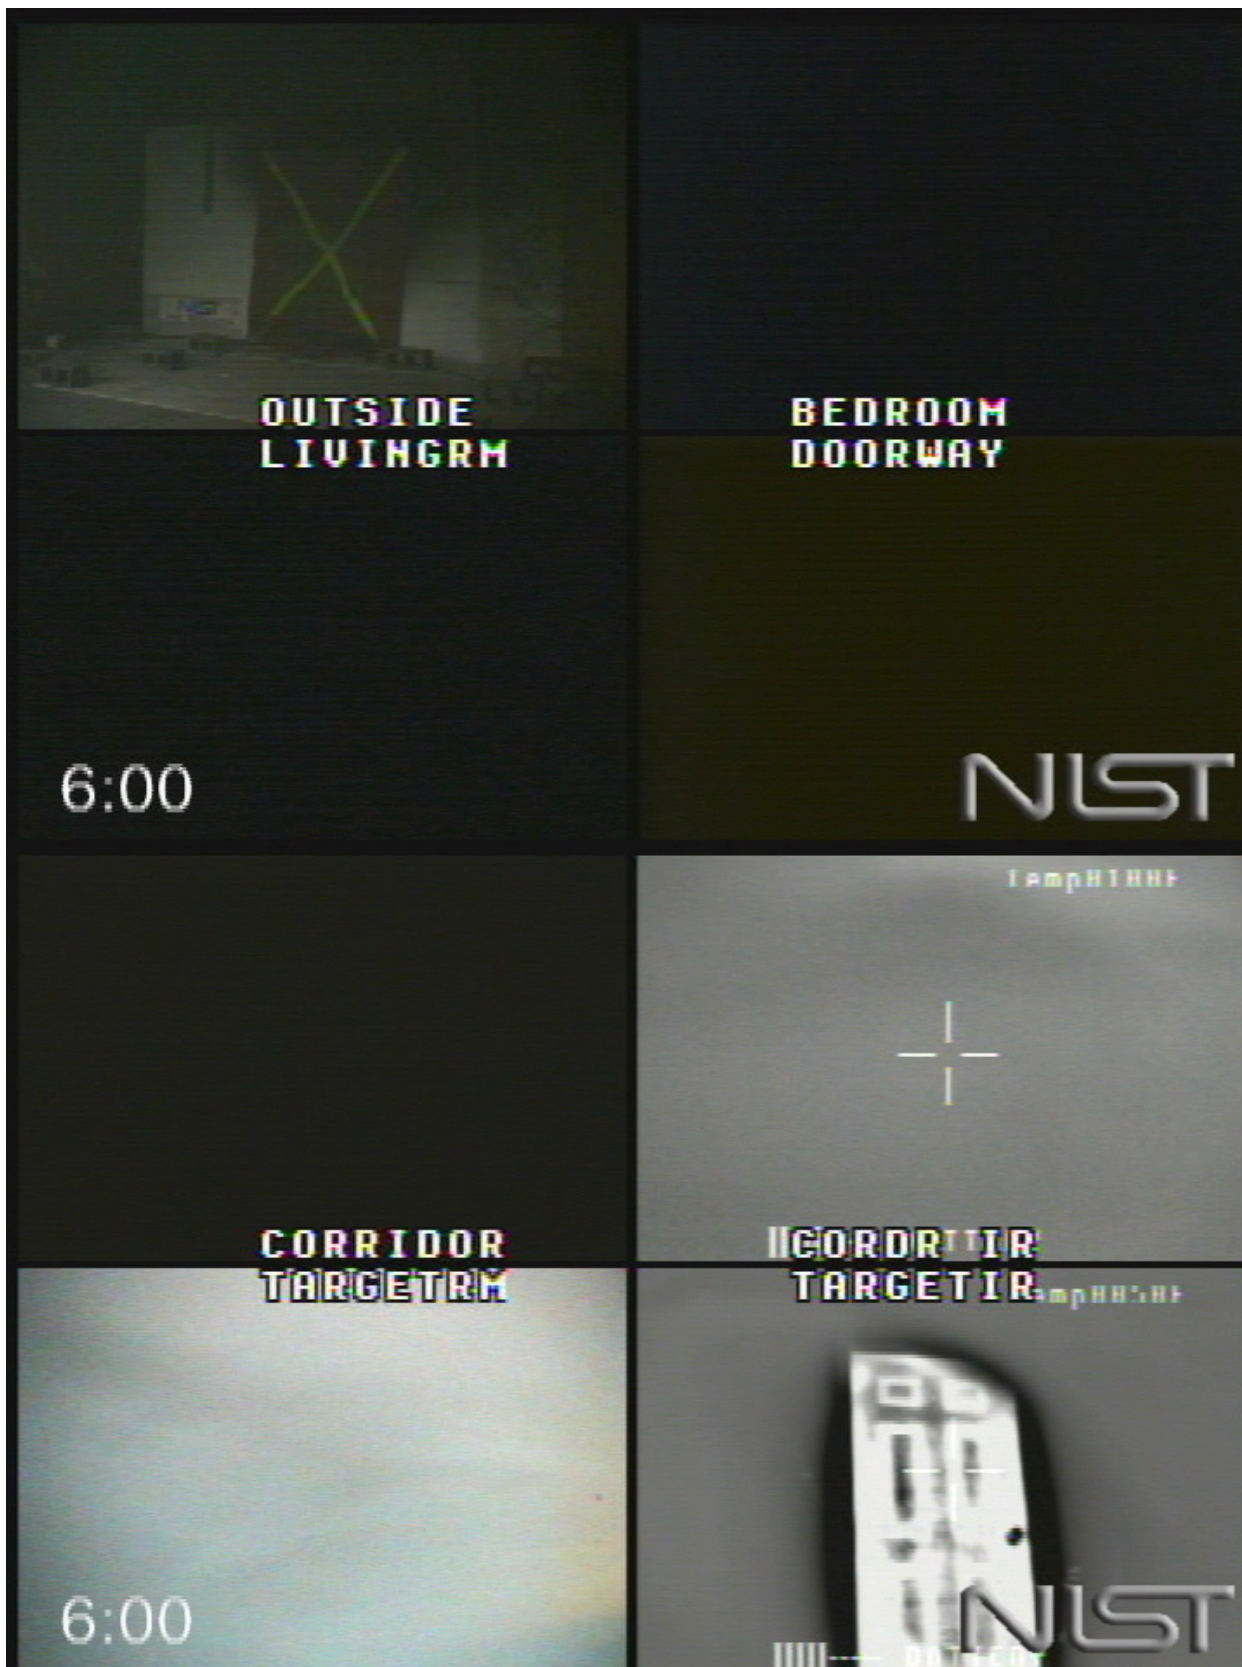
Figure 5.5.1-10. Experiment 5, 360 s after ignition.

Figure 5.5.1-10 shows the conditions at 360 s after ignition, or approximately 30 s since deployment of the wind control device. The interior video views were still obscured by soot. The thermal image from the corridor was still saturated with heat. In the target room the door continued to heat up but remained fully intact. White smoke obscured the view in the target room.
