NIST Technical Note 1618

Fire Fighting Tactics Under Wind Driven Conditions: Laboratory Experiments

Daniel Madrzykowski
Stephen Kerber

January 2009

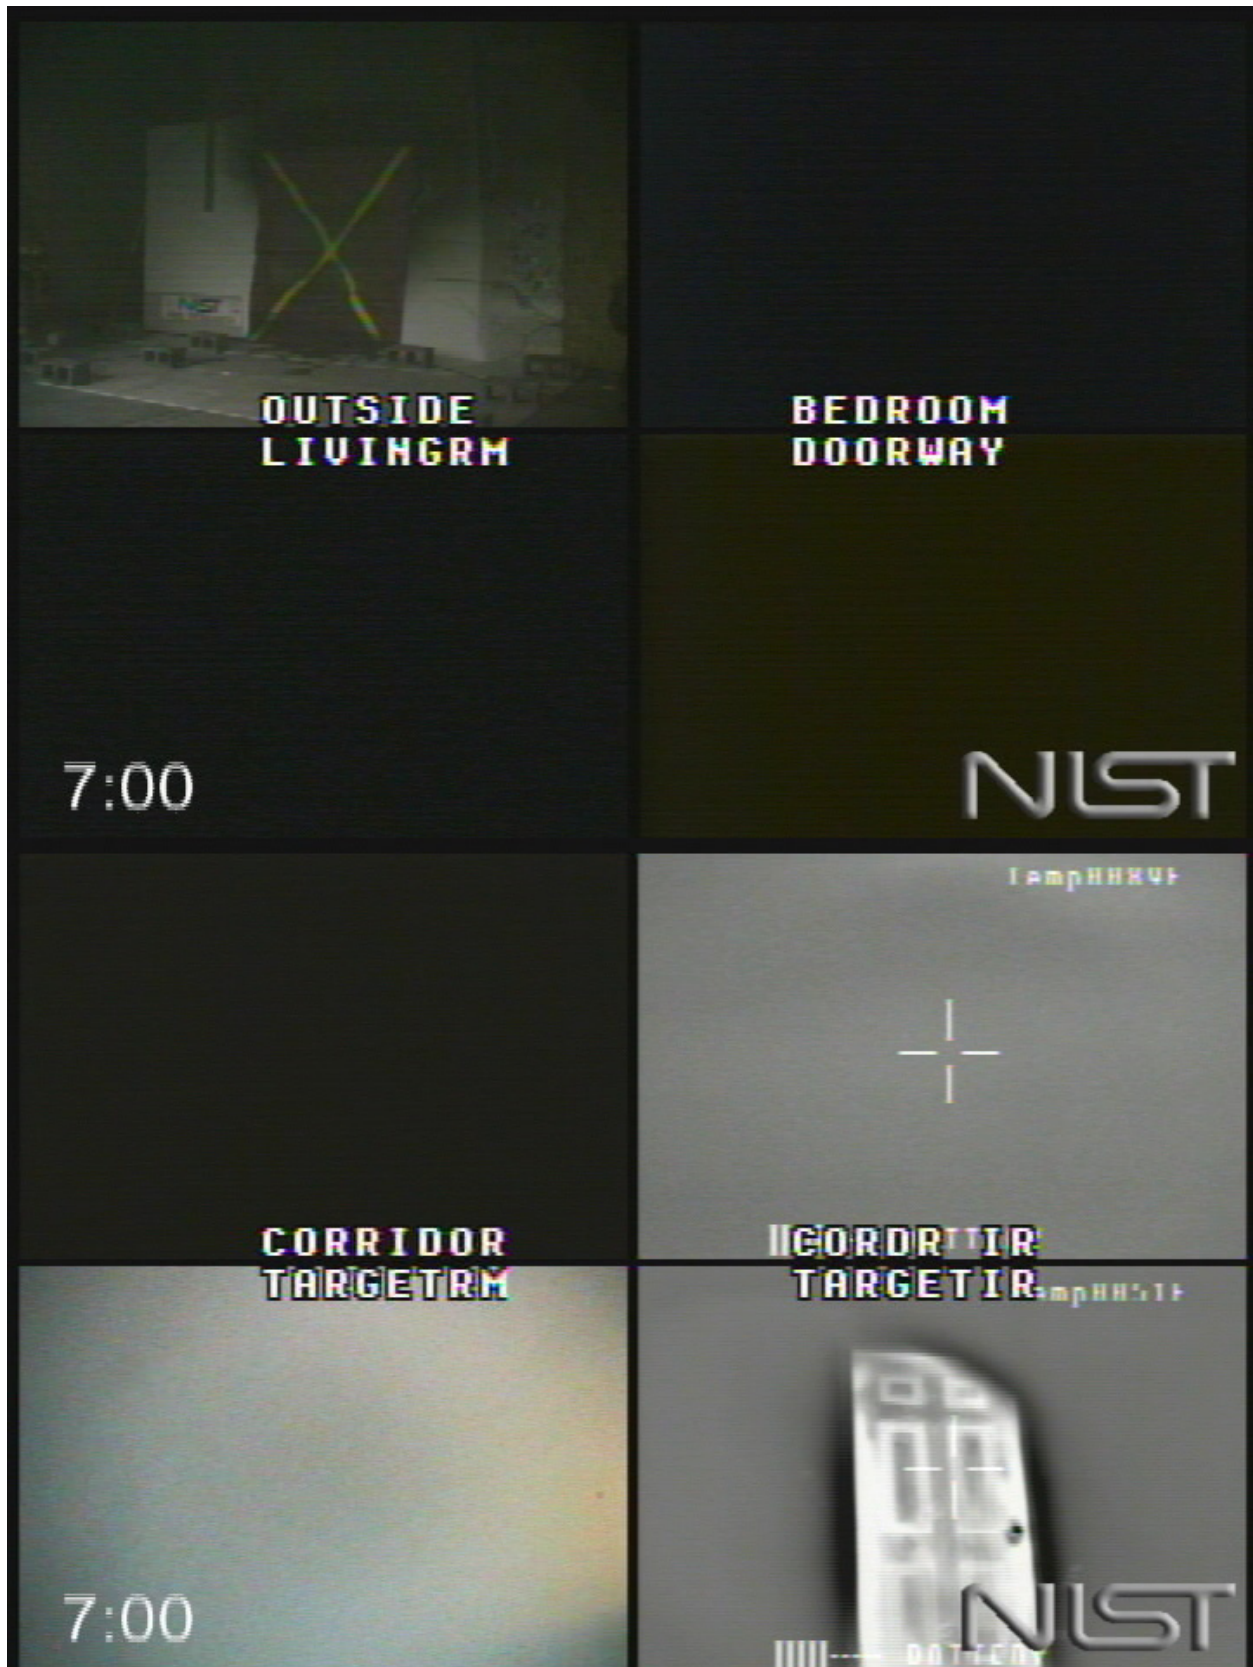
Figure 5.5.1-11. Experiment 5, 420 s after ignition.

Figure 5.5.1-11 shows the conditions at 420 s after ignition, which was about 30 s after the window sprinkler was activated. The interior video views were still obscured by soot. The target room thermal image shows the door is cooling down slightly.

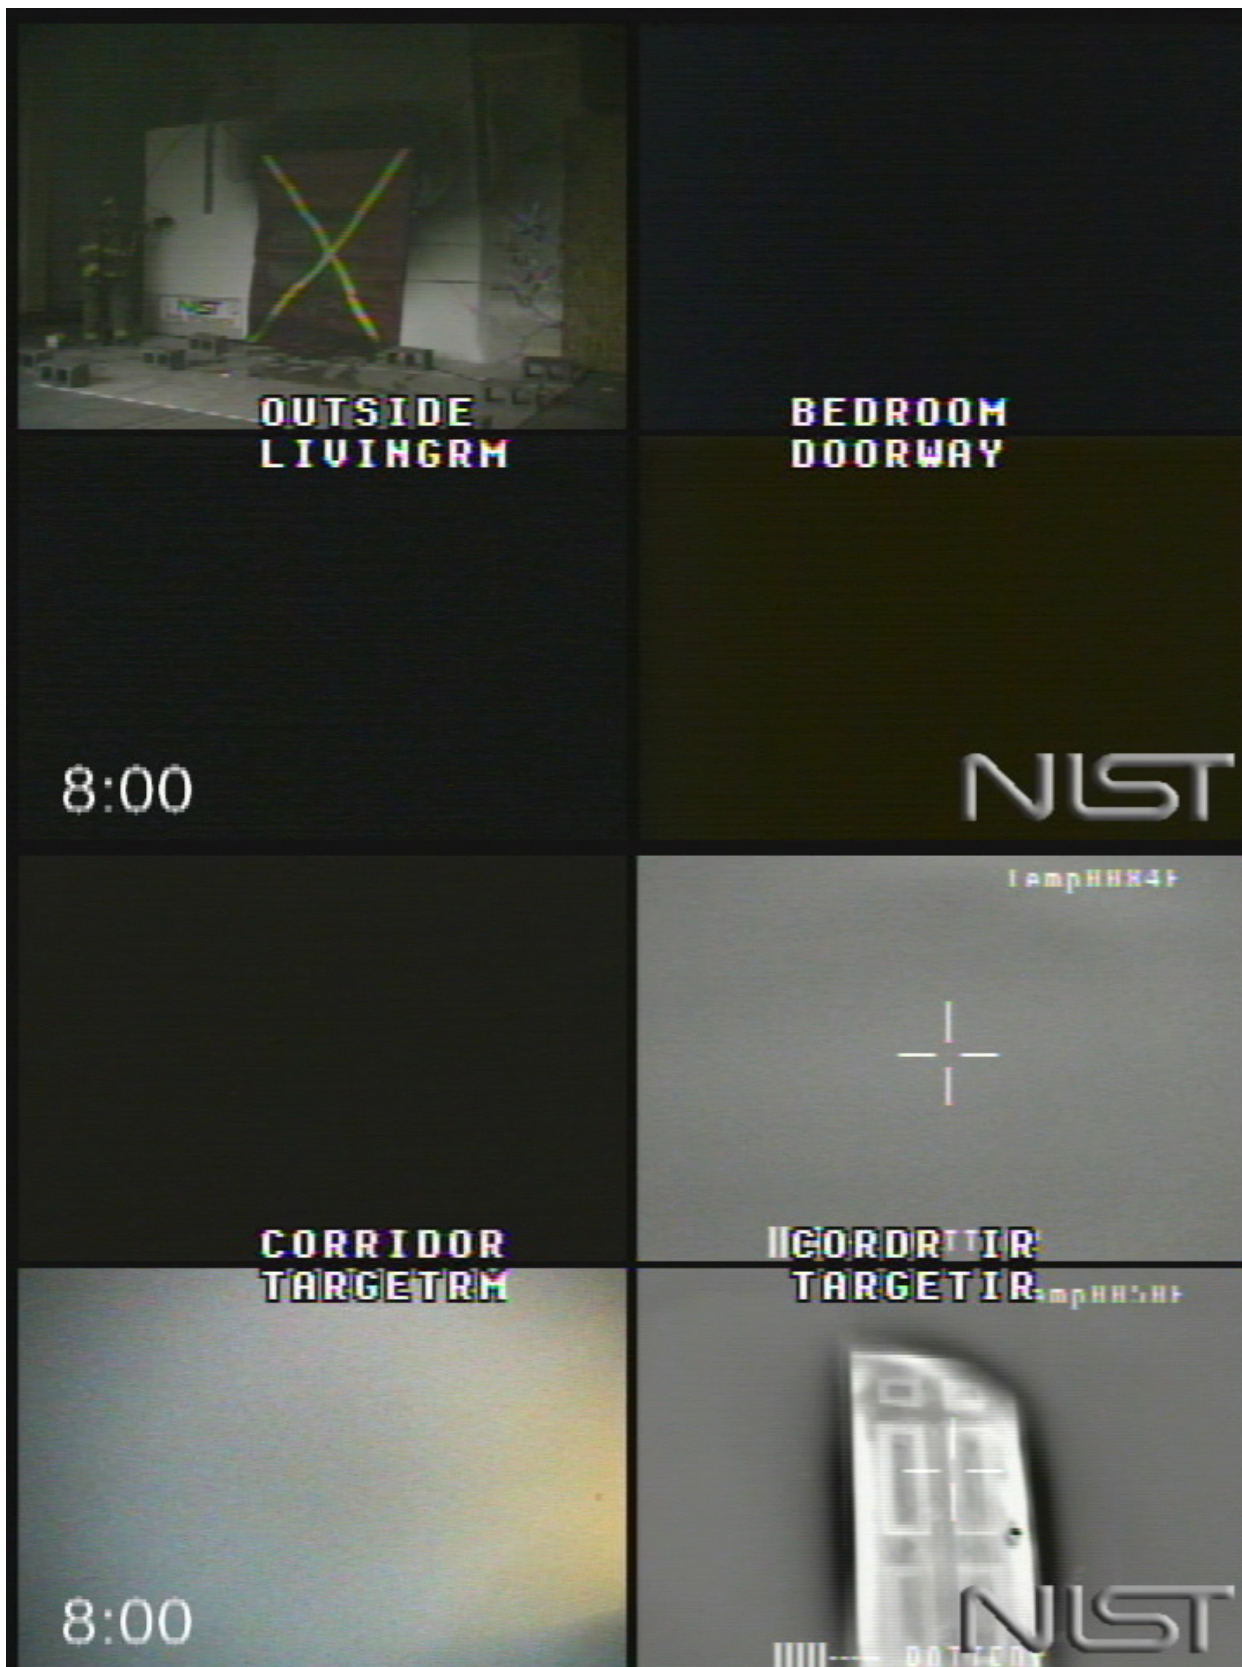
Figure 5.5.1-12. Experiment 5, 480 s after ignition.

The images in Figure 5.5.1-12 were recorded at 480 s after ignition, and 88 s after the window sprinkler was activated. There was very little change in any of the video or thermal images. Figure 5.5.1-13 shows the conditions just after the WCD was removed from the window after the experiment was terminated at 500 s. There were no flames coming out of the bedroom and the fire was knocked down significantly, but not completely extinguished.

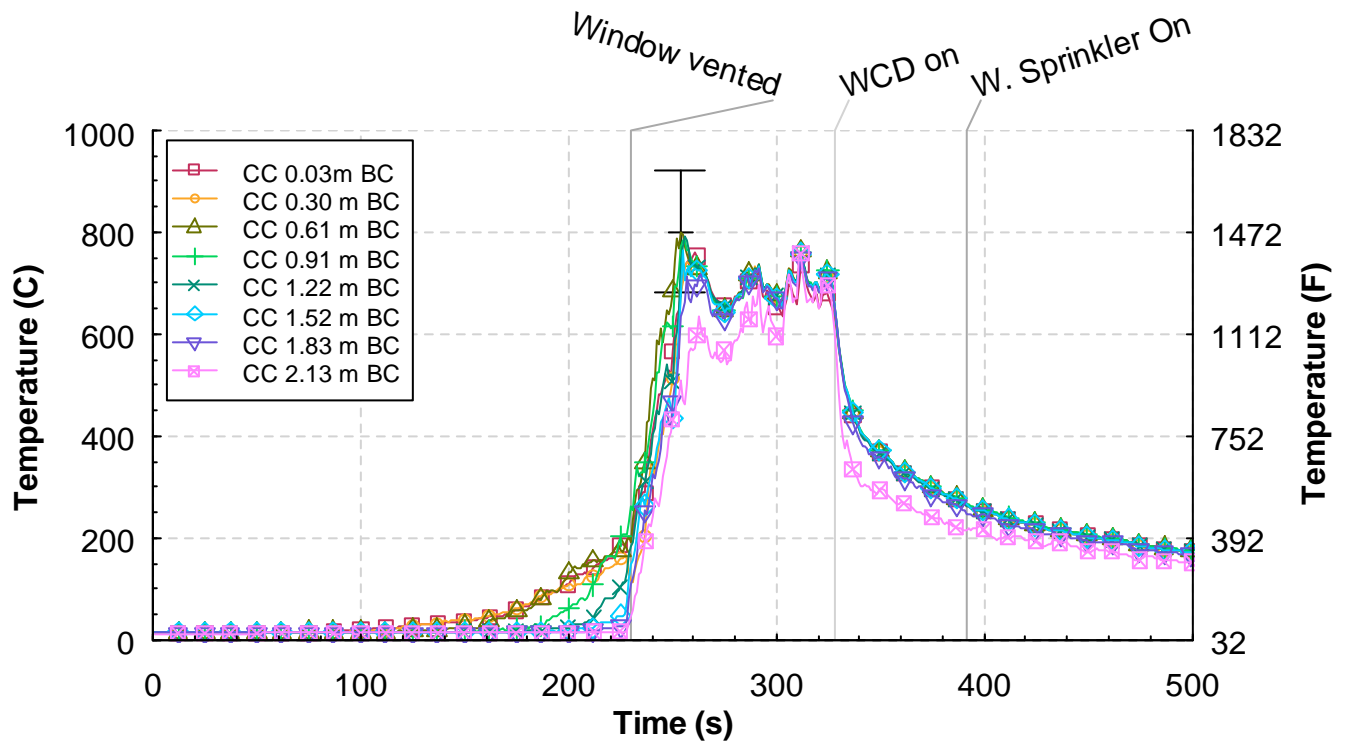
Temperature conditions in the corridor are given in Figure 5.5.3-6 through Figure 5.5.3-9. The three thermocouple arrays located just outside the doorway from the living room all elevated very quickly

after the failure of the window. Temperatures in this area all exceeded 700 °C (1292 °F) at 260 s, 30 s after window failure. Temperatures were lower and there was a vertical temperature gradient in the southwest corner of the corridor, or the dead end, because it was out of the flow path of the products of combustion. Once the WCD was deployed the temperatures throughout the corridor decreased to below 400 °C (752 °F), with the lowest temperatures in the southwest corner. The temperature 2.13 m (7 ft) below the ceiling in the southwest corner remained below 300 °C (572 °F) for the duration of the experiment. After the introduction of water into the bedroom the temperatures throughout the corridor slowly declined to less than 200 °C (392 °F).

Figure 5.5.3-6. Temperature versus time from the corridor center (CC) thermocouple array, Experiment 5.

Figure 5.5.3-7. Temperature versus time from the corridor south (CS) thermocouple array, Experiment 5.

Figure 5.5.3-8. Temperature versus time from the corridor southwest (CSW) thermocouple array, Experiment 5.

Figure 5.5.3-9. Temperature versus time from the corridor north (CN) thermocouple array, Experiment 5.

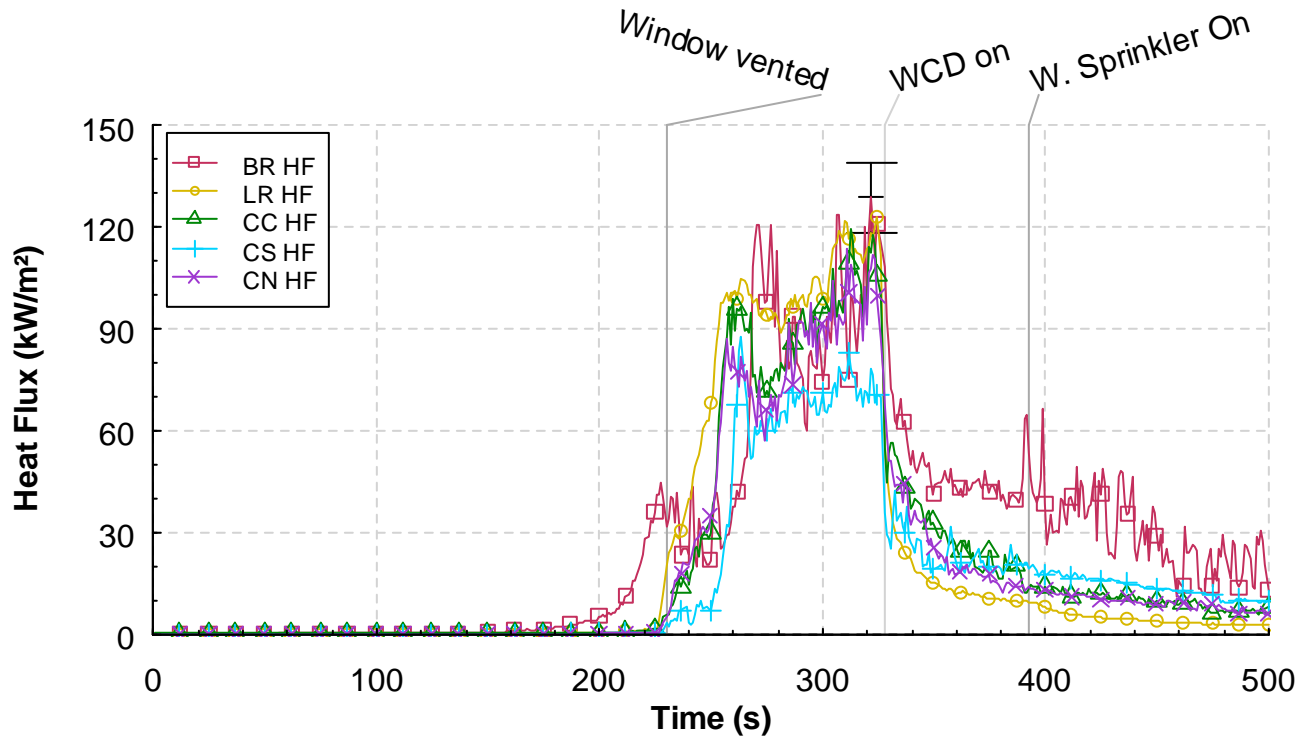
Figure 5.5.4-1. Heat flux versus time at five locations, Experiment 5.

The time history from all five heat flux gauges is given in Figure 5.5.4-1. The heat flux in the bedroom increased to more than 40 kW/m^2 prior to the window failure. After the window vented, the heat flux measurement in the bedroom increased to 120 kW/m^2 in 40 s. Every other heat flux measurement exceeded 60 kW/m^2 in the same period of time after window failure.

After the WCD was deployed the heat fluxes throughout the structure decreased to below 50 kW/m^2 in less than 10 s. The heat fluxes steadily decreased to approximately 40 kW/m^2 in the bedroom and less than 15 kW/m^2 in the rest of the structure, just prior to water application.

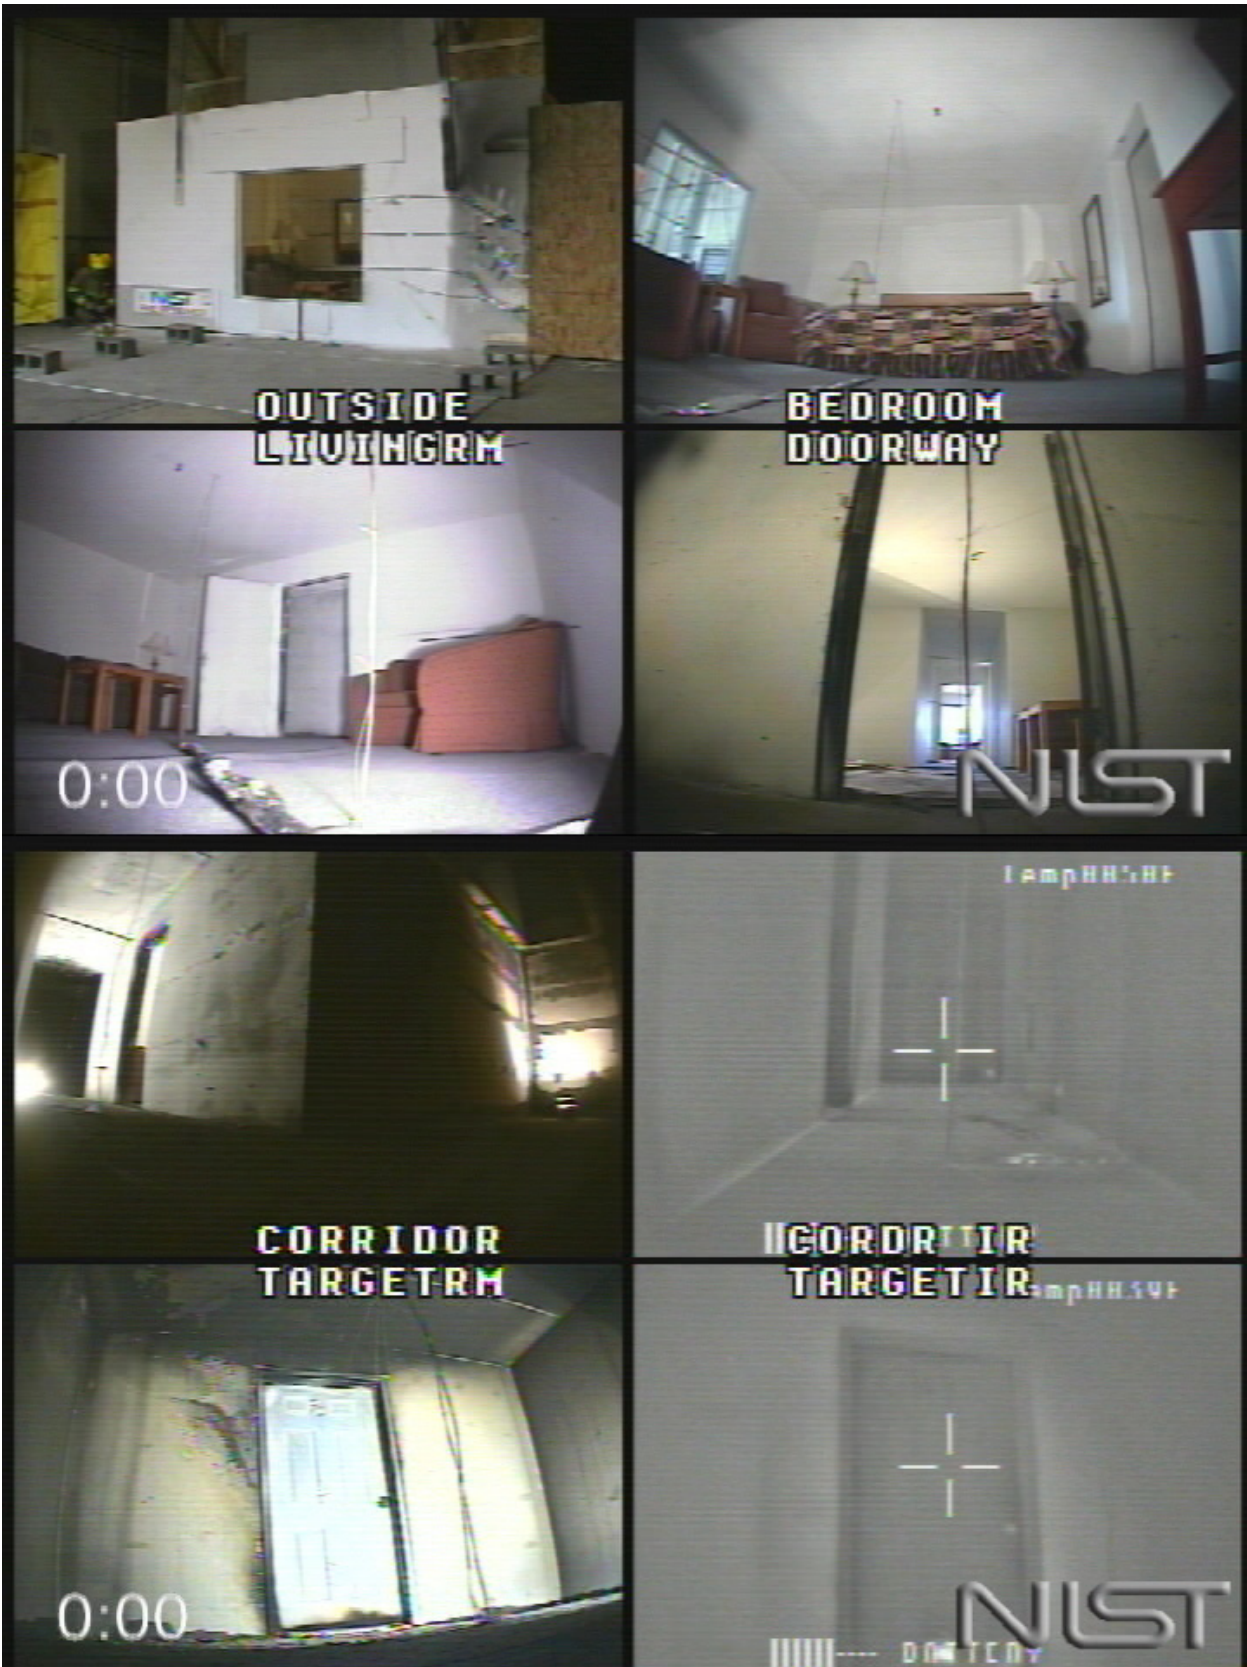
Figure 5.6.1-1. Experiment 6, ignition.

Figure 5.6.1-1 shows the conditions at the time of ignition. At this point, the six video views are clear and unobstructed. However, the thermal images provide limited thermal contrast, because the surfaces in the view were at nearly equal temperature.

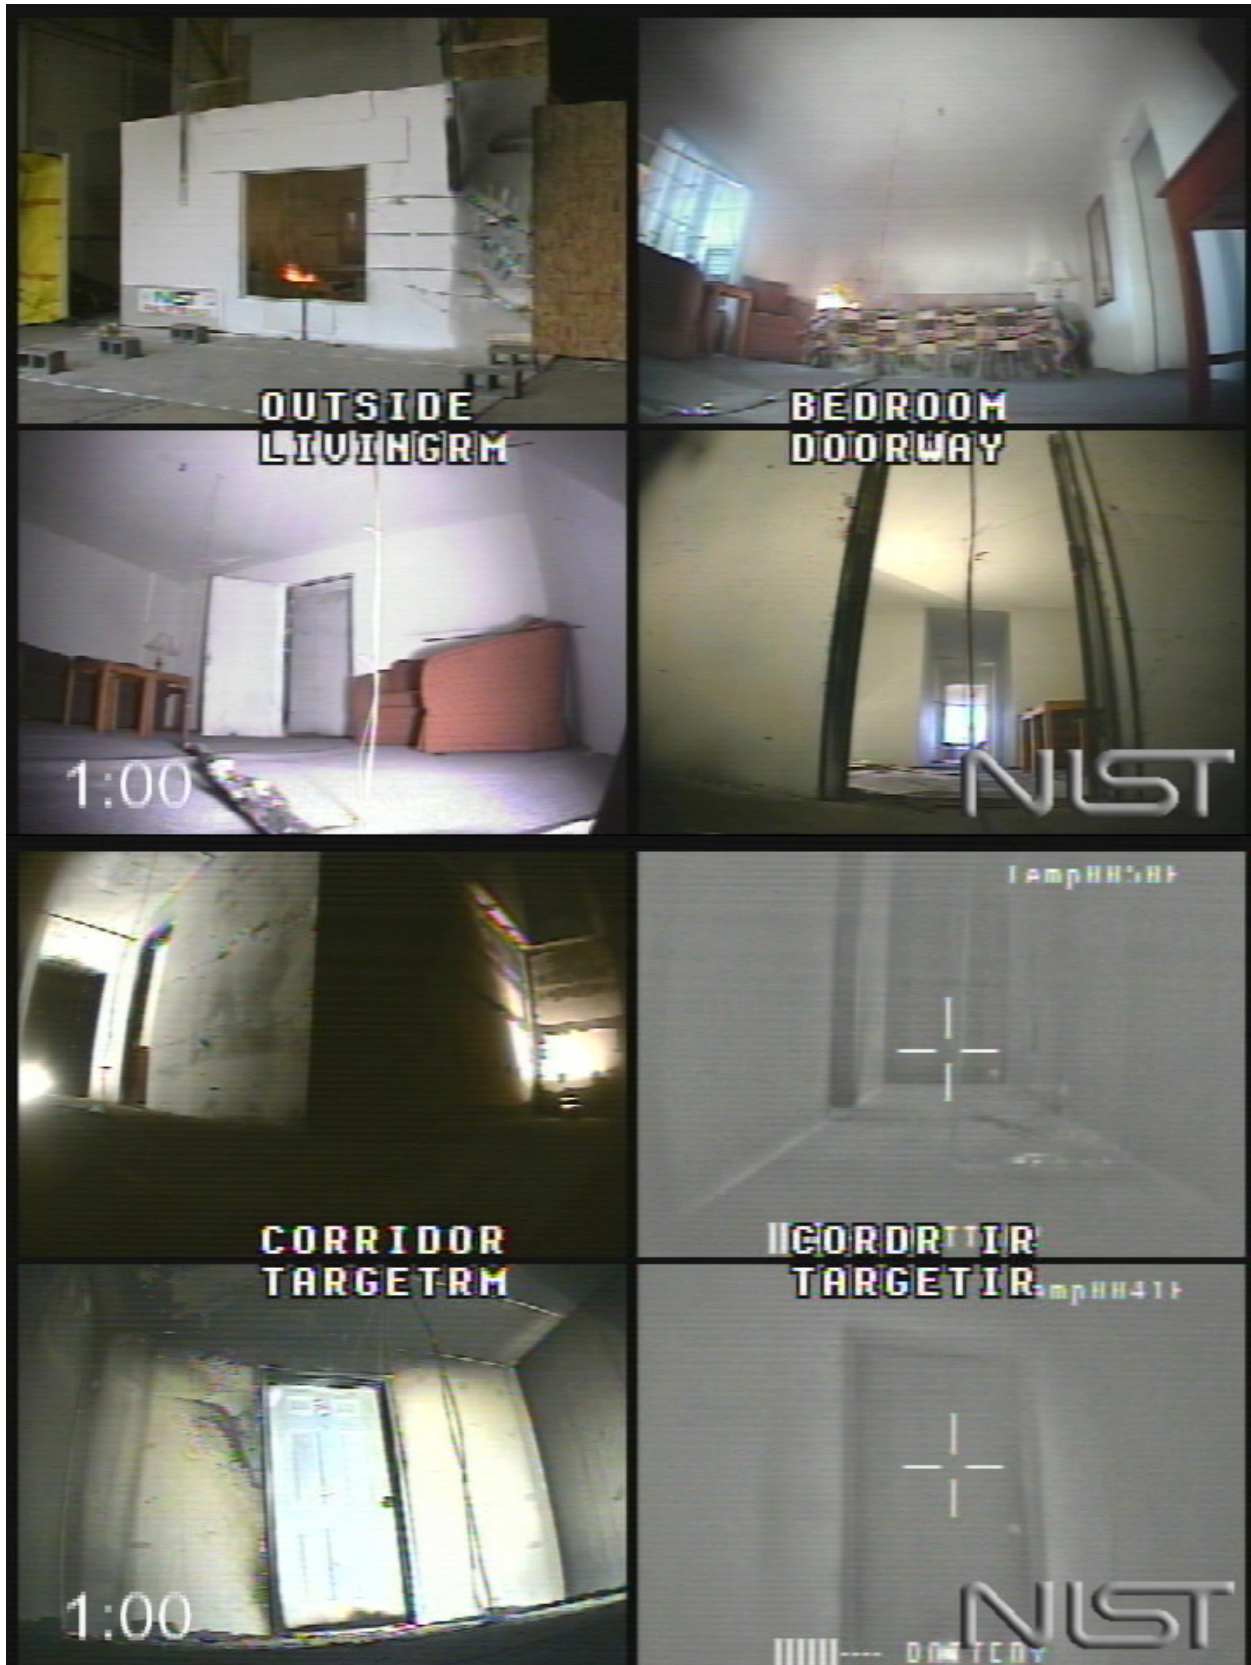
Figure 5.6.1-2. Experiment 6, 60 s after ignition.

The images in Figure 5.6.1-2 were captured 60 s after ignition. The fire from the trash container began to spread to the bed. Light colored smoke was produced and a thin smoke layer had developed across the ceiling of the bedroom. There was no smoke or change in thermal condition, in the living room, target room or corridor at this time.

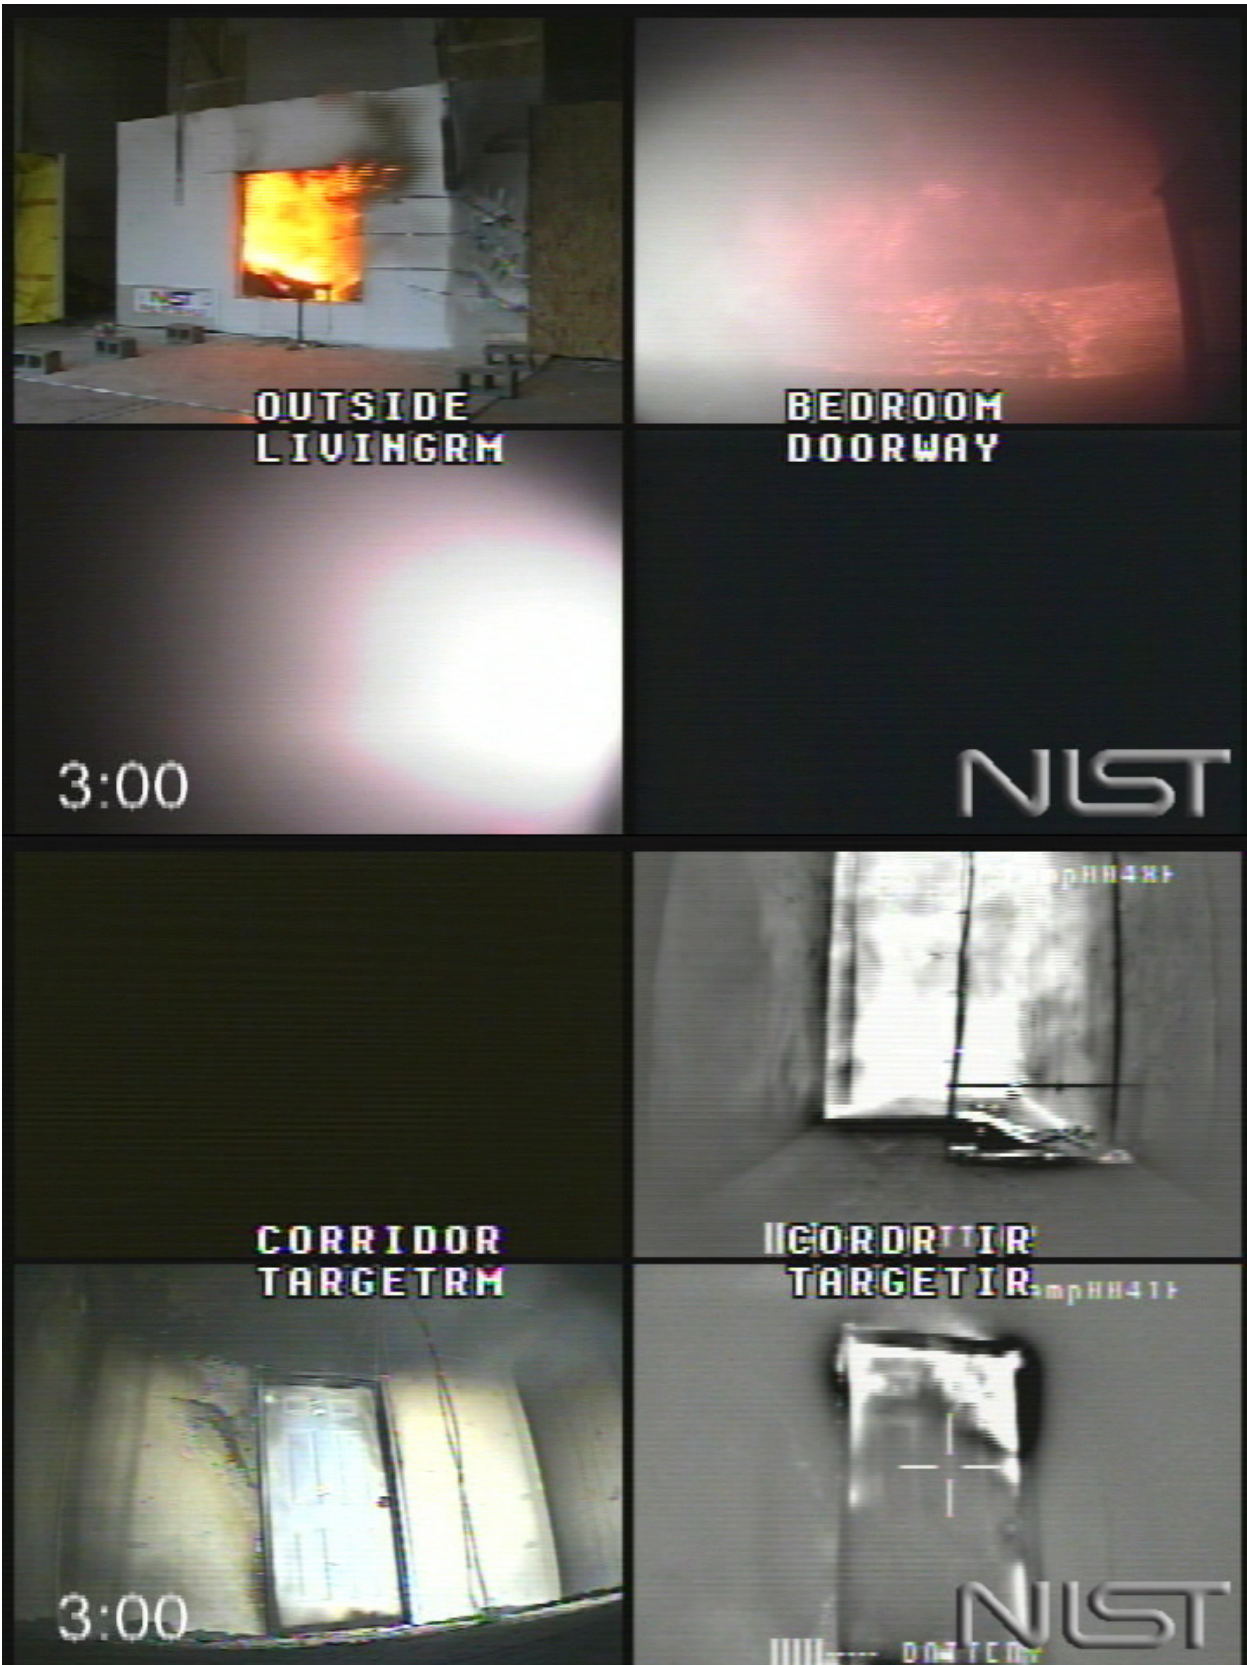
Figure 5.6.1-5. Experiment 6, 180 s after ignition.

Figure 5.6.1-5 shows the conditions at 180 s after ignition. Flames are seen filling the bedroom and moving across the floor level. The camera views in the living room, hallway and corridor are still obscured by smoke. Conditions in the image from the corridor IR camera and the target room views have not changed much since the previous figure.

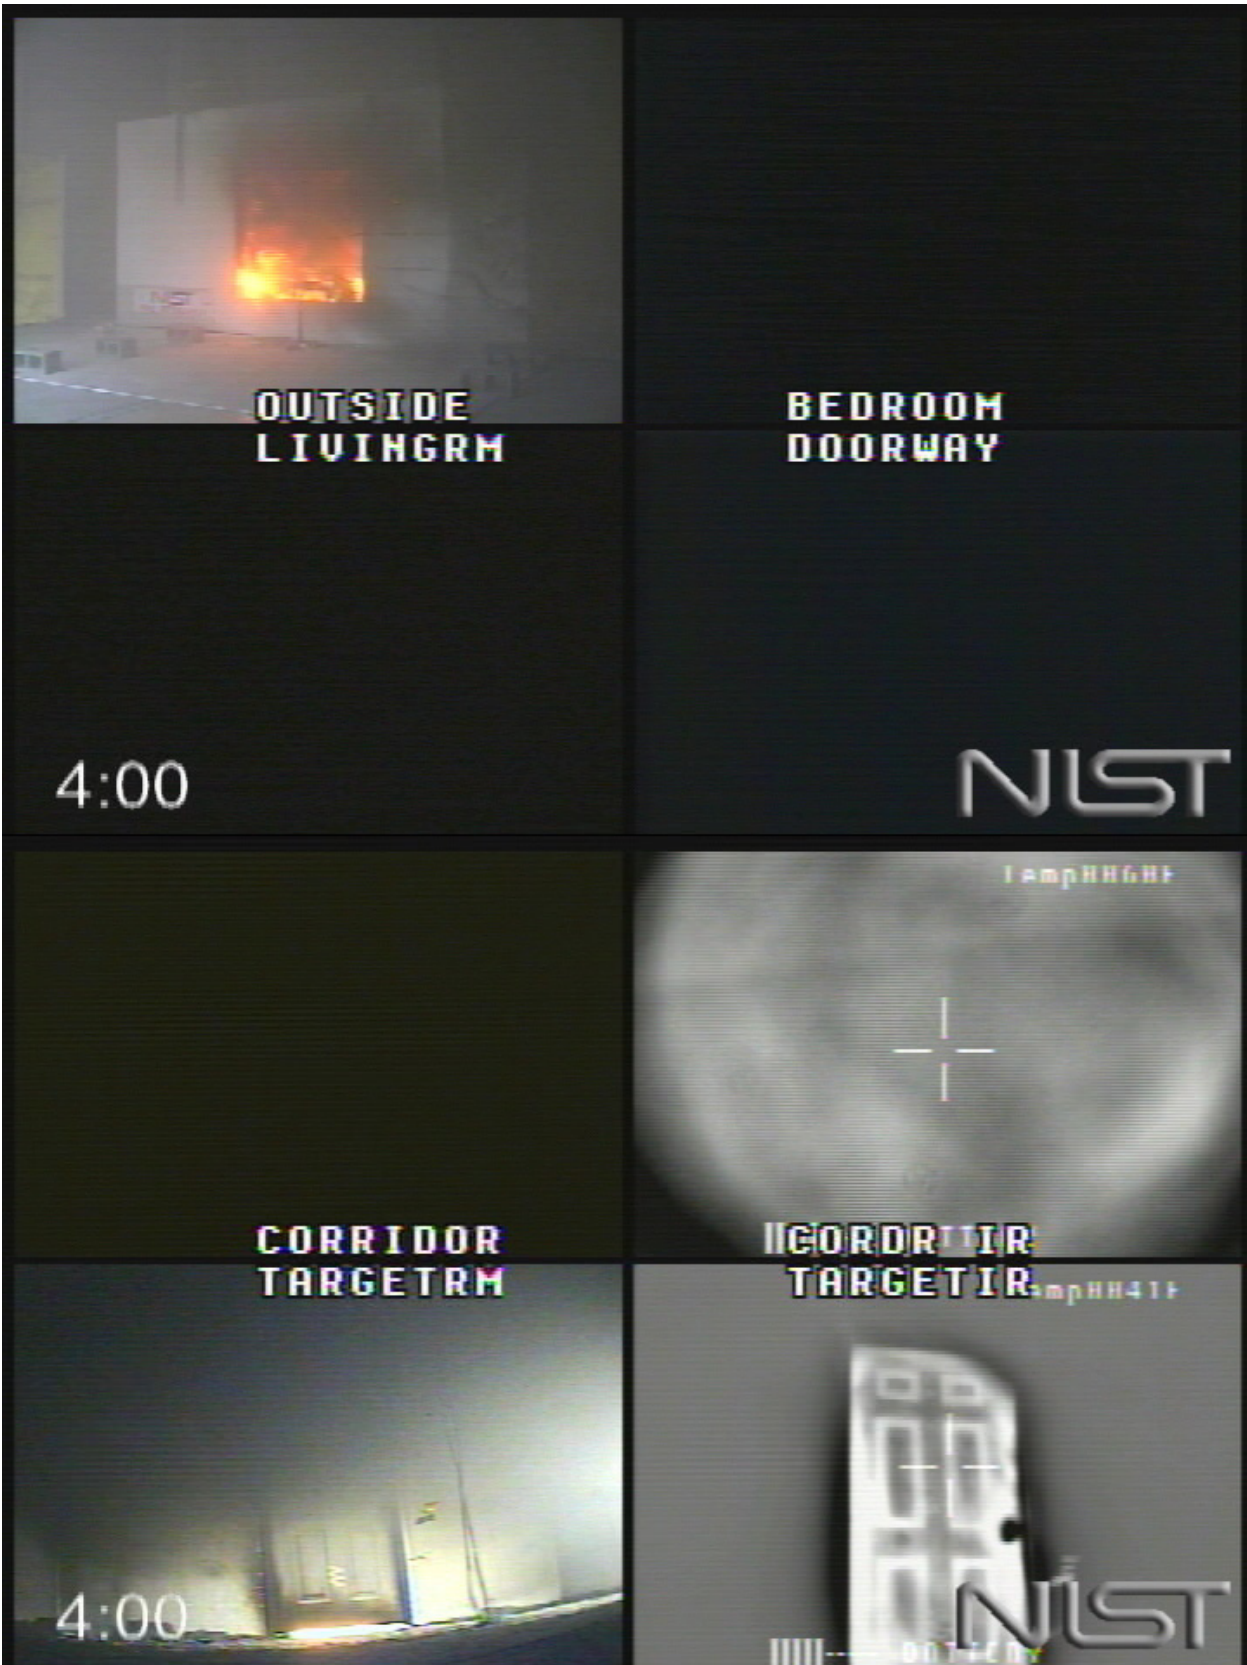
Figure 5.6.1-7. Experiment 6, 240 s after ignition.

Figure 5.6.1-7 shows the conditions at 240 s after ignition. Flames were pulsing out of the window opening. Smoke was obscuring the views in the bedroom, living room and corridor. The amount of heat entering the hallway has caused the image from the corridor IR camera to deteriorate substantially. The visual image in the target room showed flames continuing to burn under the door. The visibility at the lower layer in the target room remained good.

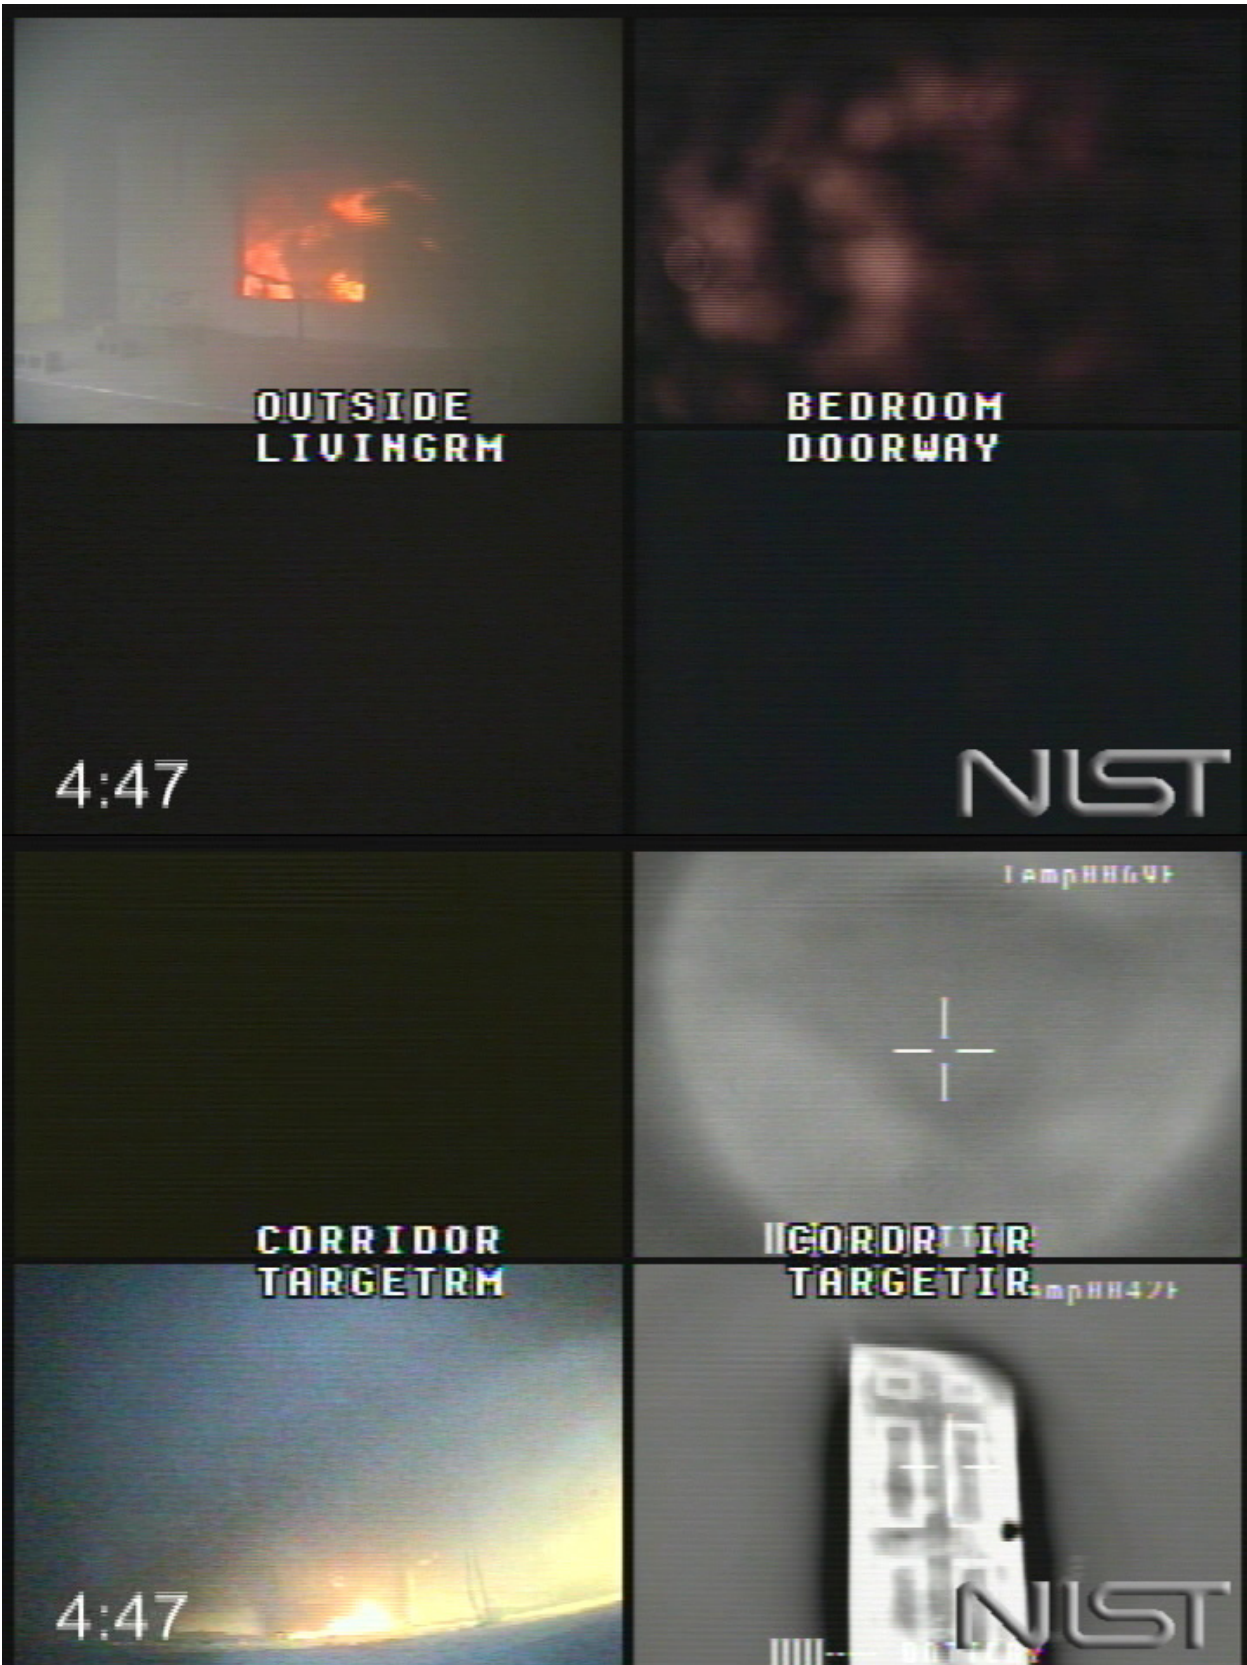
Figure 5.6.1-9. Experiment 6, 287 s after ignition, 20 s after window sprinkler activation.

At 287 s after ignition, the images in Figure 5.6.1-9 were recorded. The window sprinkler had been activated for 20 s. Flames still pulsed from the window opening. The flames near the window appeared to partially be blocked by soot. The interior video views were still obscured, only a glow was visible in the bedroom view. The thermal view of the corridor was obscured due to high thermal conditions. Conditions in the target room had decayed as the hot gas layer dropped within 0.30 m (1.0 ft) of the floor. Flames were still visible under the door to the hallway. In the thermal image of the target room door, the door had become whiter in color, indicating that it had become hotter.

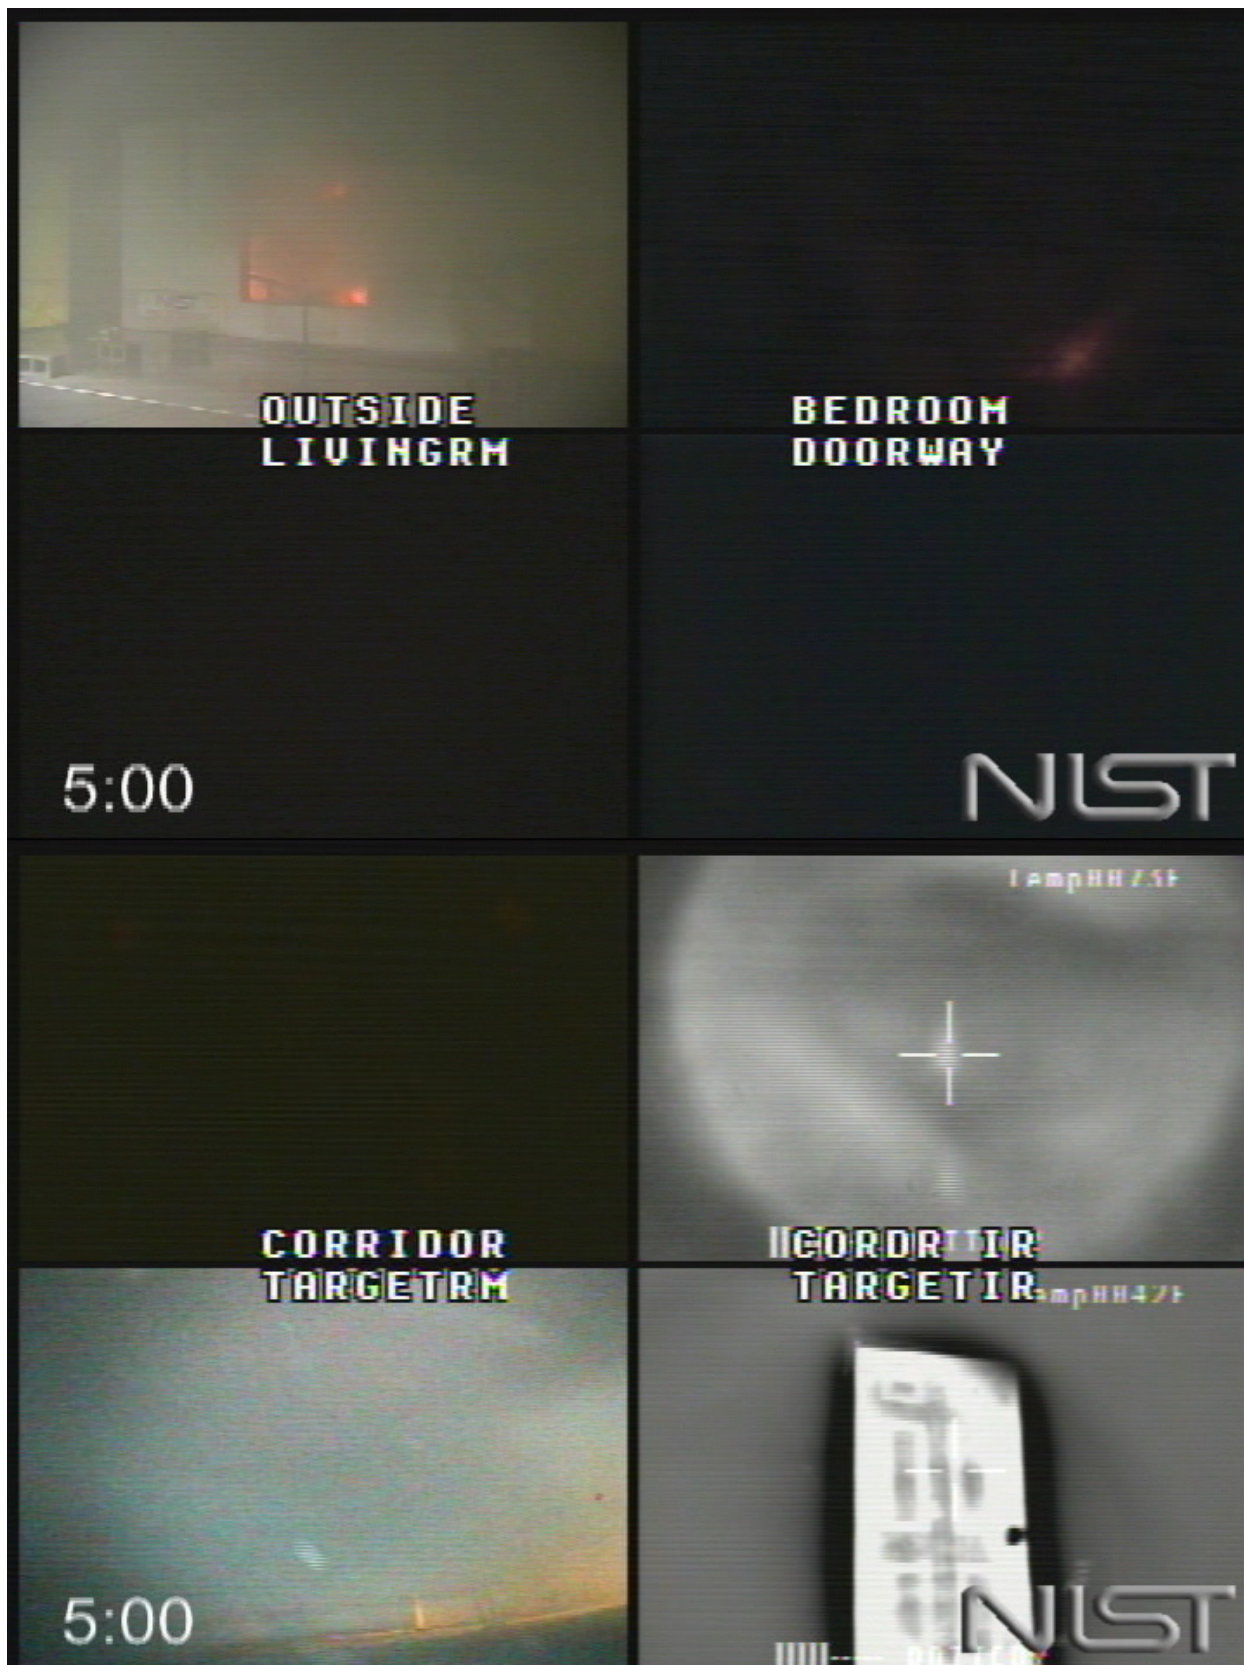
Figure 5.6.1-10. Experiment 6, 300 s after ignition.

Figure 5.6.1-10 shows the conditions at 300 s after ignition, or approximately 8 s after the water fog was started across the window opening. The interior video views were still obscured by smoke. The thermal image from the corridor was still saturated due to high heat conditions. In the target room, the smoke layer was near the floor, flames were no longer visible coming under the door. The door continued to heat up, as shown in the target room thermal view.

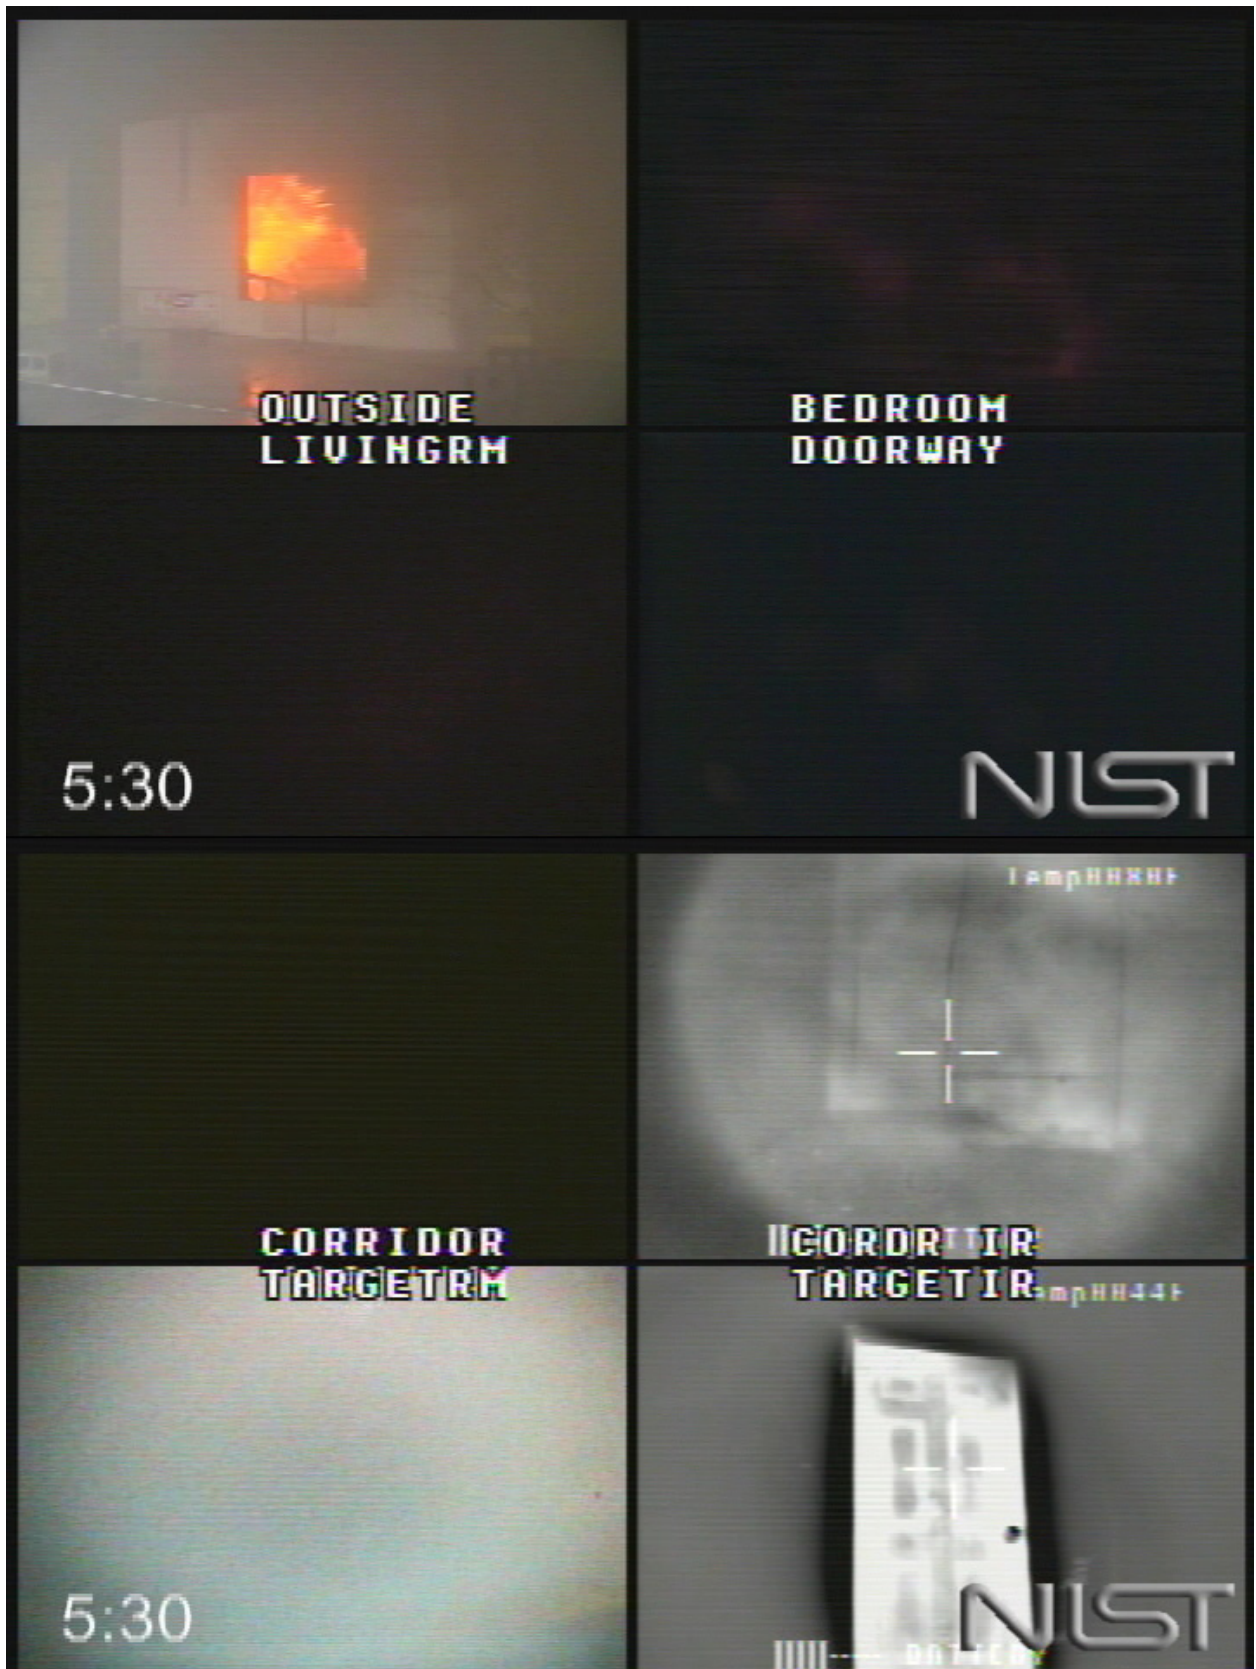
Figure 5.6.1-11. Experiment 6, fog stream across window off, 330 s after ignition.

Figure 5.6.1-11 shows the conditions at 330 s after ignition, just as the fog water was shut off. The window sprinkler was still activated. The area in the center of the window opening was free from fire.

All of the interior video views were still obscured by soot. The corridor thermal image shows more contrast indicating that the thermal conditions in that location had cooled. The target room thermal image shows that the door remained hot.
