NIST Technical Note 1618

Fire Fighting Tactics Under Wind Driven Conditions: Laboratory Experiments

Daniel Madrzykowski
Stephen Kerber

January 2009

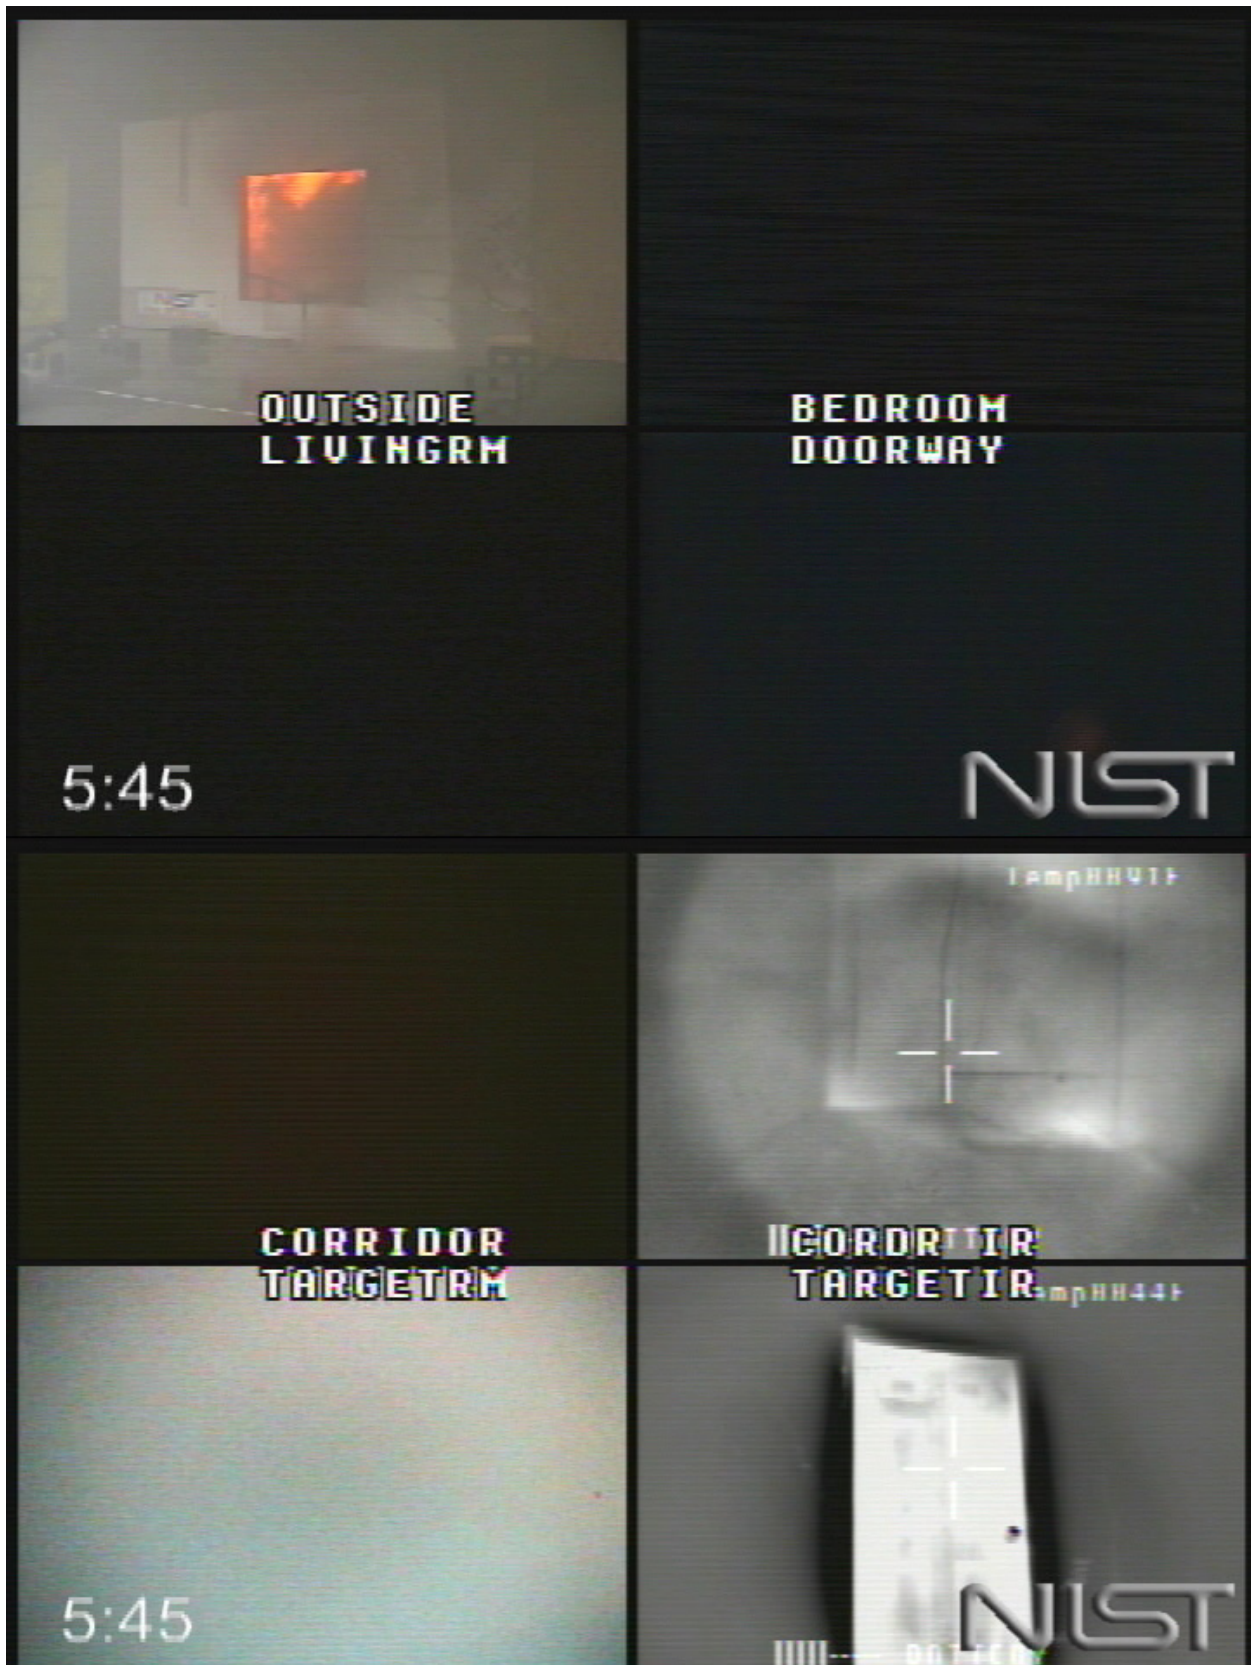
Figure 5.6.1-12. Experiment 6, direct fog stream on, 345 s after ignition.

The images in Figure 5.6.1-12 were recorded at 345 s after ignition, just prior to the activation of the fog stream into the window opening. The volume of flame visible through the window opening had decreased. All of the interior video views were obscured by smoke. The thermal images showed cooler conditions in the corridor and a hotter target room door when compared with the previous figure.

Figure 5.6.1-13 shows the conditions 13 s after the fog spray directly into the window was started. The images seem similar to the images in Figure 5.6.1-12.

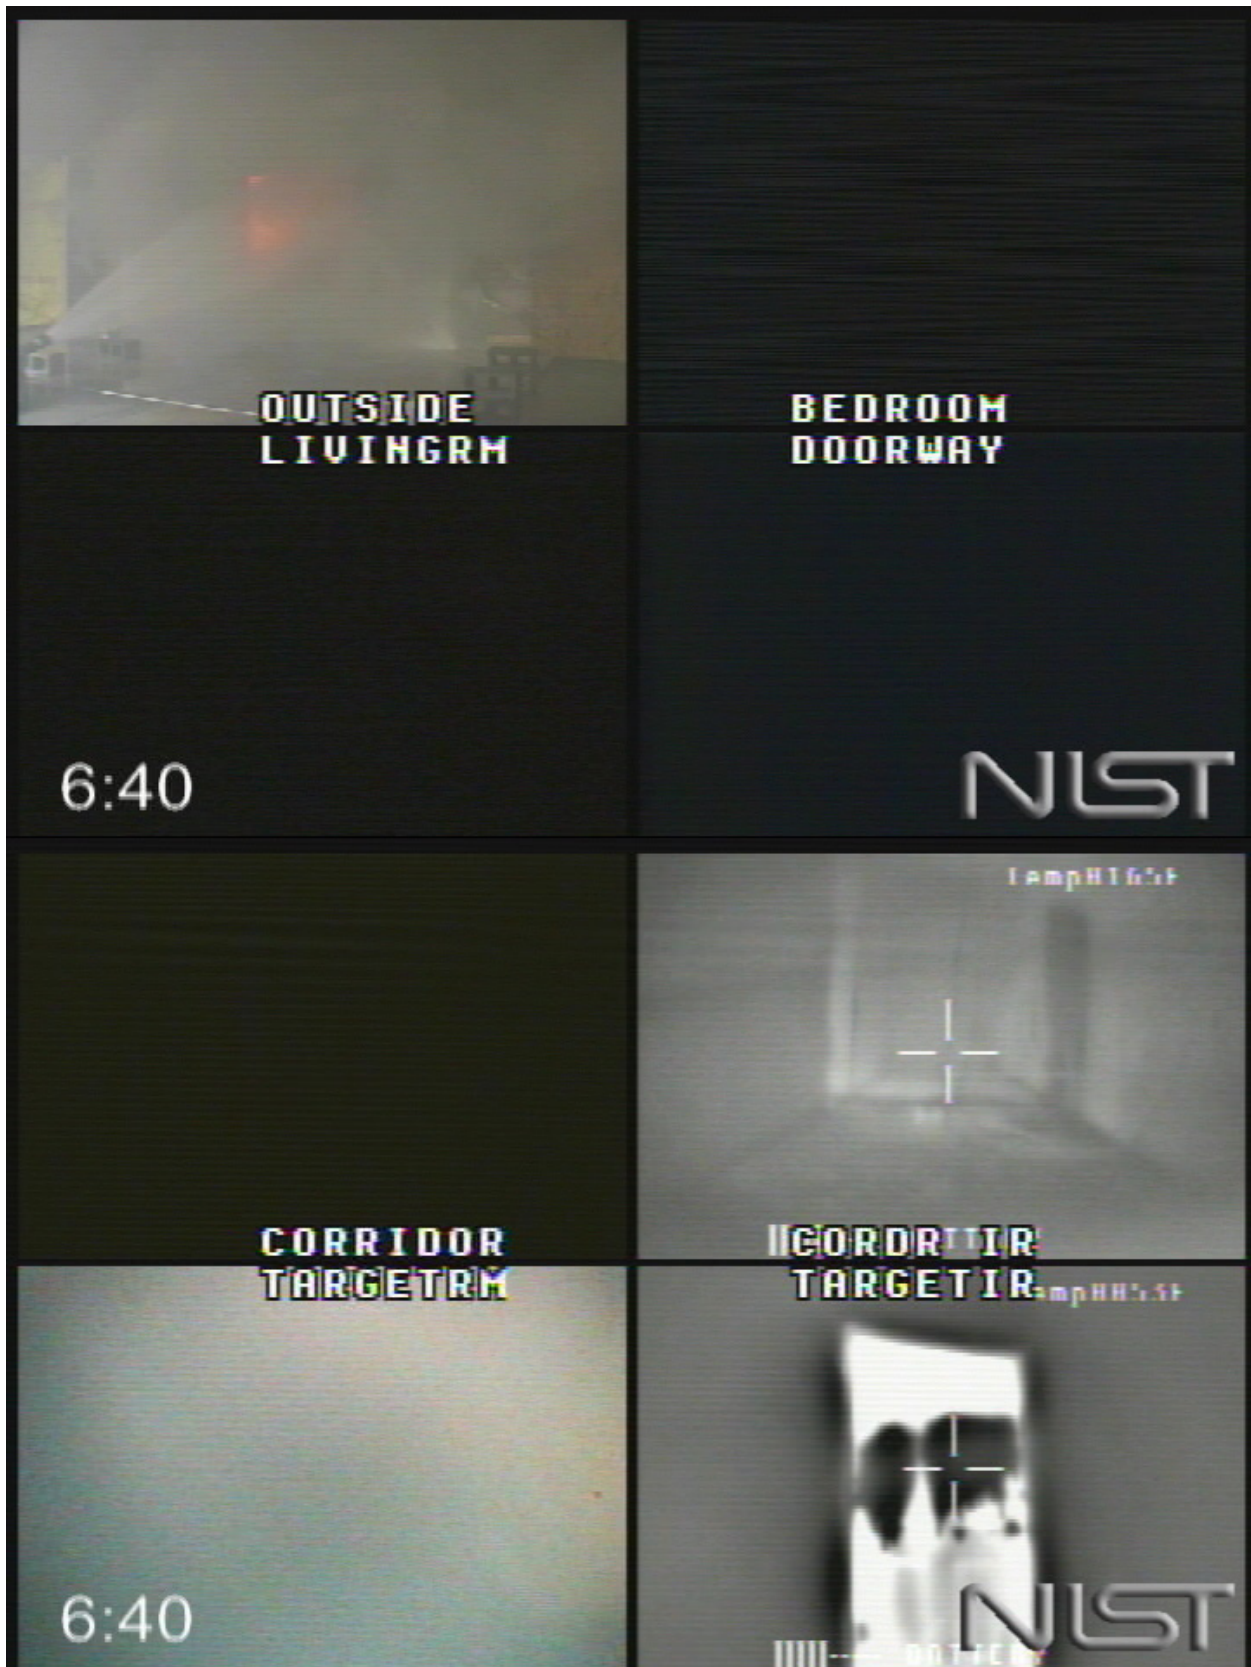
Figure 5.6.1-14. Experiment 6, 400 s after ignition.

The images in Figure 5.6.1-14 were recorded after 50 s of direct, fog stream application. The flames in the bedroom had decreased. The interior video views were still obscured. The corridor thermal view shows continued cooling. The black area on the east wall across from the door is indicative of the wall cooling due to the water. Portions of the target room door appear to have been impacted by the water in the areas that appear dark.

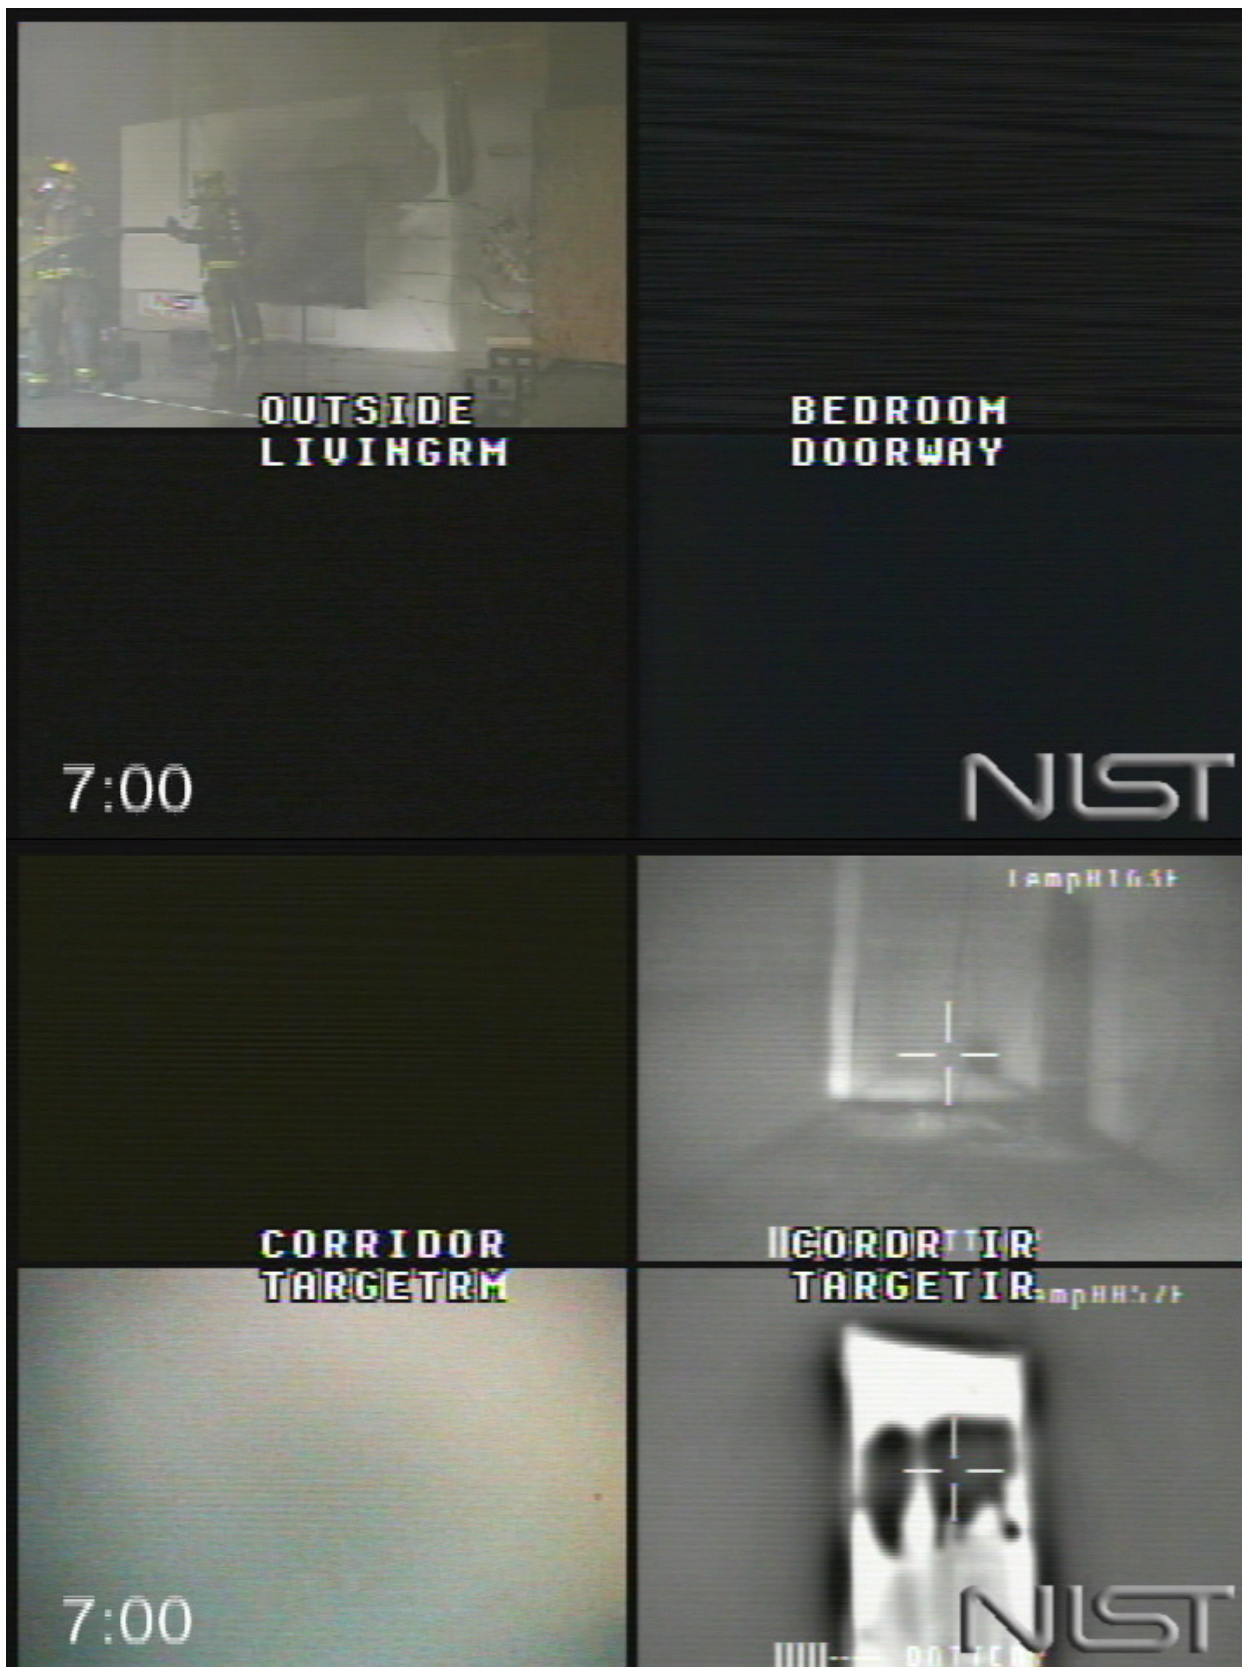
Figure 5.6.1-15. Experiment 6, 420 s after ignition.

The post-test images are shown in Figure 5.6.1-15. The fire in the bedroom had been suppressed. The conditions in the corridor continued to cool. All other views had not changed. Post test inspection indicated that the protective covers for the interior video cameras were coated with soot.

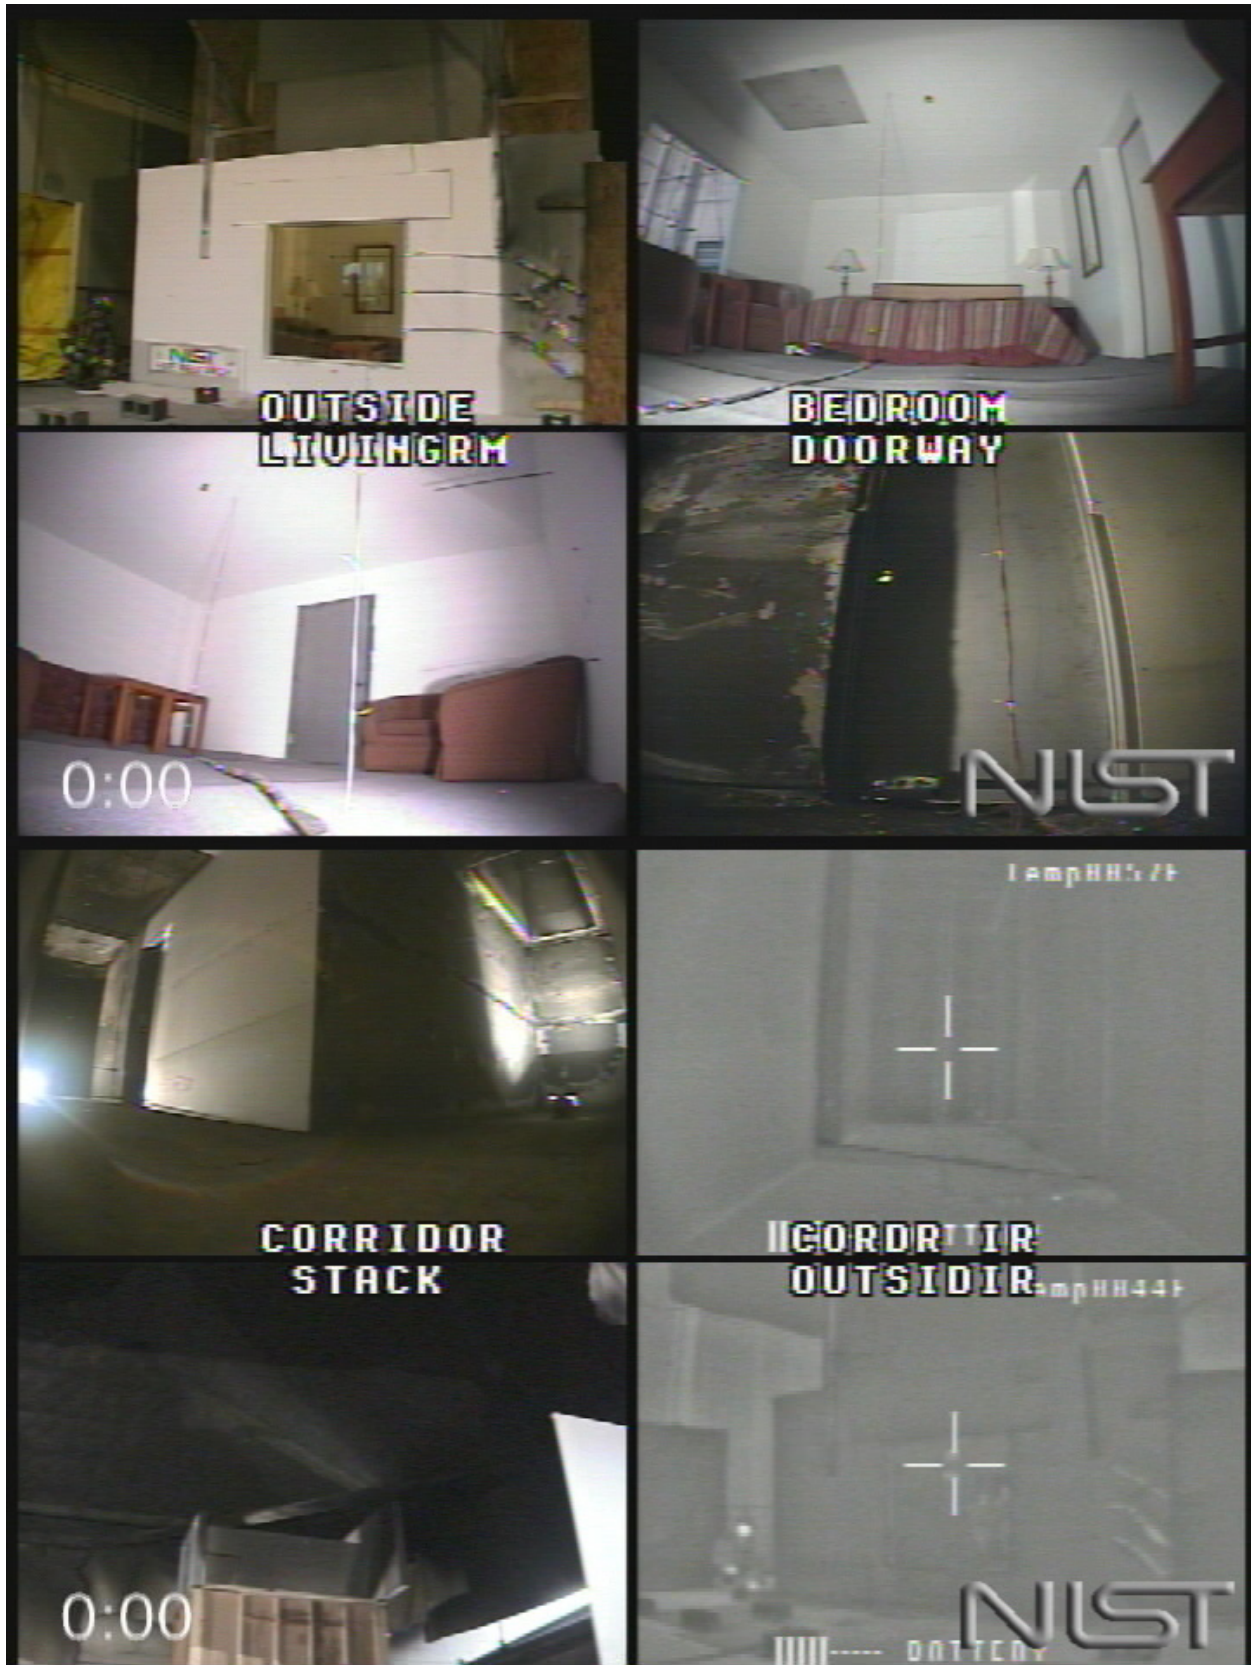
Figure 5.7.1-1. Experiment 7, ignition.

Figure 5.7.1-1 through Figure 5.7.1-13 present sets of eight images, one from each camera position, at a given time, from the time of ignition to 550 s after ignition. Each image view is labeled. Figure 5.7.1-1 shows the conditions at the time of ignition. At this point, the six video views are clear and unobstructed. However, the thermal images provide limited thermal contrast, because the surfaces in the view were at nearly equal temperature.

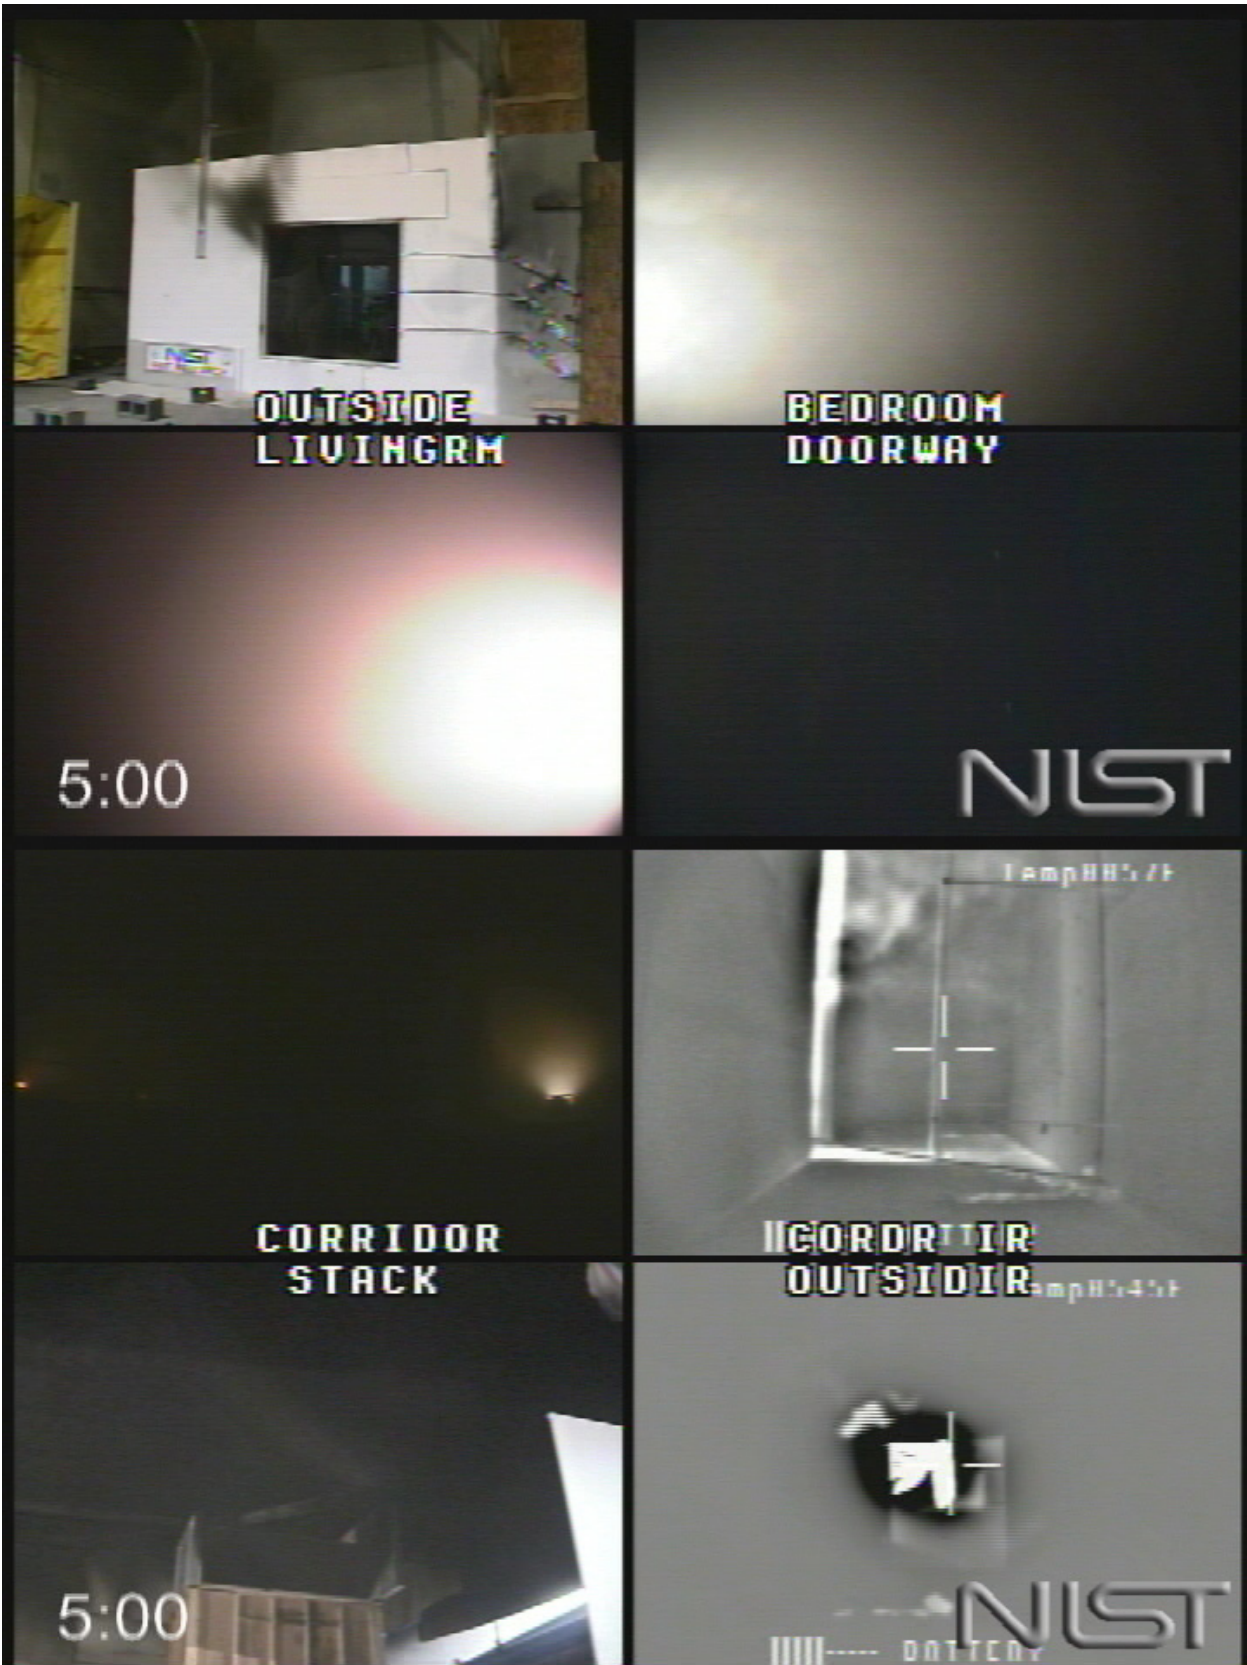
Figure 5.7.1-6. Experiment 7, 300 s after ignition.

Figure 5.7.1-6 shows the images at 300 s after ignition. The smoke layer descended to the floor in most of the structure. The corner of the window had cracked and fell out. There was an increase in the amount of heat entering the corridor through cracks around the door and the visibility in the corridor was diminishing. Light smoke was visible from the stack.

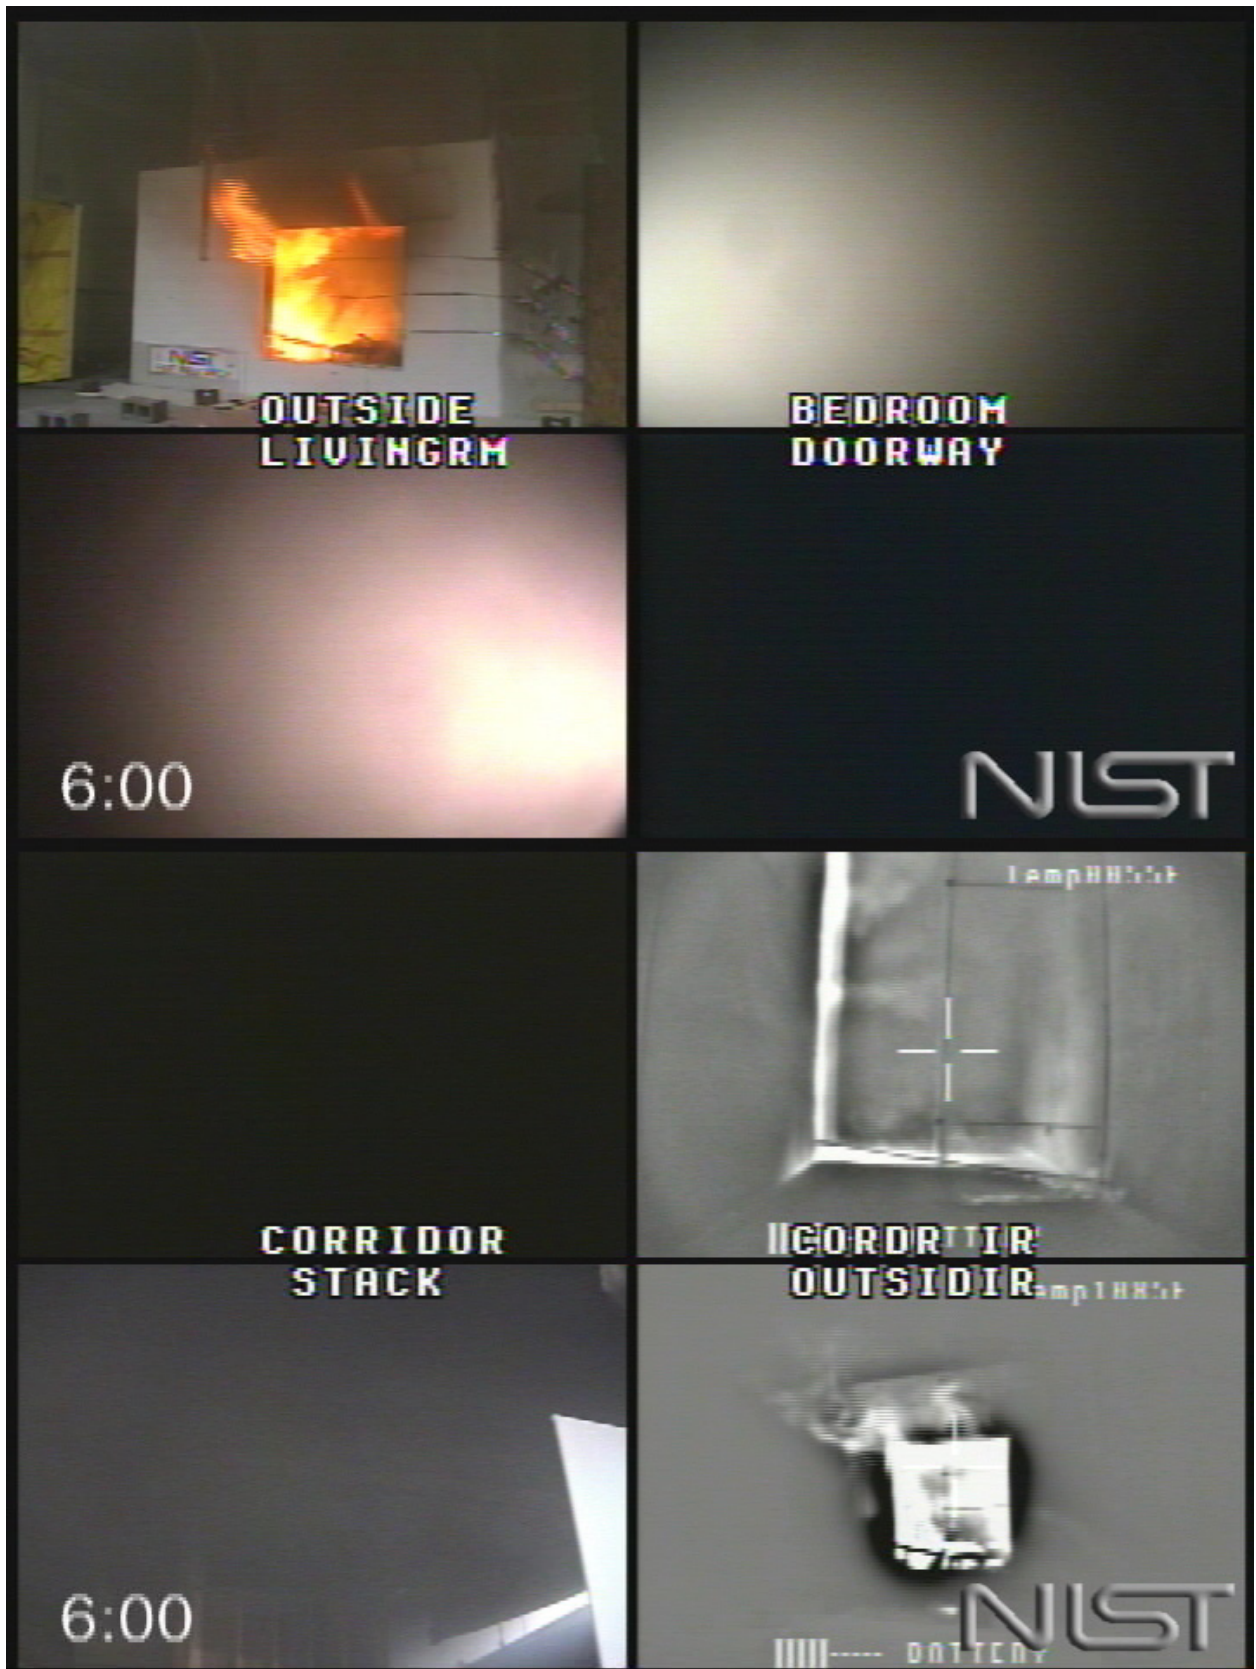
Figure 5.7.1-8. Experiment 7, 360 s after ignition.

Figure 5.7.1-8 shows the conditions at 360 s after ignition. Flames are still flowing out of the top of the window opening. There was very little visibility in the rest of the structure. The door to the corridor was still closed so the heat was being forced around the door and through the hole for the door knob. The stack was being obstructed by smoke as well.

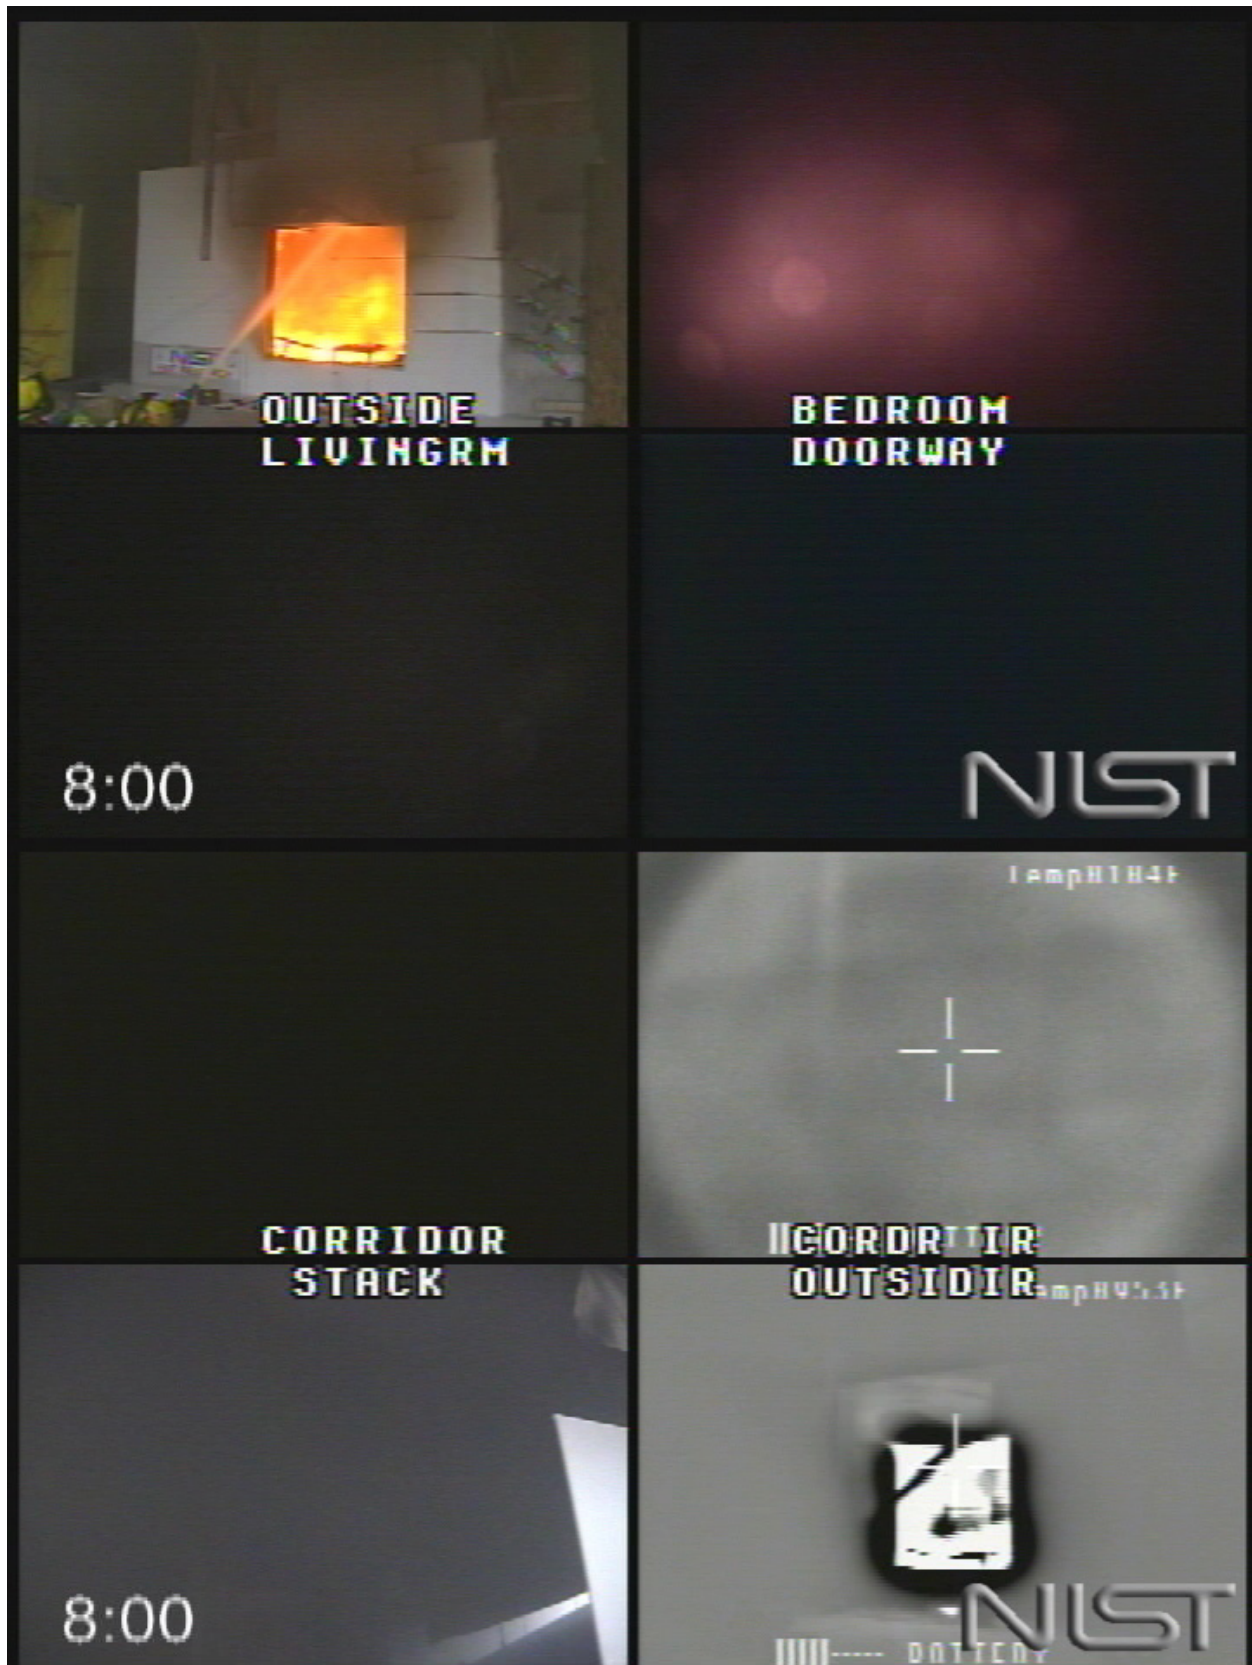
Figure 5.7.1-11. Experiment 7, 480 s after ignition.

Figure 5.7.1-11 shows the conditions at 480 s after ignition, or approximately 45 s since activation of the hose stream. The interior video views were still obscured by soot, but the bedroom view was returning to show flames. The thermal image from the corridor was still saturated with heat but started to improve in clarity. The outside thermal imaging view shows all of the heat going back into the structure.

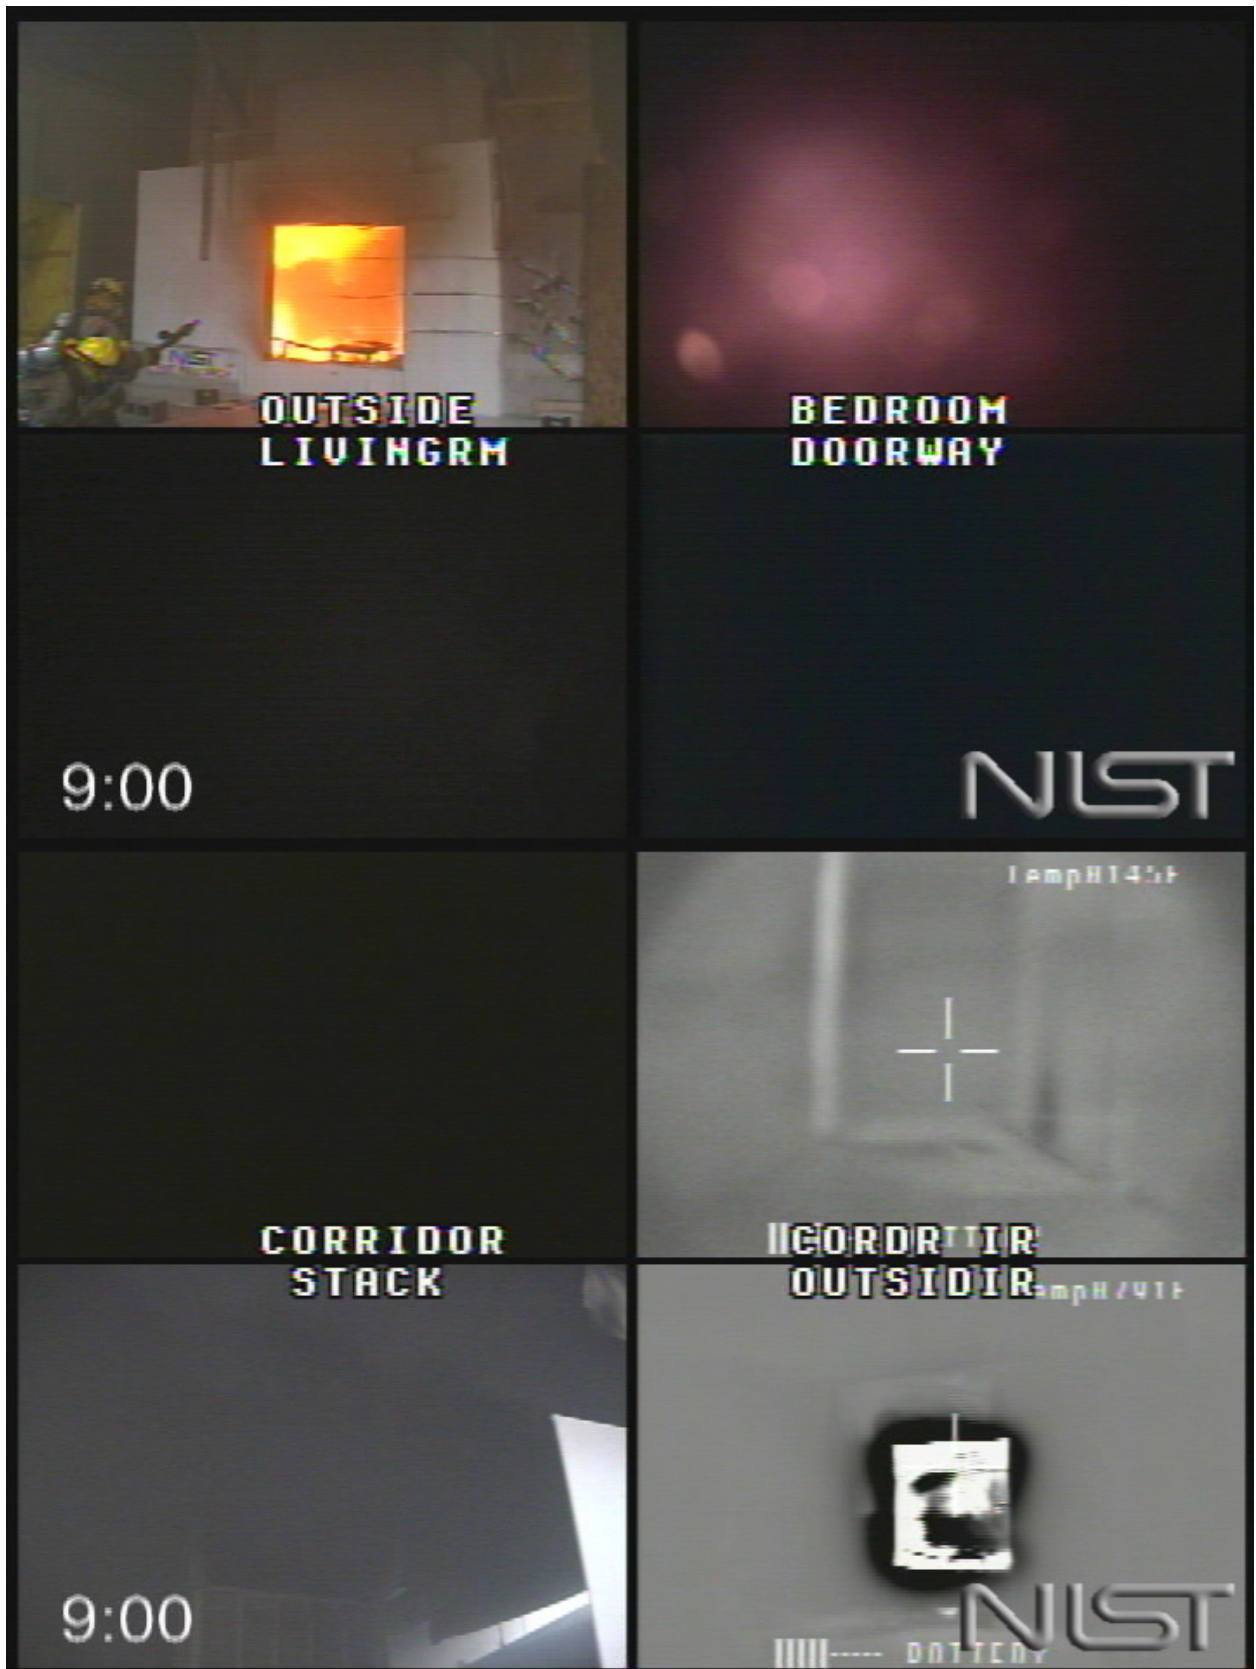
Figure 5.7.1-12. Experiment 7, 540 s after ignition.

Figure 5.7.1-12 shows the conditions at 540 s after ignition, which was about 2 s after the hose stream was turned off. Flames are still visible in the bedroom, but not coming out of the bedroom window. The internal views are still obscured but the thermal imaging view in the corridor has returned to a usable image showing little heat flow. The dark spots on the wall and floor also indicate that water made it to the corridor. The stack was once again visible showing a reduced smoke production rate.

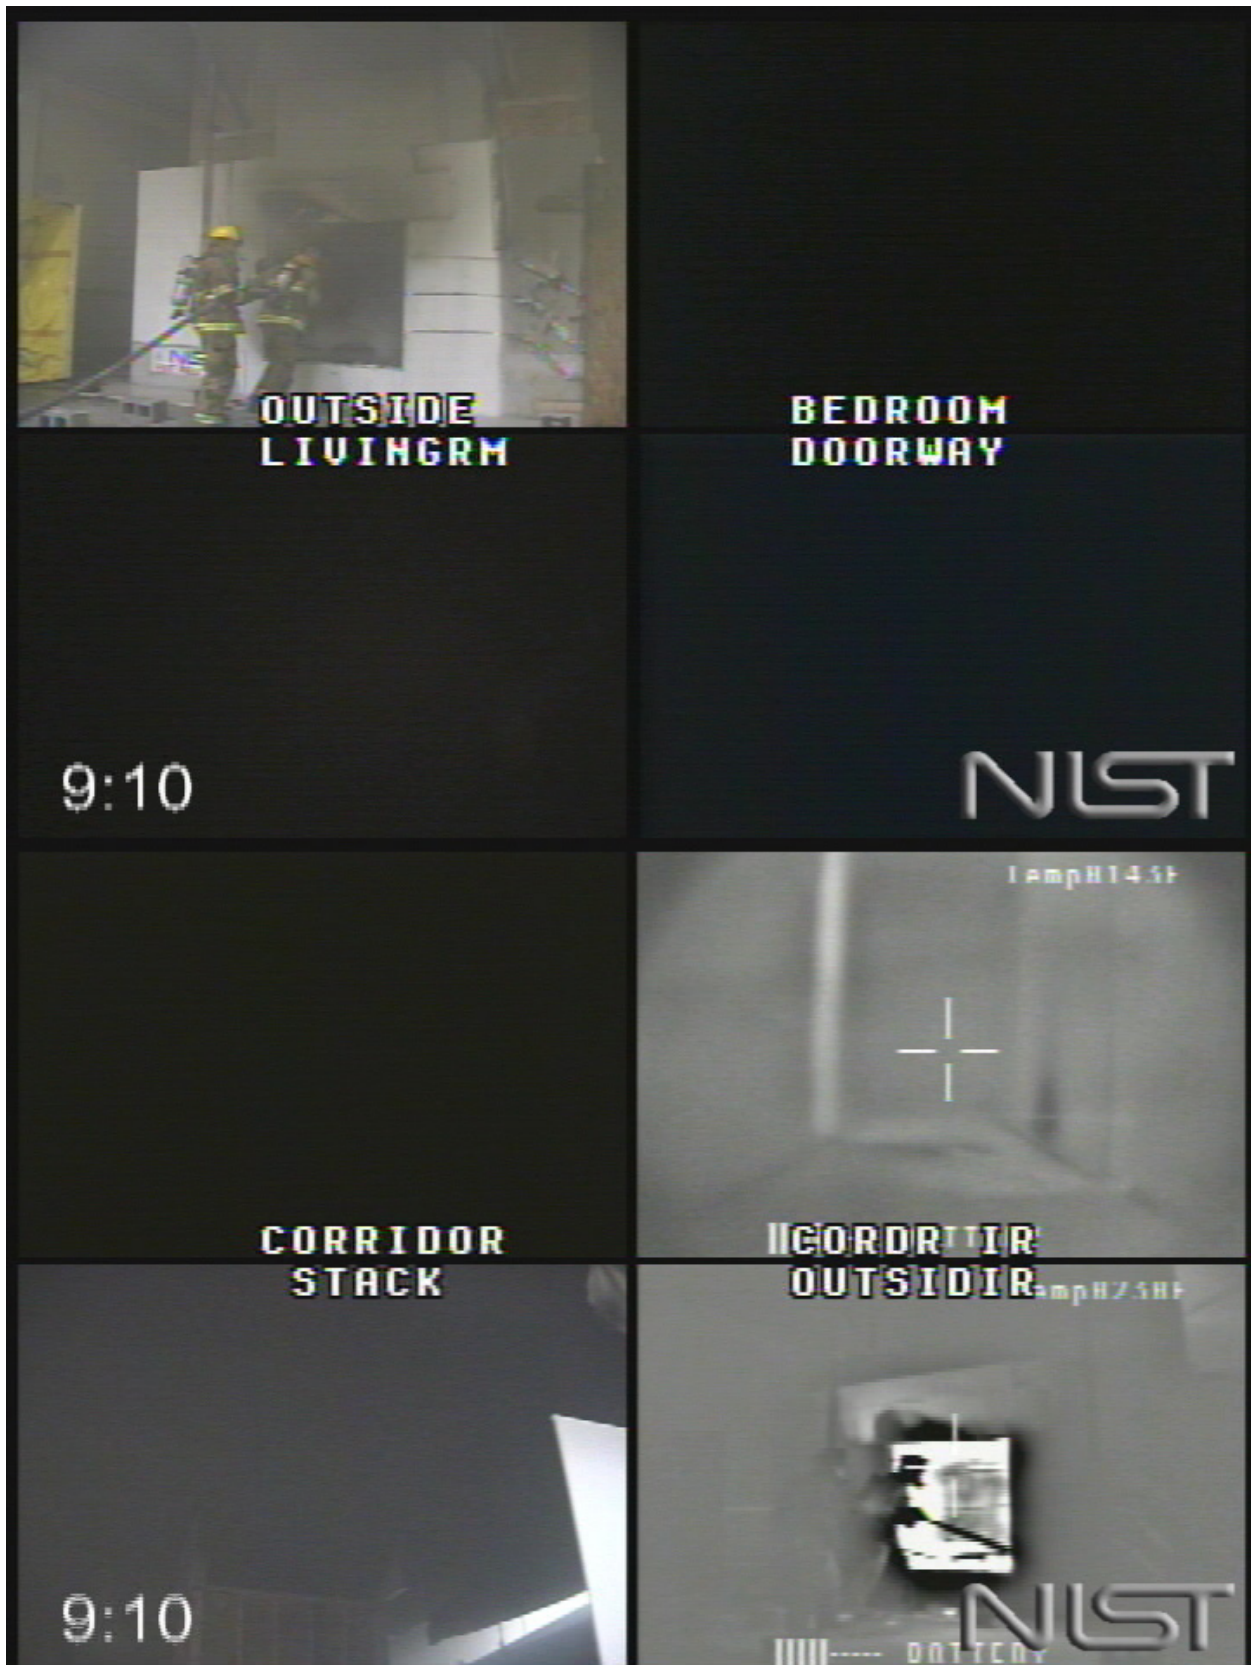
Figure 5.7.1-13. Experiment 7, direct suppression, 550 s after ignition.

The final images at 550 s after ignition show final suppression of the burning items remaining in the bedroom. The water did not reach the furnishings just inside the window so they needed to be extinguished from inside the window. All of the interior images were still obscured by soot deposition on the camera lenses.

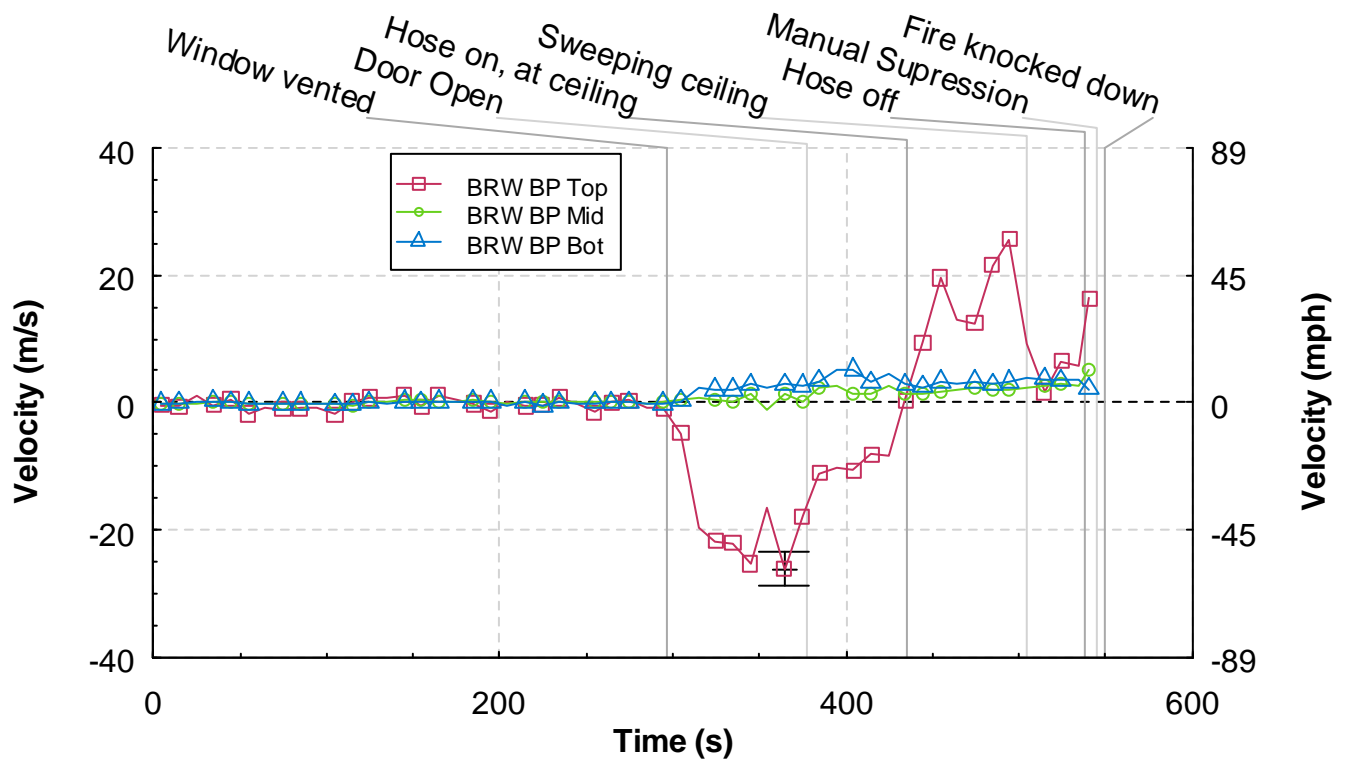
Figure 5.7.6-1. Velocity versus time from the bedroom window (BRW) bi-directional probe array, Experiment 7.

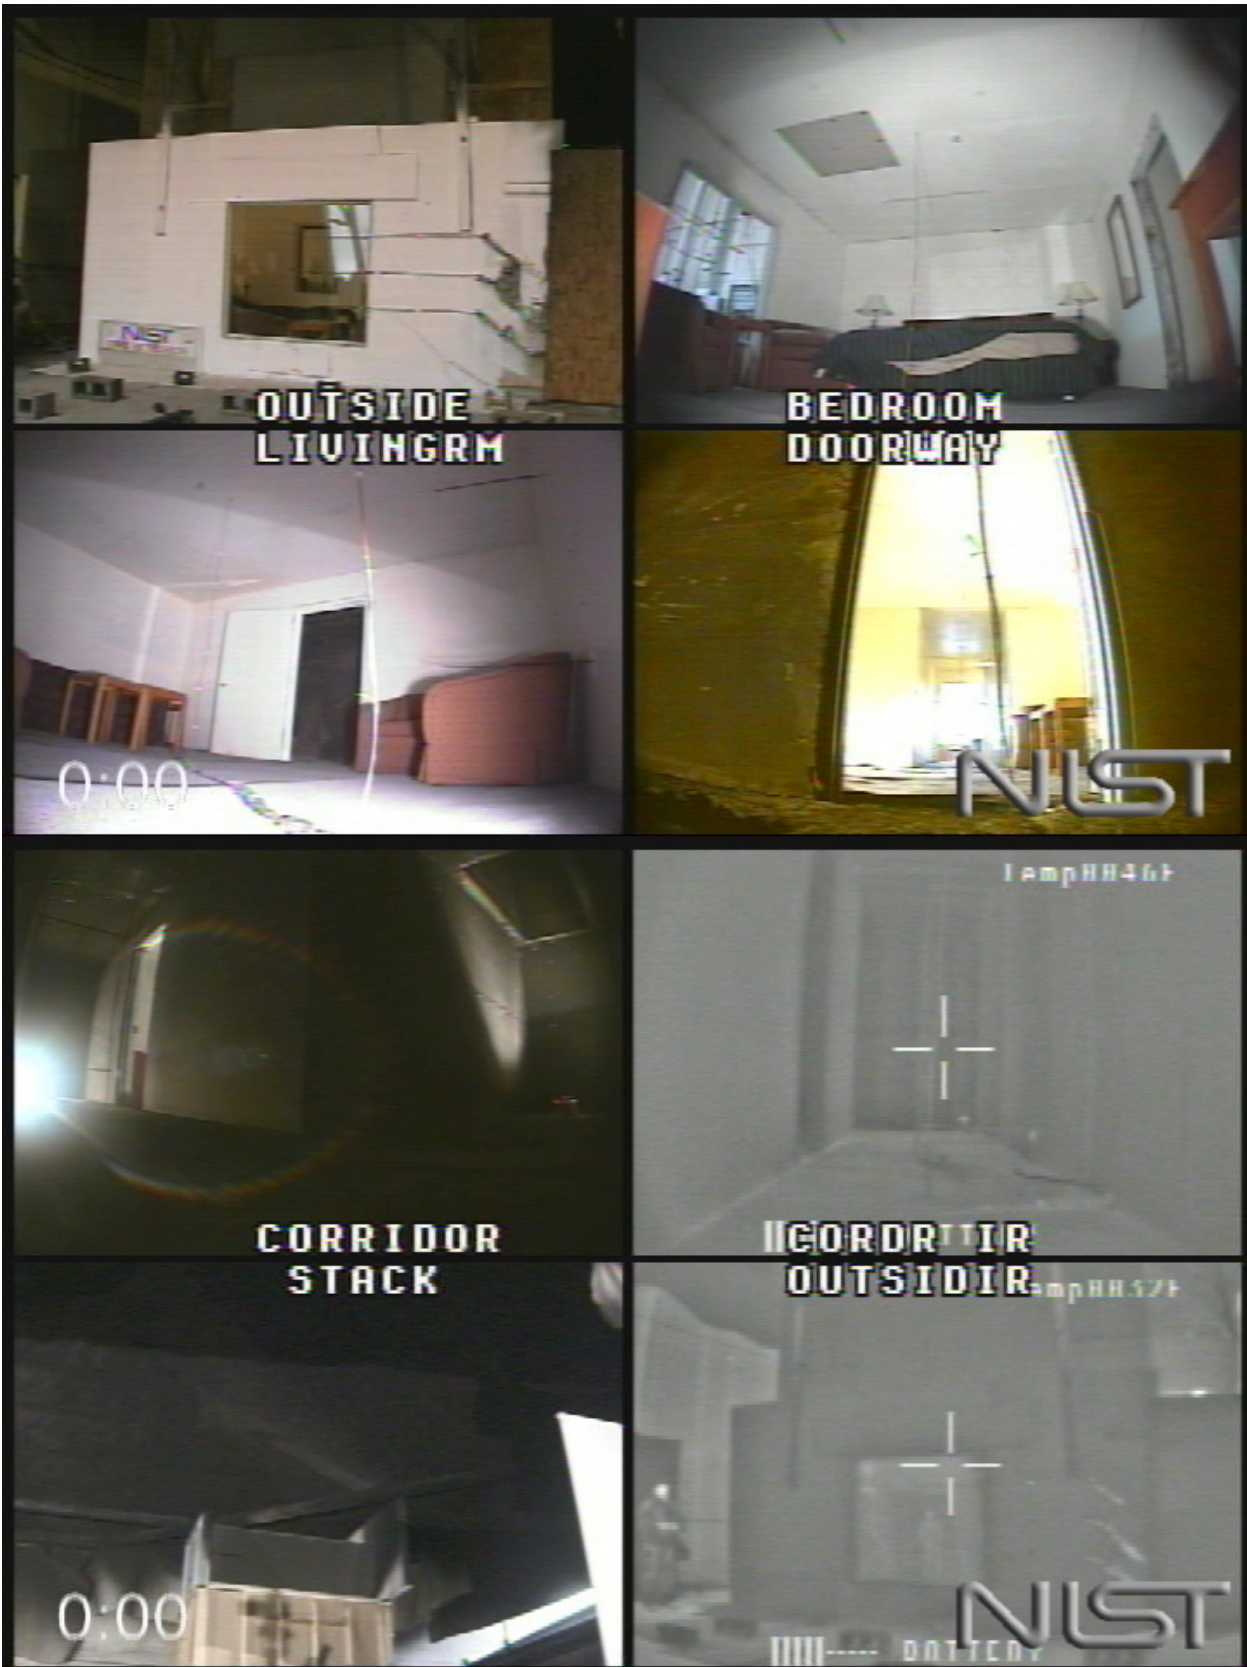
Figure 5.8.1-1. Experiment 8, ignition.

Figure 5.8.1-1 shows the conditions at the time of ignition. At this point, the eight video views were clear and unobstructed. However, the thermal images provided limited thermal contrast because the surfaces in the view were at nearly equal temperature.
