NIST Technical Note 1618

Fire Fighting Tactics Under Wind Driven Conditions: Laboratory Experiments

Daniel Madrzykowski
Stephen Kerber

January 2009

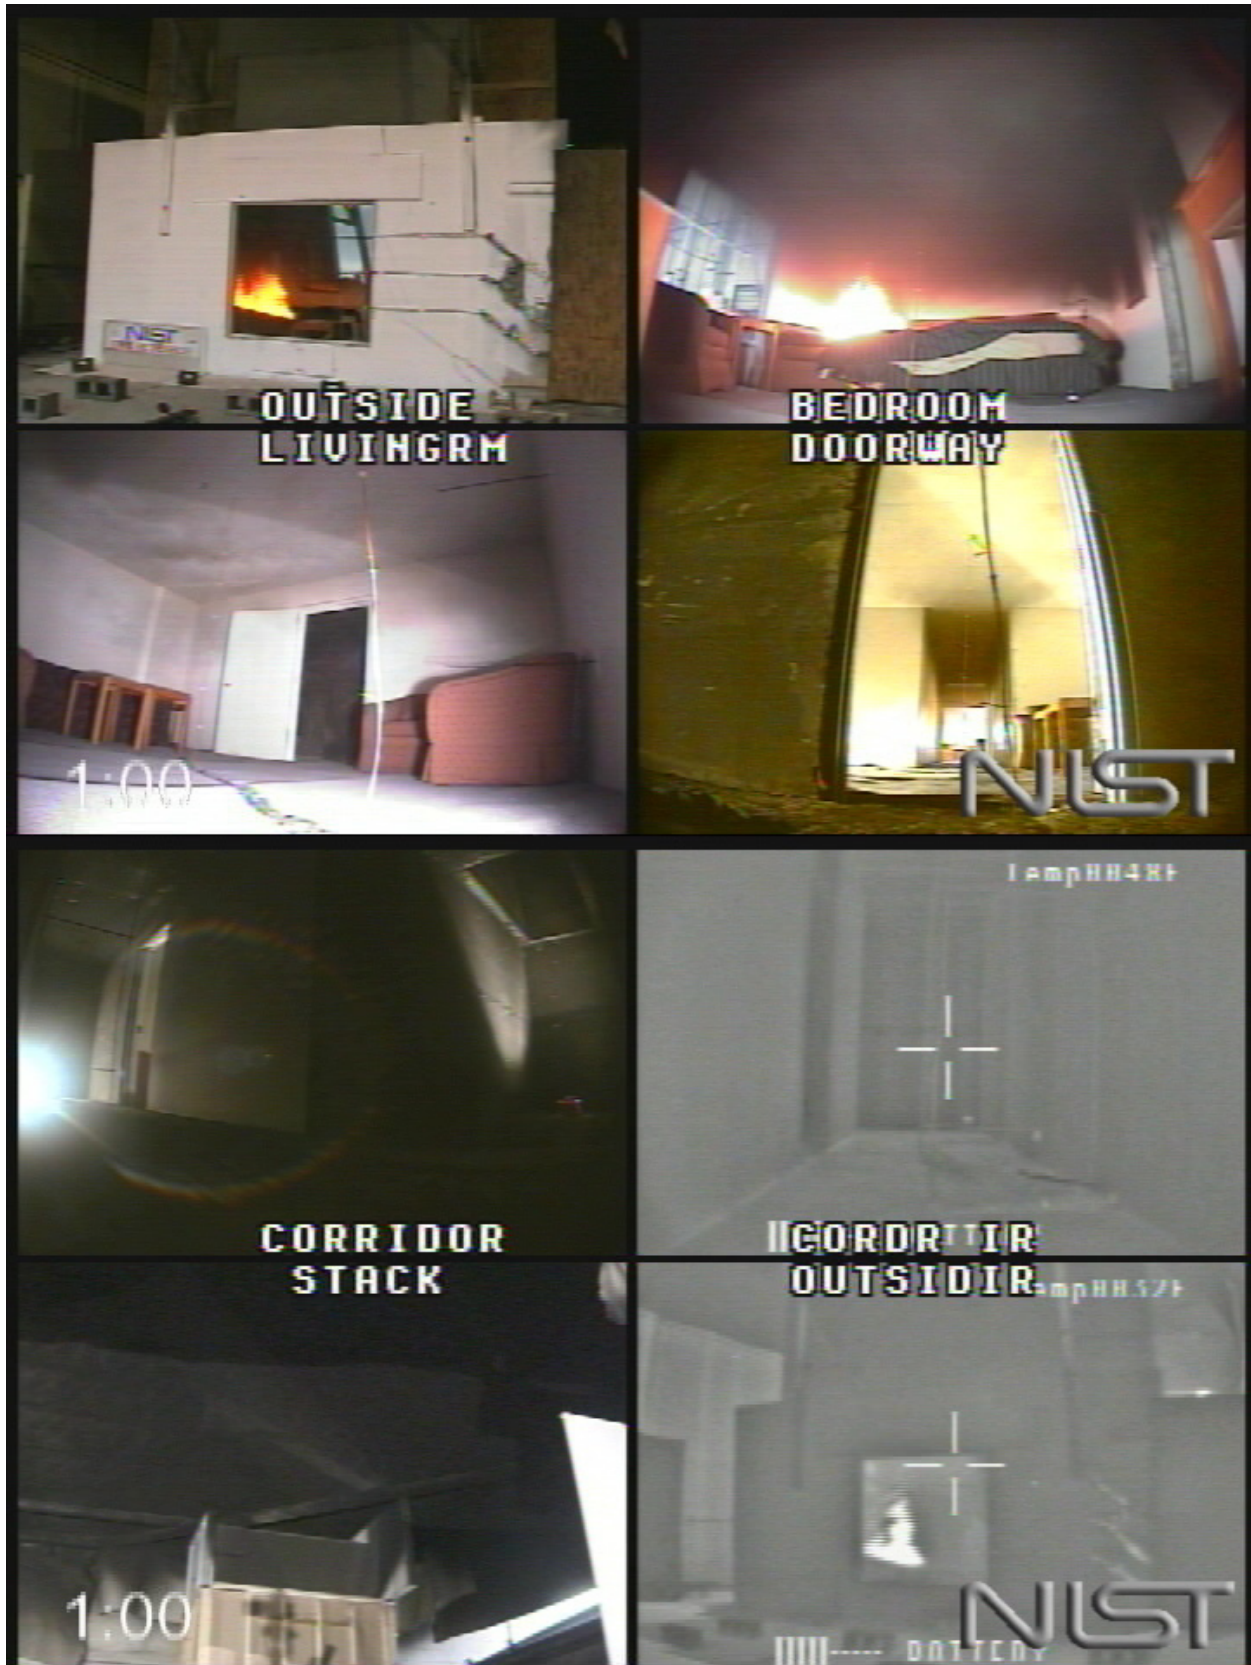
Figure 5.8.1-2. Experiment 8, 60 s after ignition.

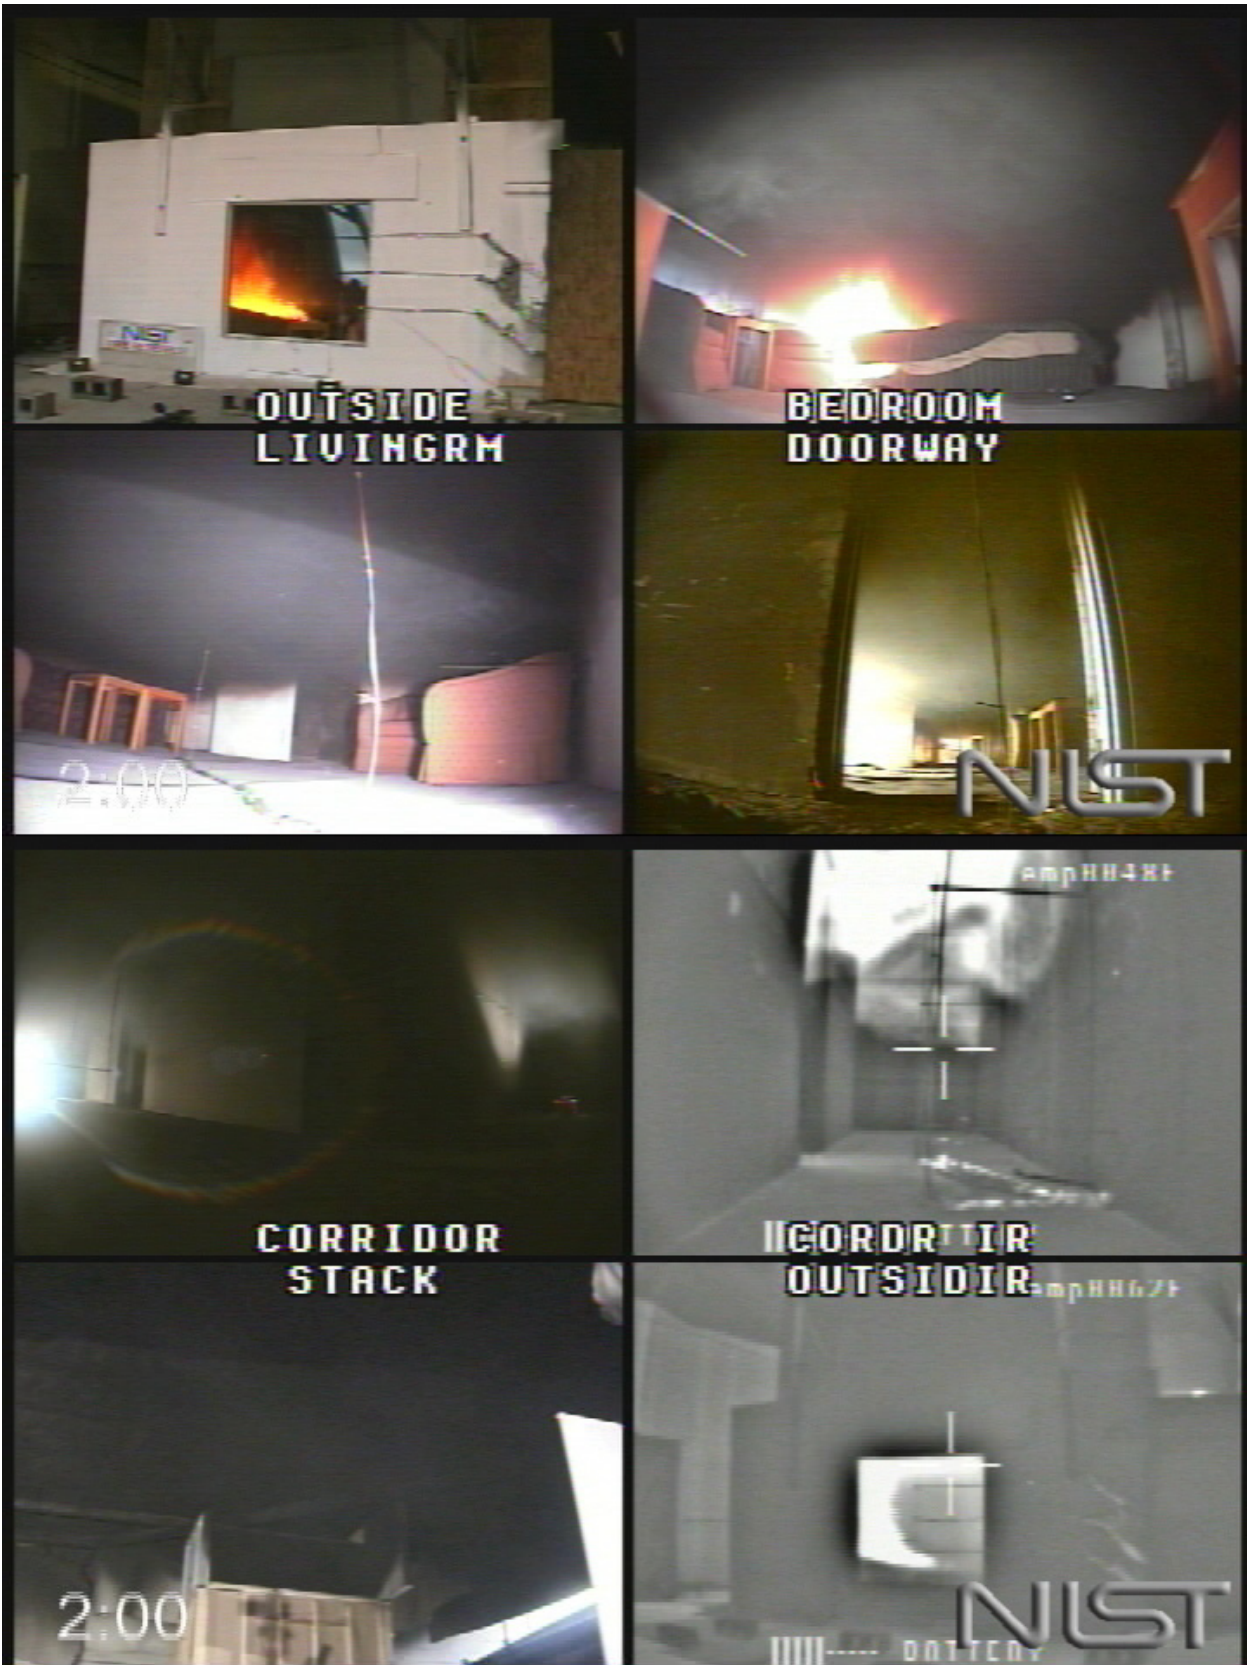
Figure 5.8.1-3. Experiment 8, 120 s after ignition.

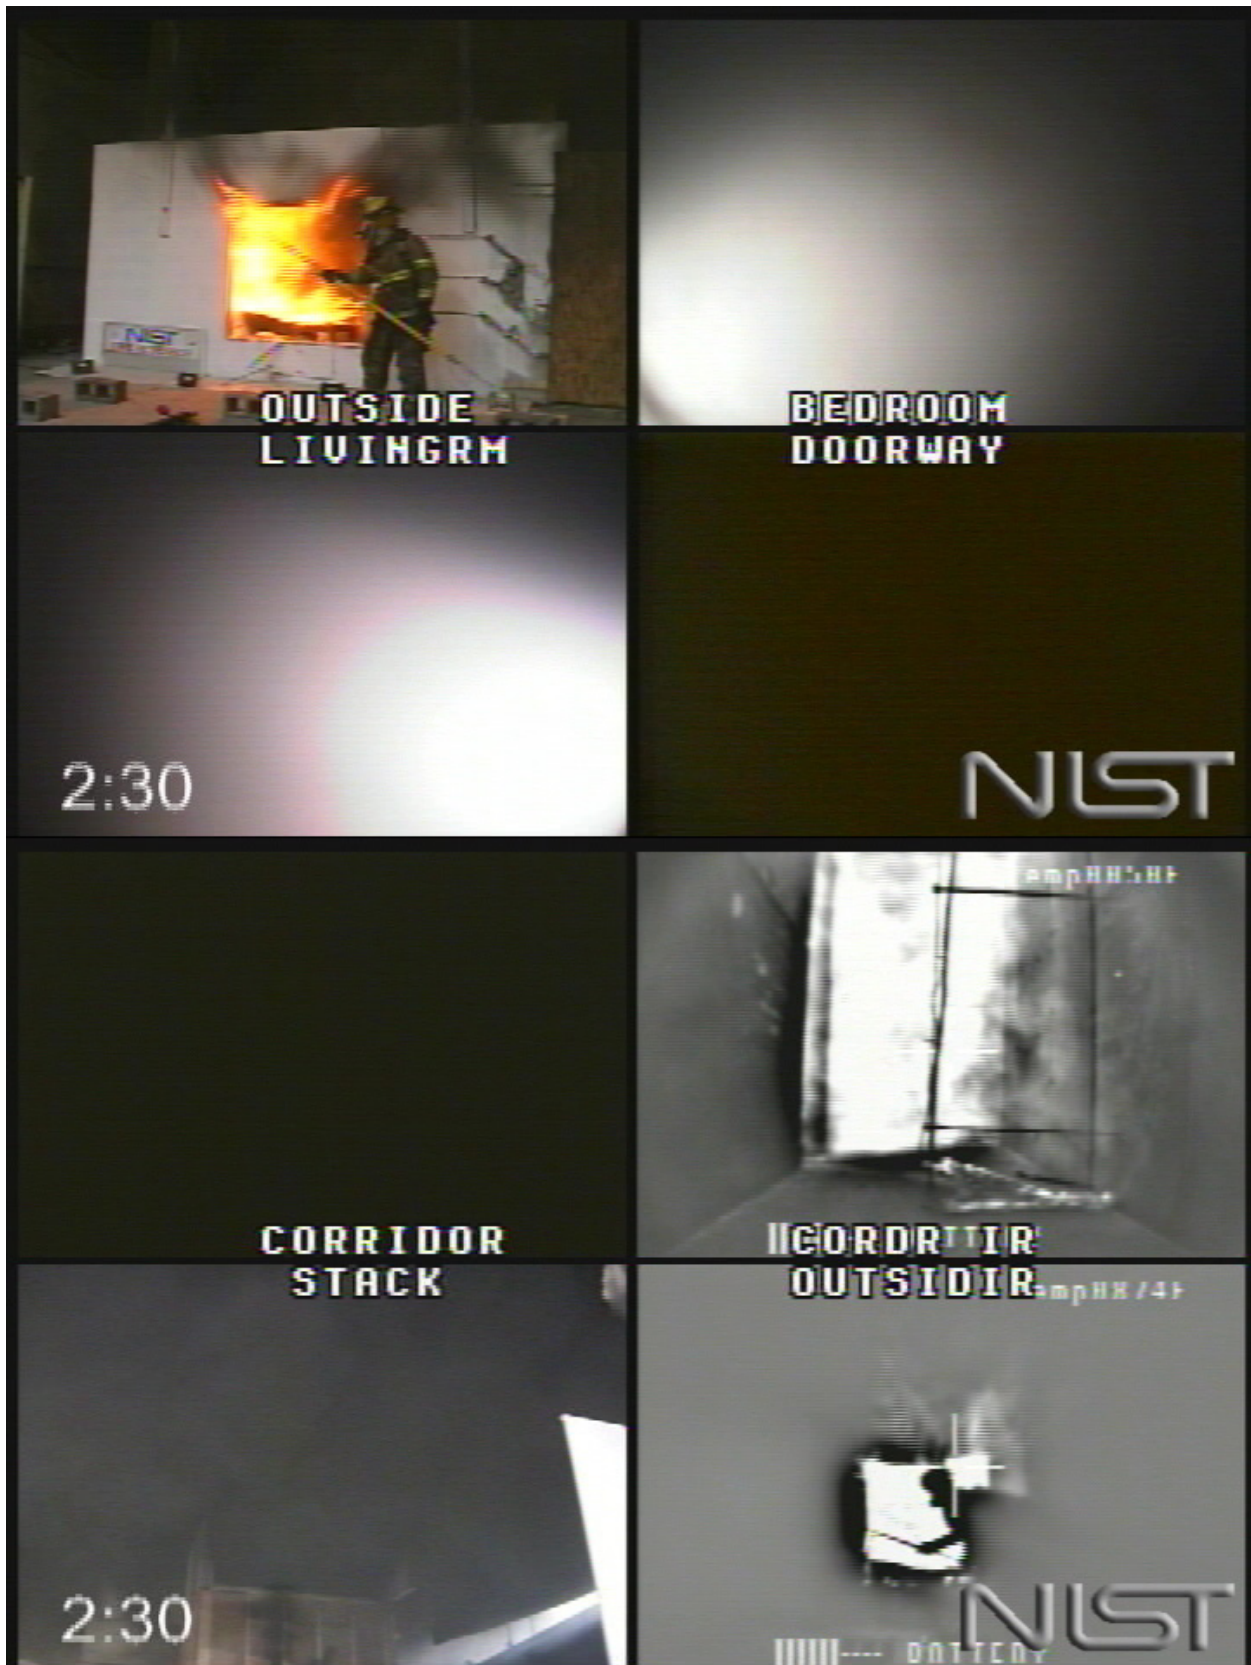
Figure 5.8.1-4. Experiment 8, window fully vented, 150 s after ignition.

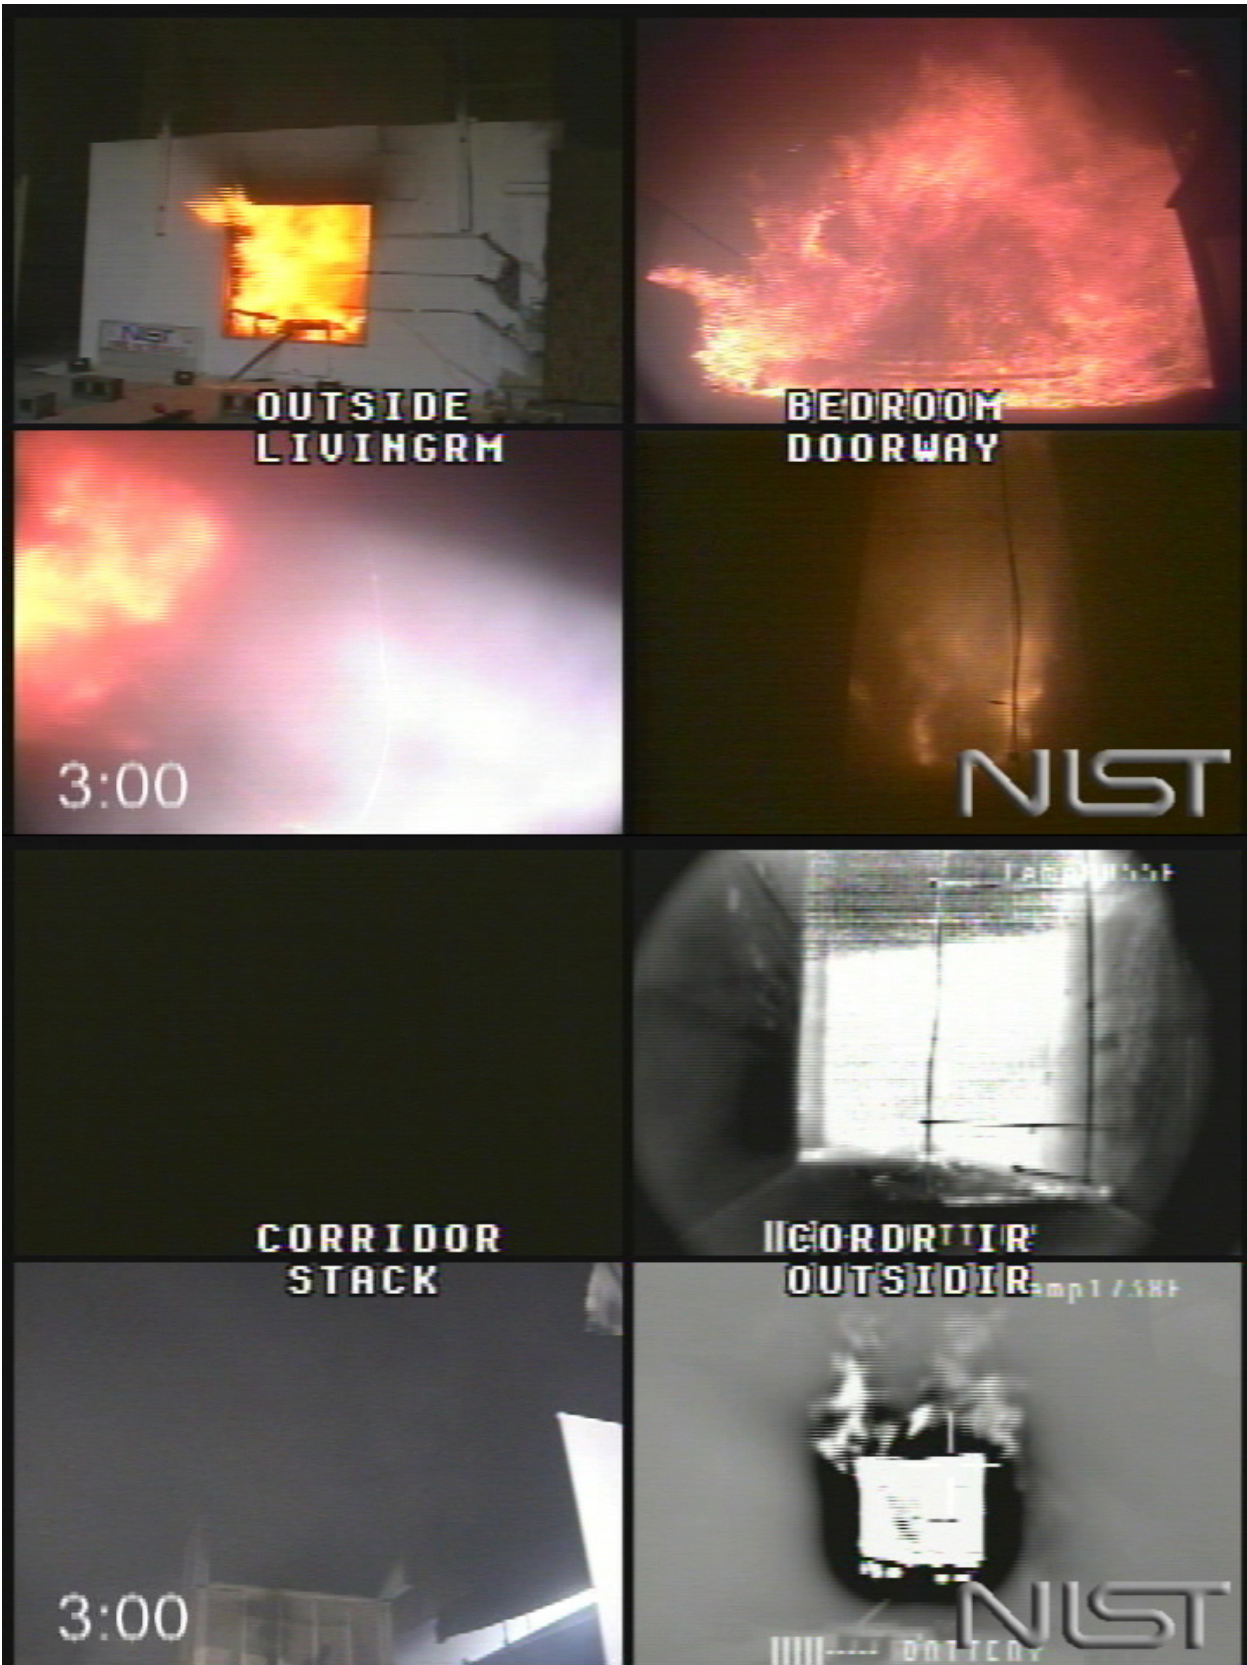
Figure 5.8.1-5. Experiment 8, 180 s after ignition.

Figure 5.8.1-5 shows the conditions at 180 s after ignition. Flames had encompassed the full height of the bedroom and extend into the living room. Some visibility has returned to the bedroom and living room.

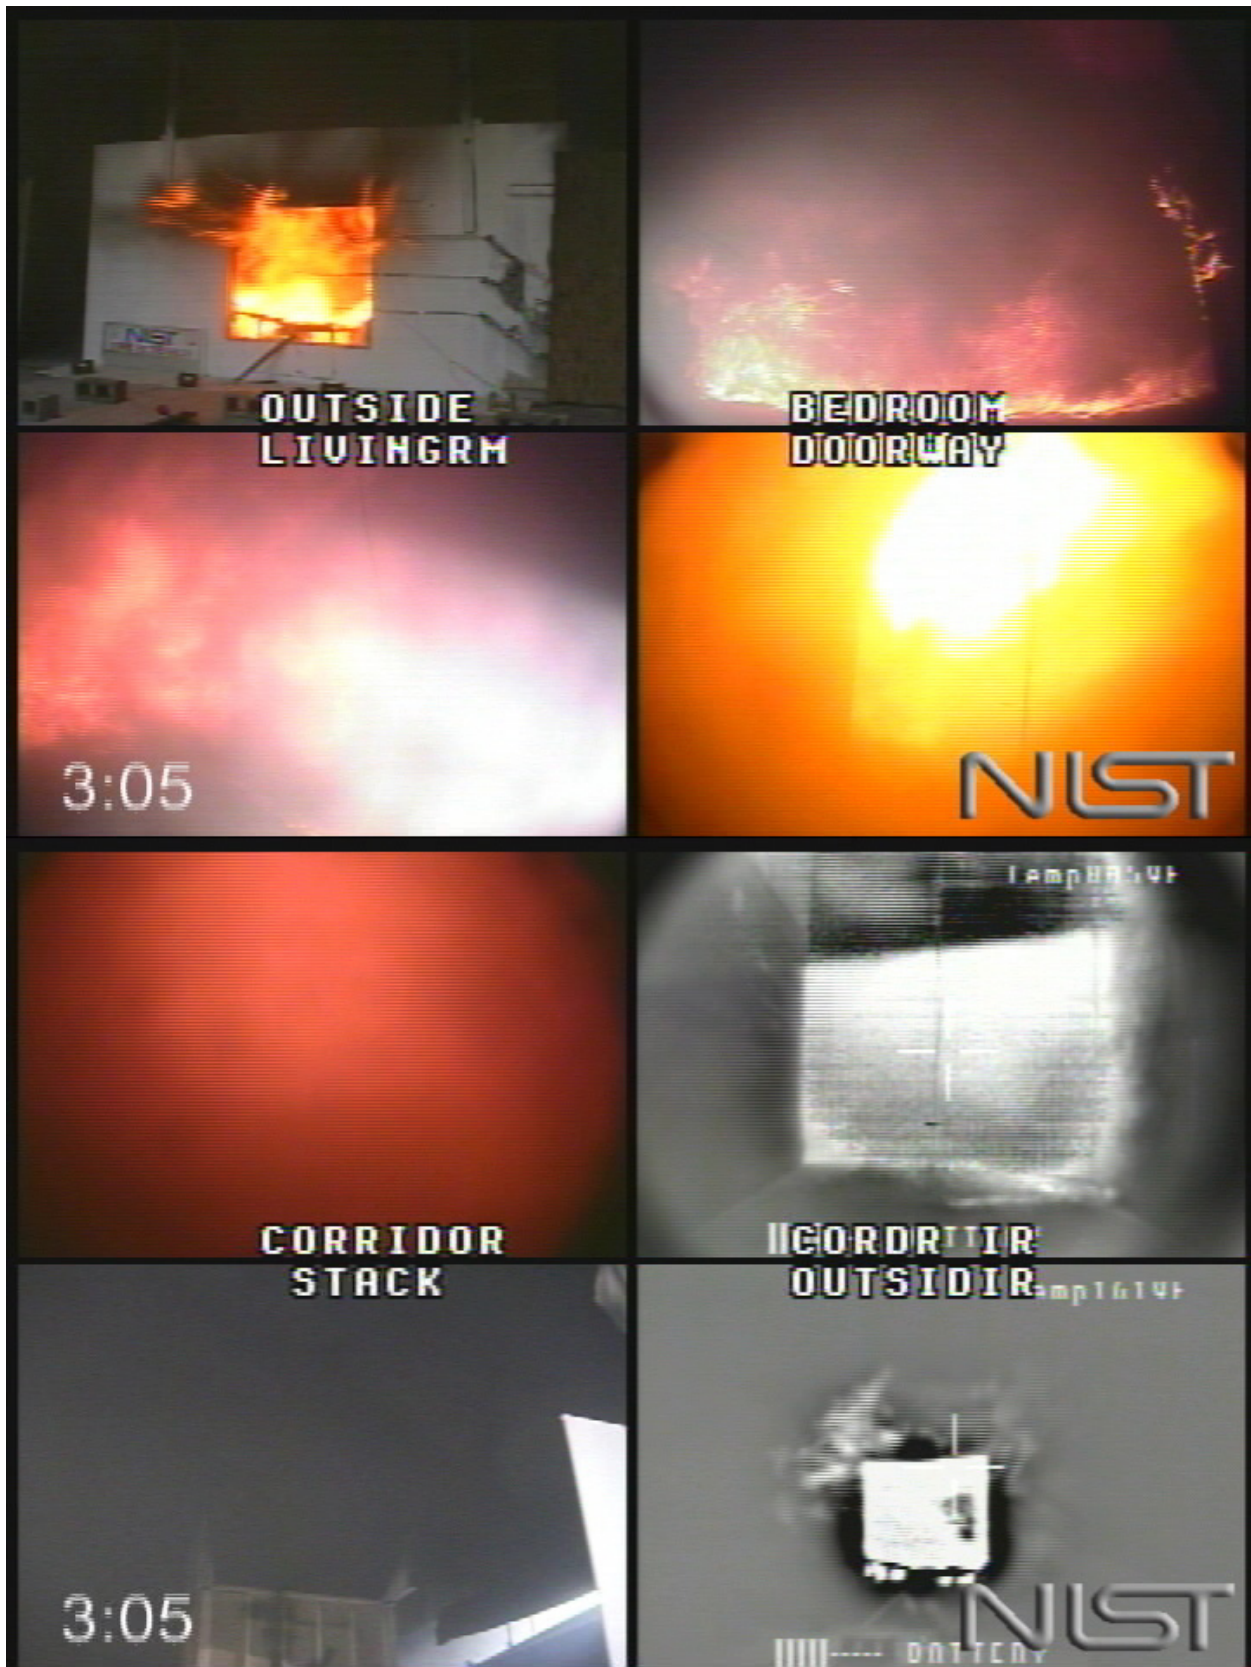
Figure 5.8.1-6. Experiment 8, corridor flames, 185 s after ignition.

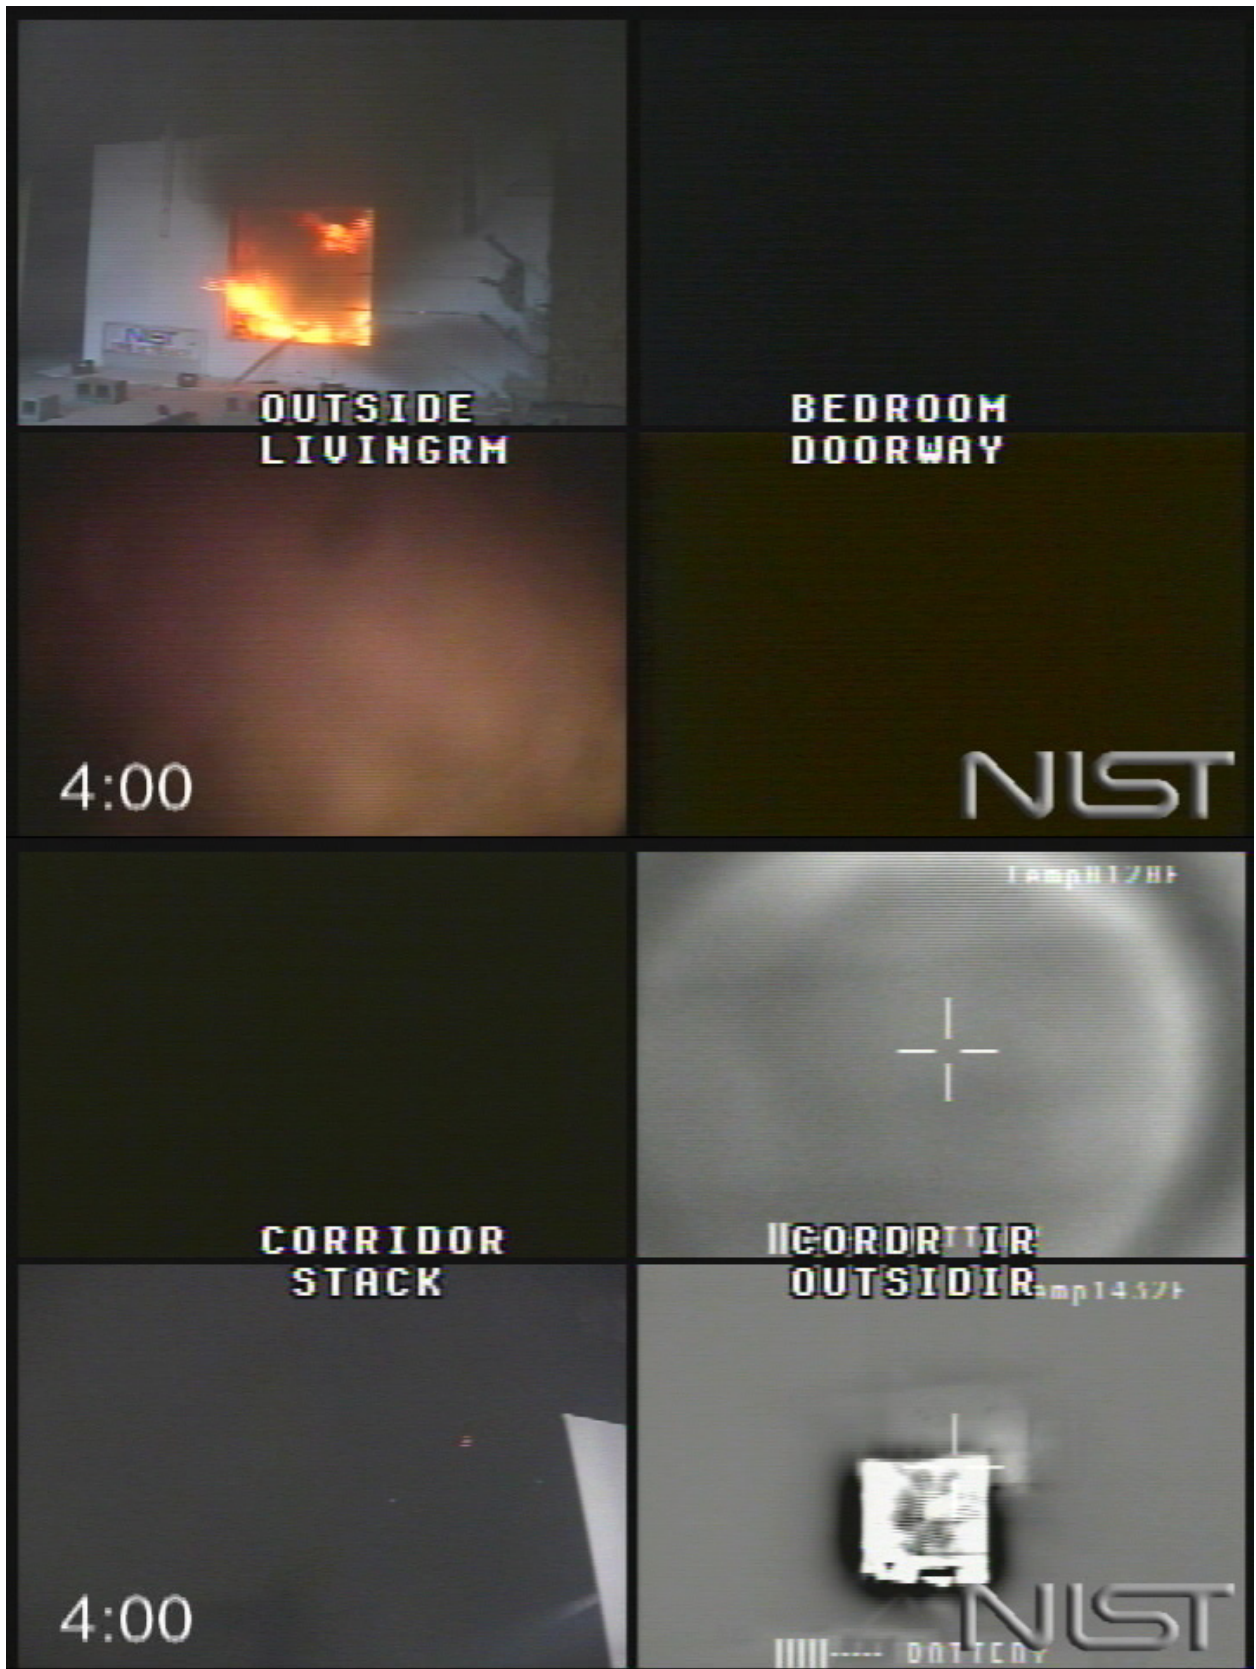
Figure 5.8.1-7. Experiment 8, 240 s after ignition.

Figure 5.8.1-7 shows the conditions at 240 s after ignition. At this point there was zero visibility in any of the internal views, including the corridor IR camera. Smoke had begun to fill the laboratory structure and has thus obscured the external stack view as well.

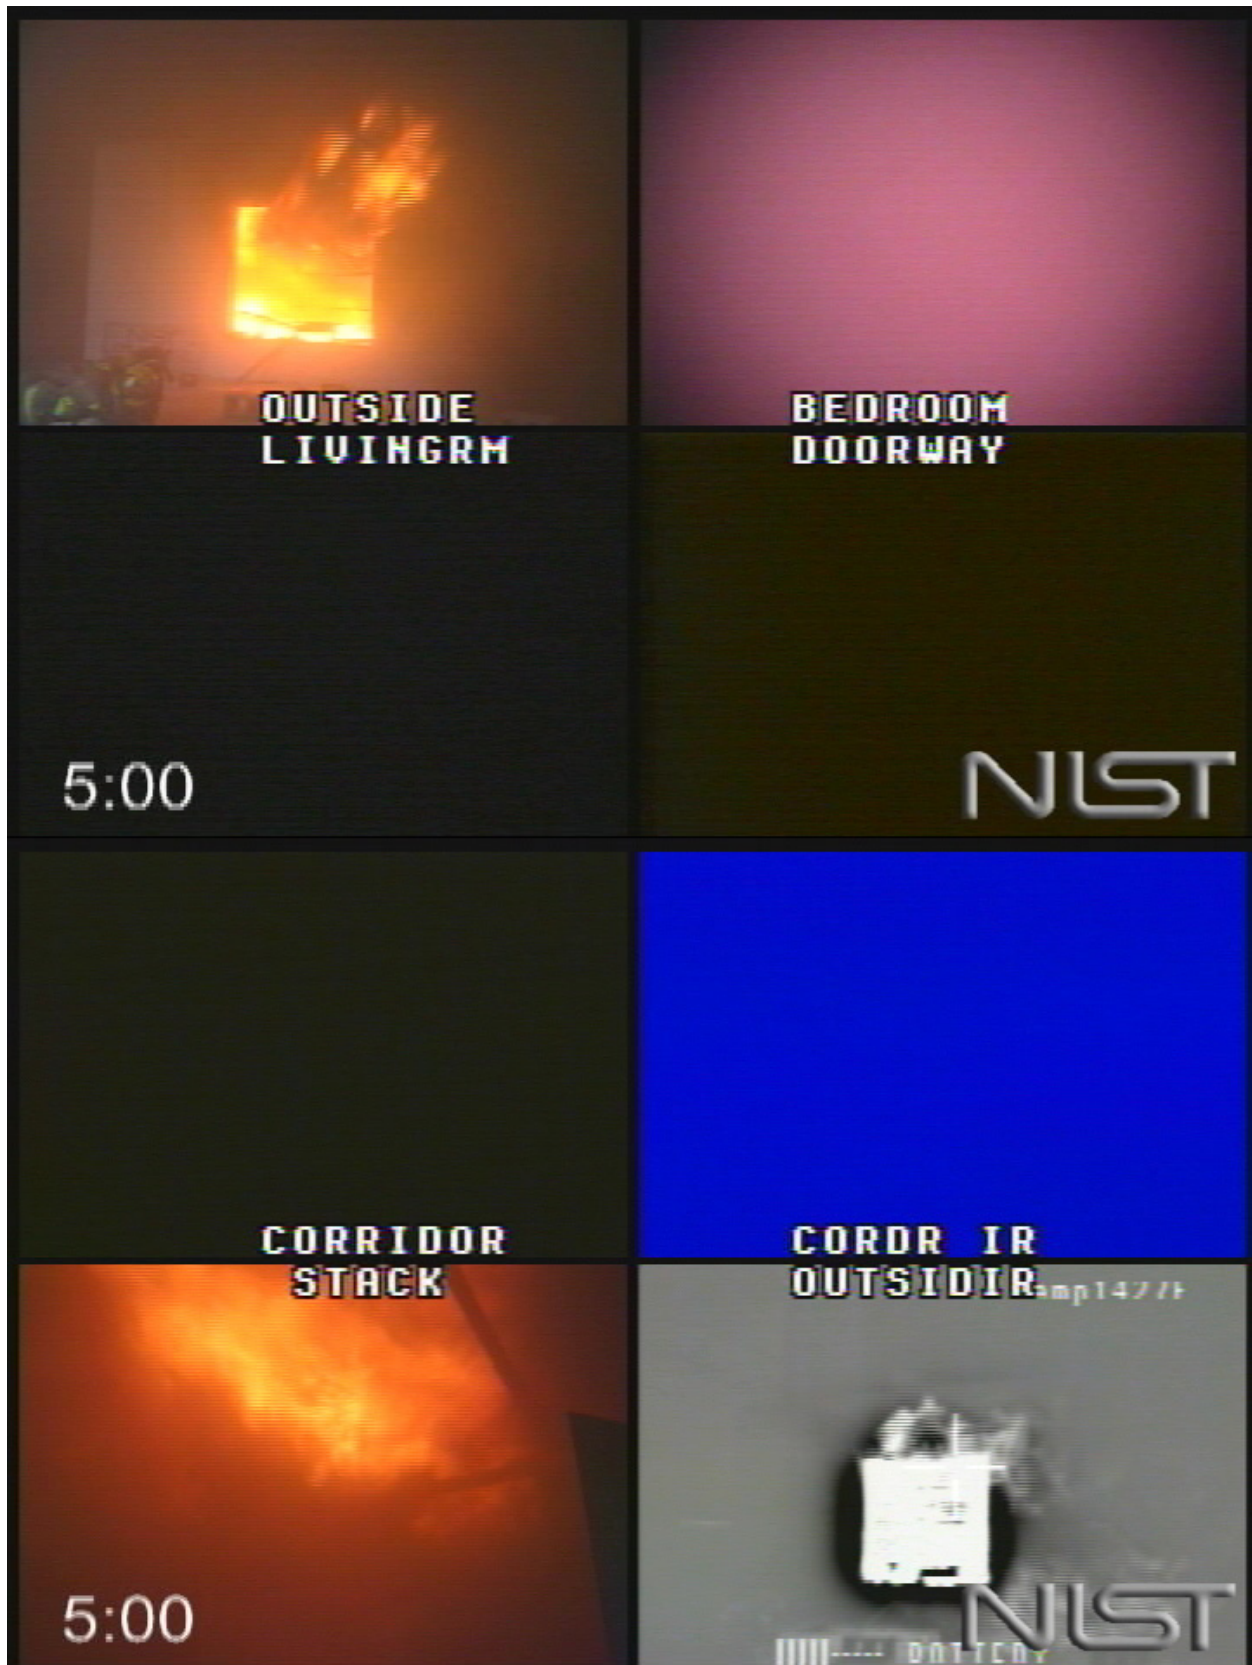
Figure 5.8.1-8. Experiment 8, 300 s after ignition.

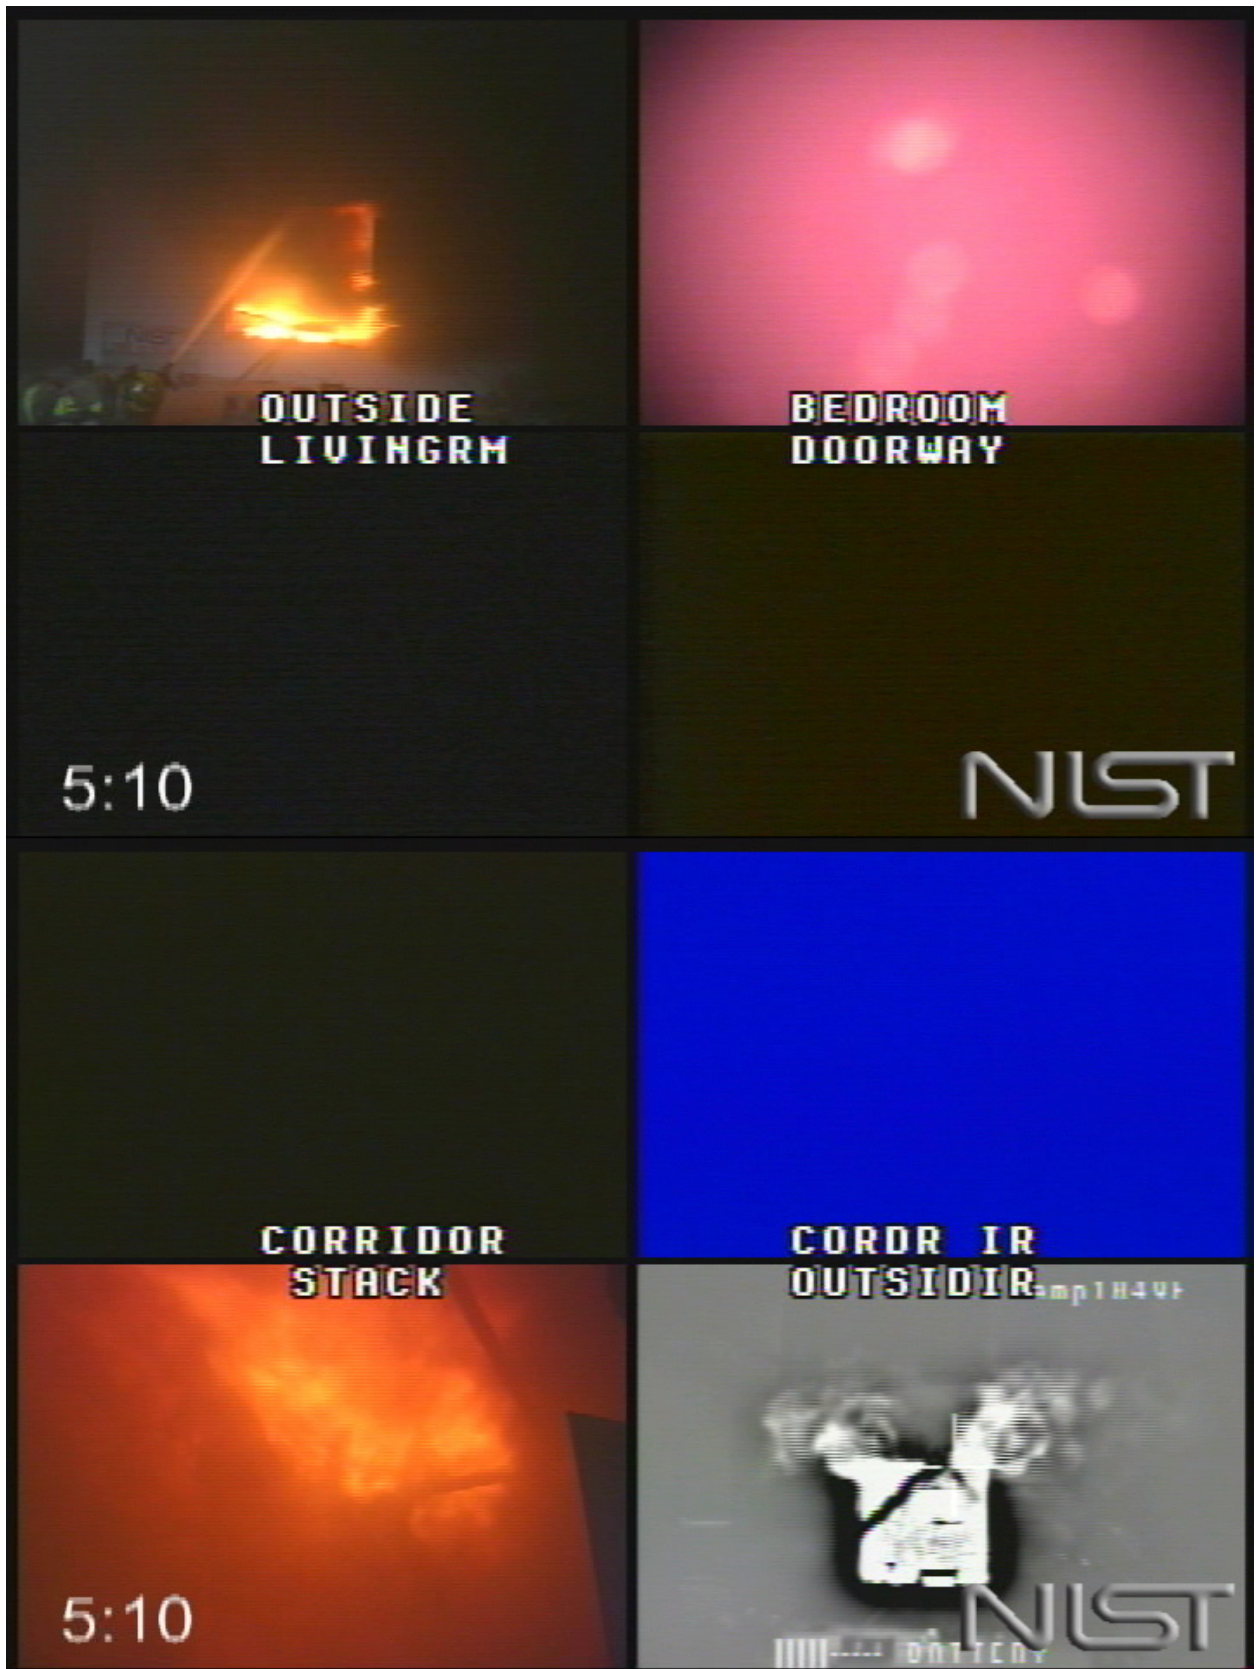
Figure 5.8.1-9. Experiment 8, indirect suppression started, 310 s after ignition.

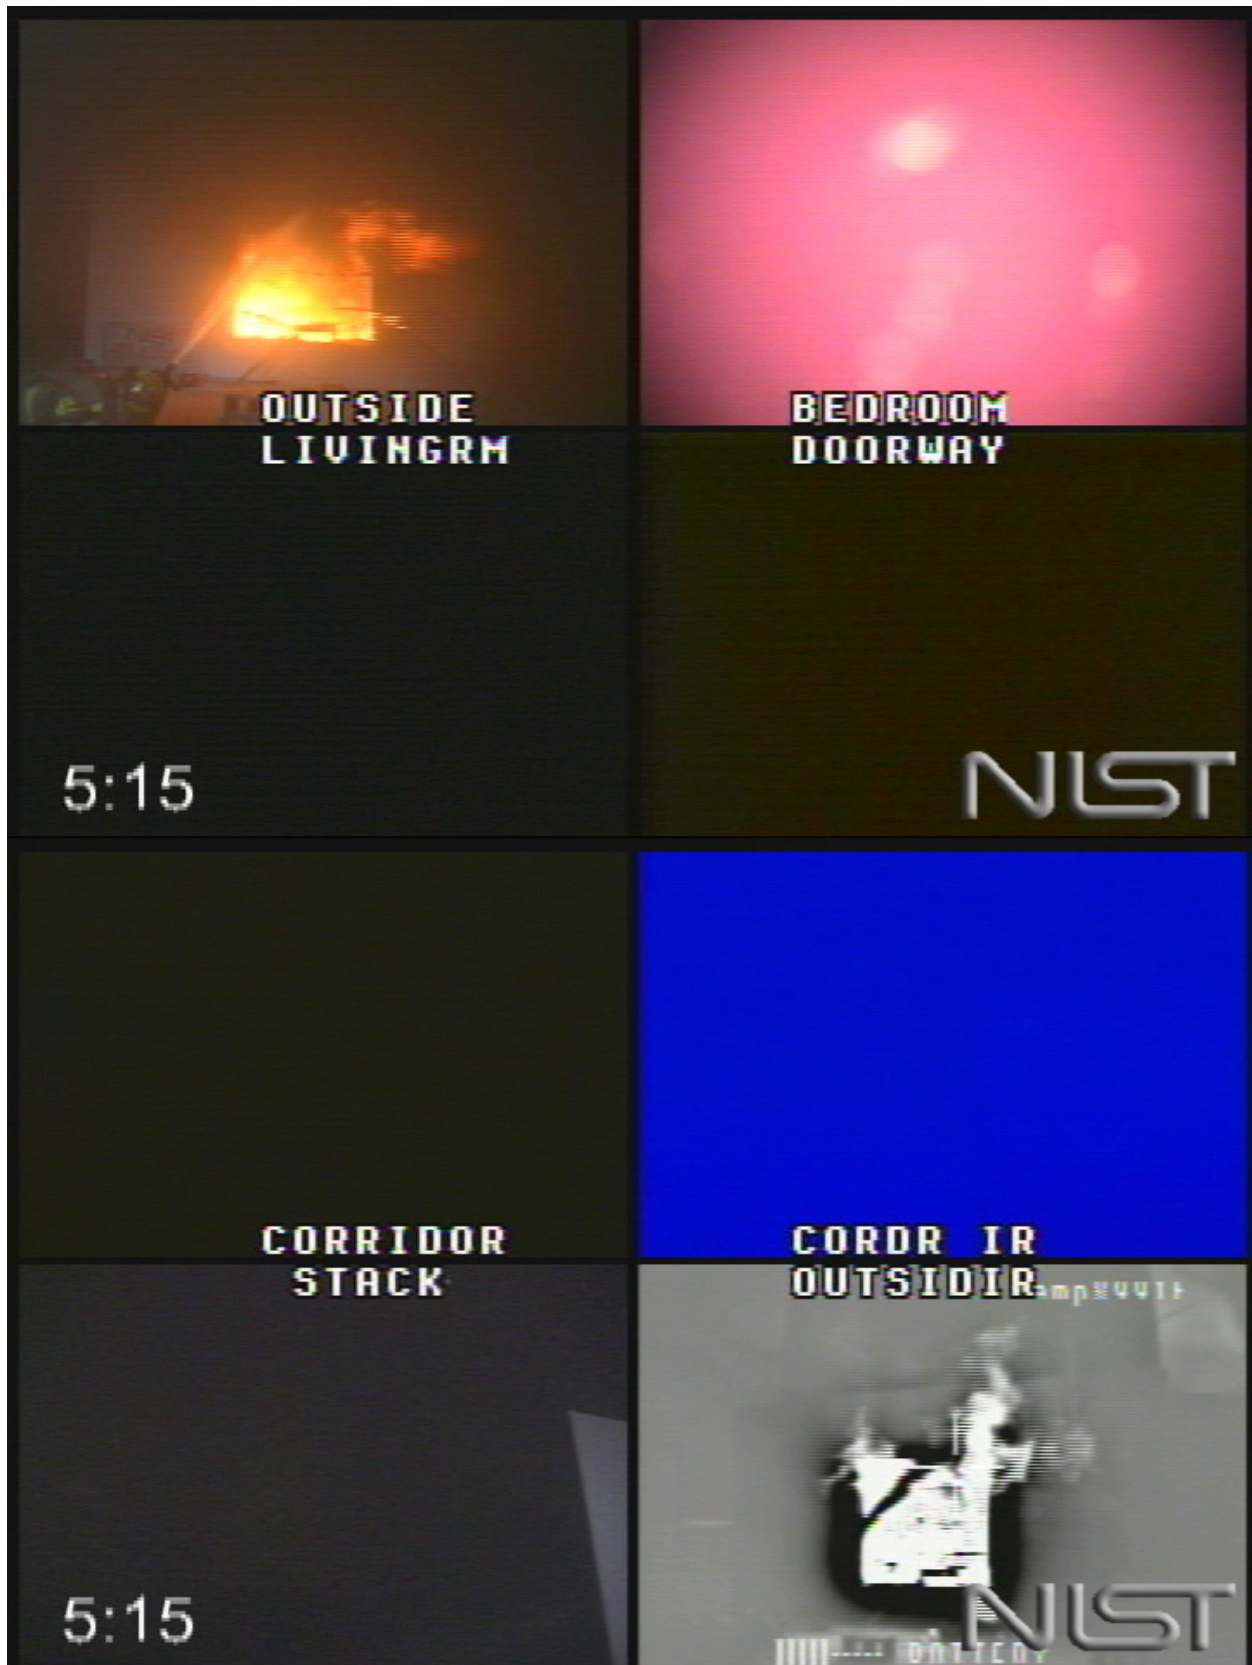
Figure 5.8.1-10. Experiment 8, flames withdraw from vent, 315 s after ignition.

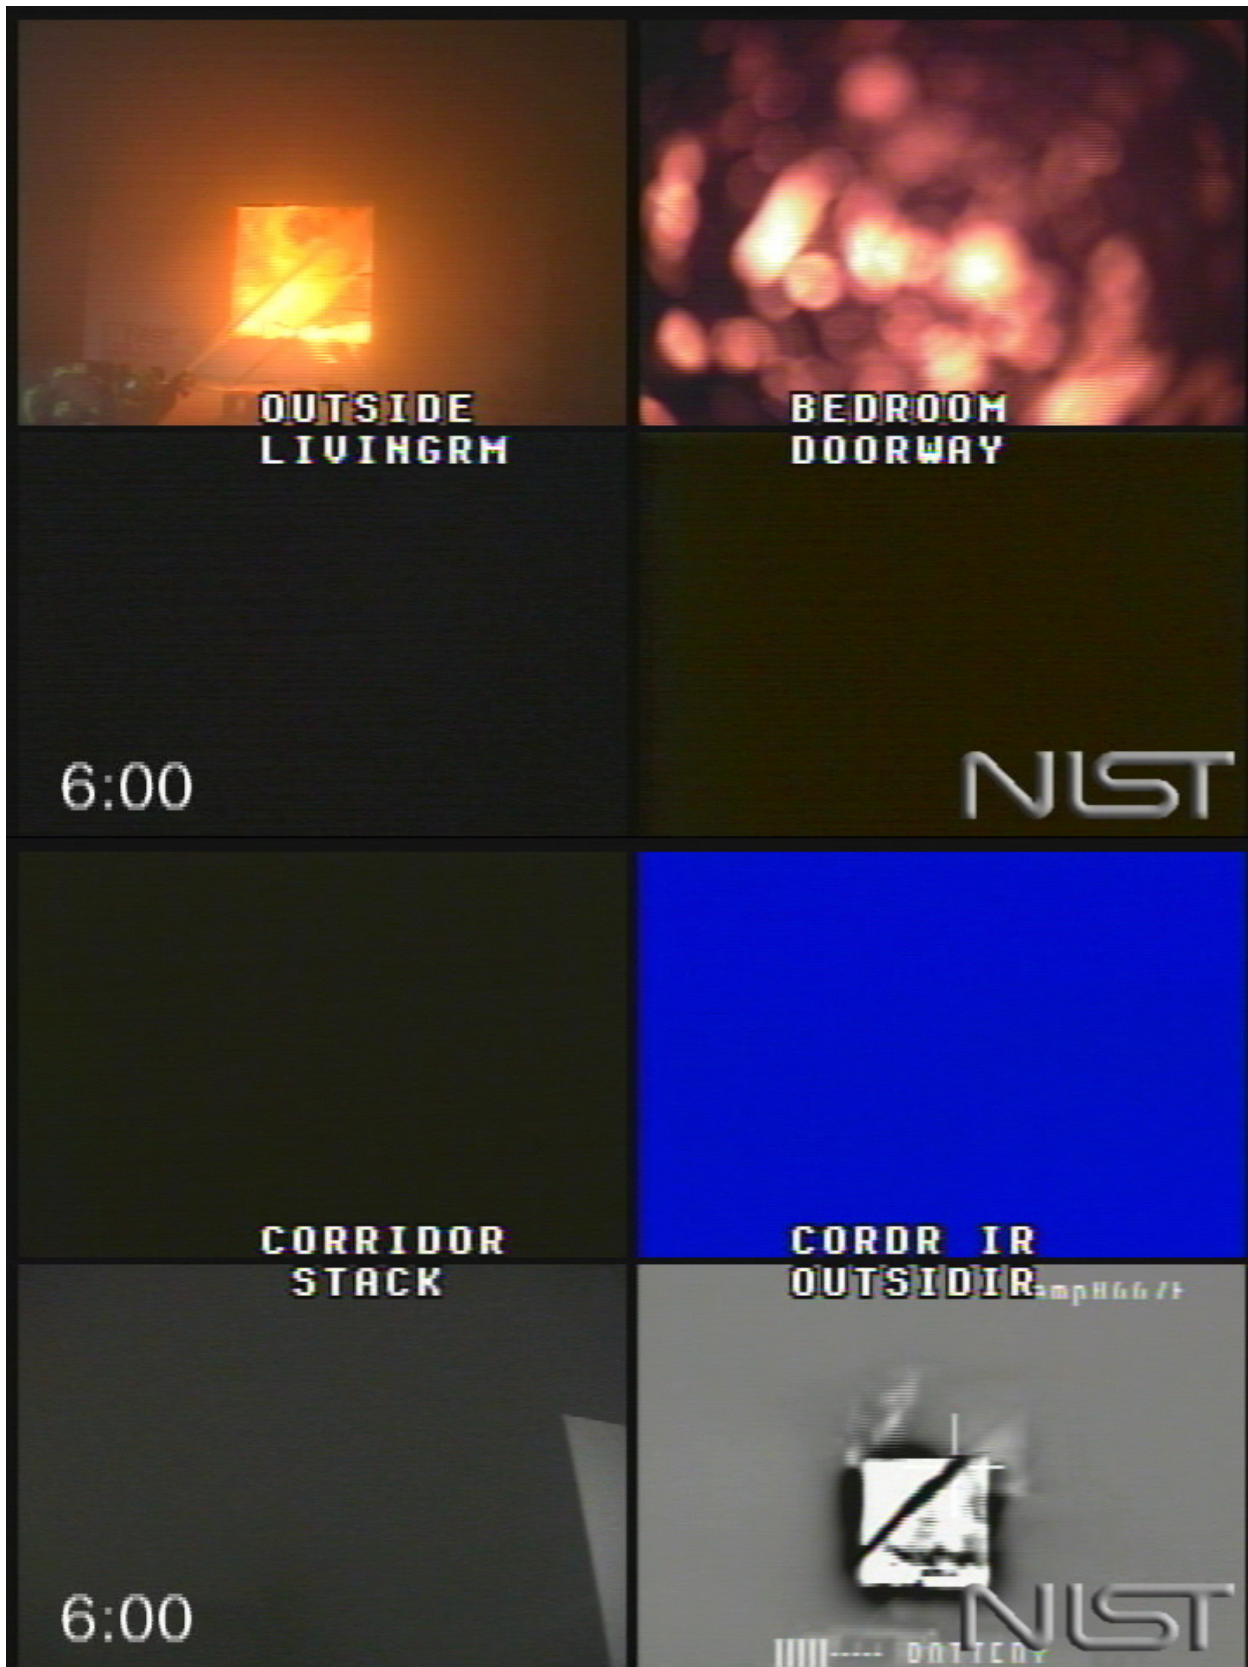
Figure 5.8.1-11. Experiment 8, 360 s after ignition.

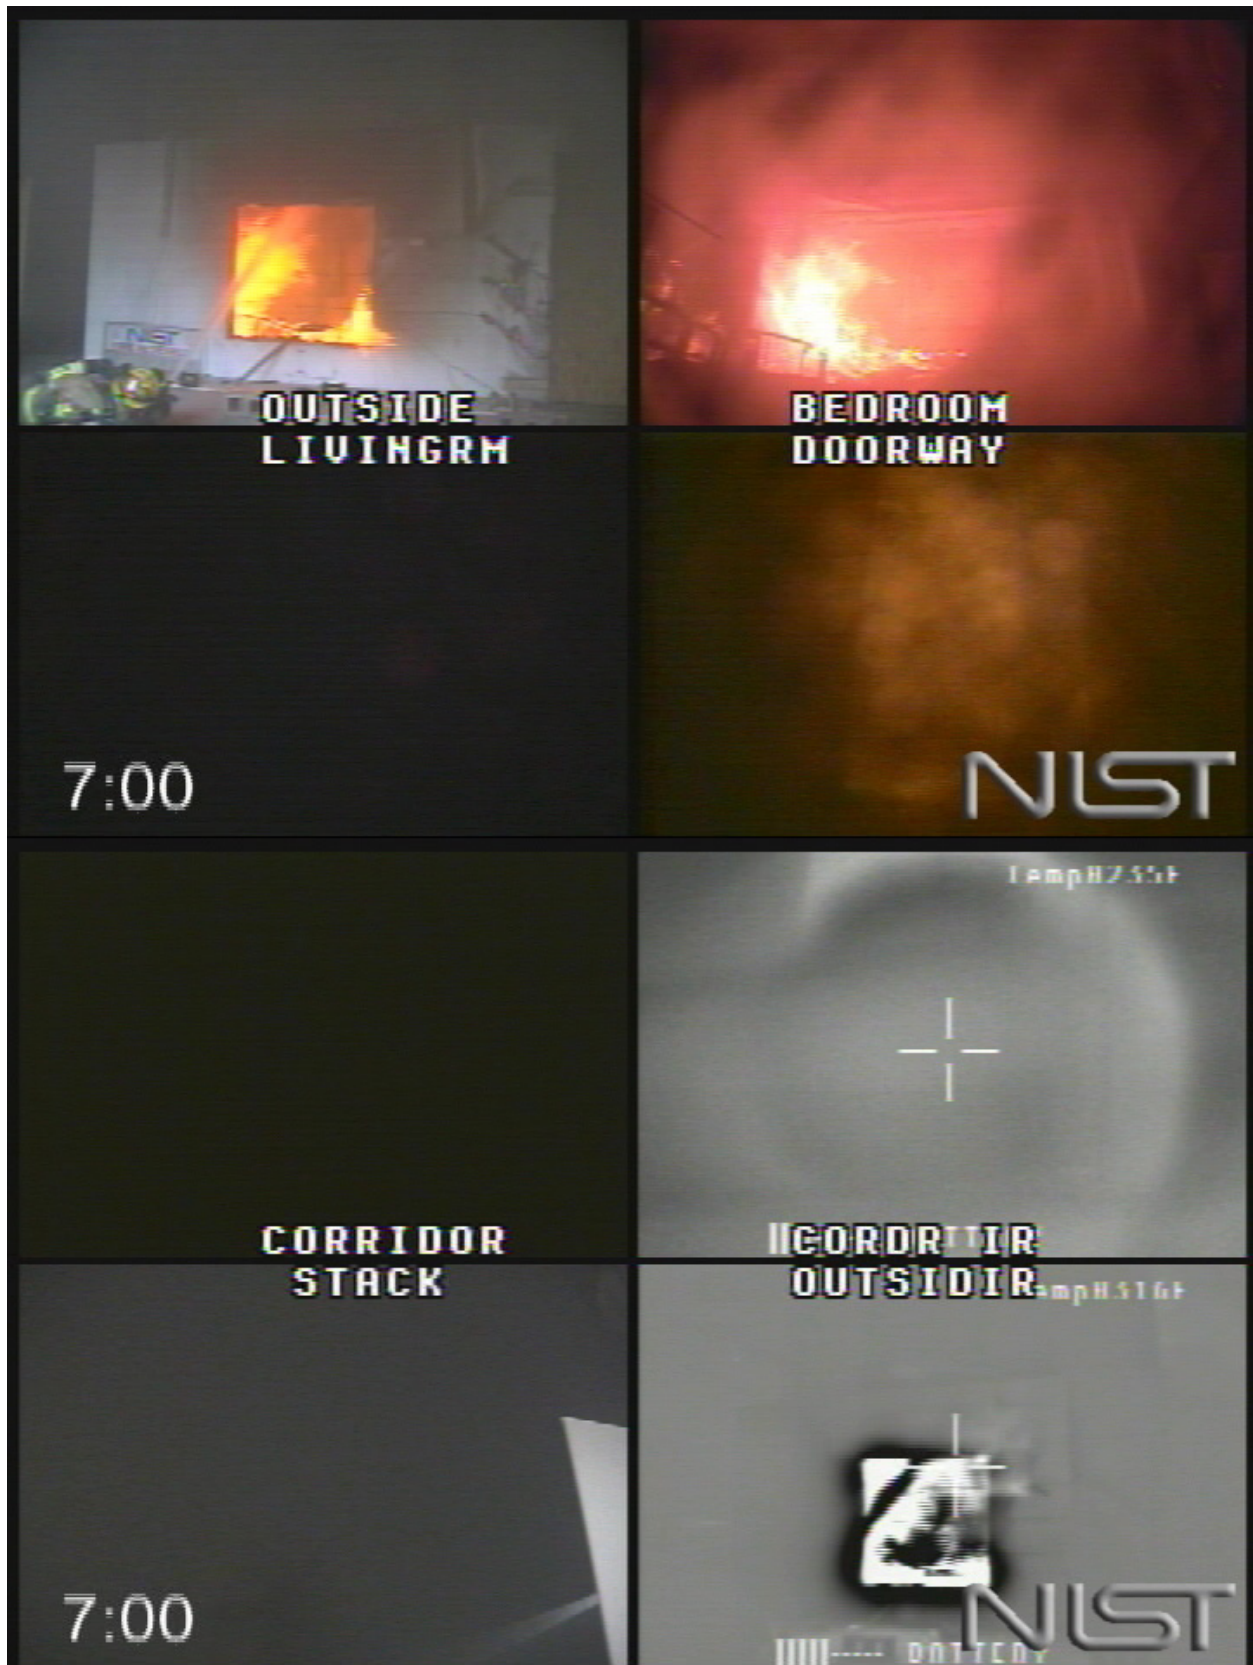
Figure 5.8.1-12. Experiment 8, 420 s after ignition.

The images in Figure 5.8.1-12 were recorded at 420 s after ignition. Visibility had returned to the bedroom and had begun to return to the living room. Indirect suppression was still ongoing.
