NIST Technical Note 1618

Fire Fighting Tactics Under Wind Driven Conditions: Laboratory Experiments

Daniel Madrzykowski
Stephen Kerber

January 2009

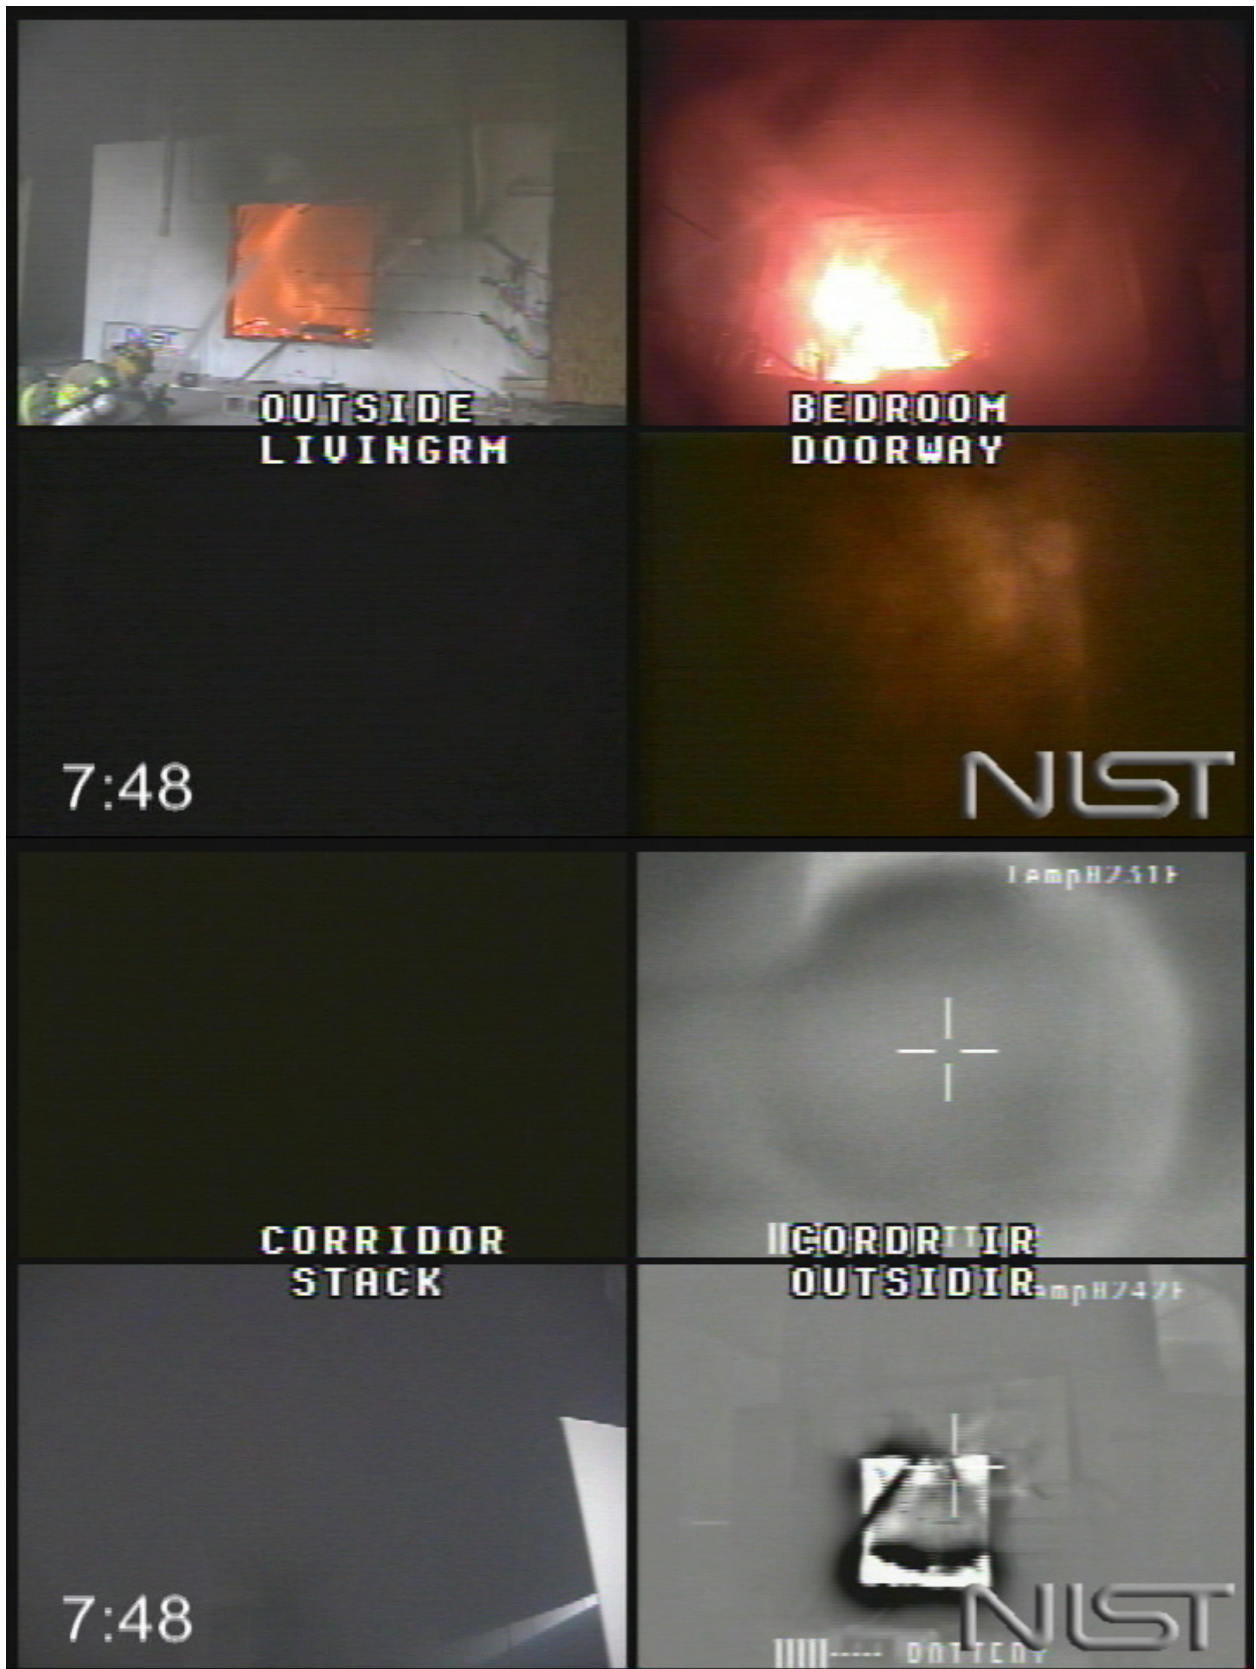
Figure 5.8.1-13. Experiment 8, indirect suppression stopped, 468 s after ignition.

The images in Figure 5.8.1-13 were recorded at 468 s after ignition. Within several seconds indirect suppression stopped and direct suppression began.

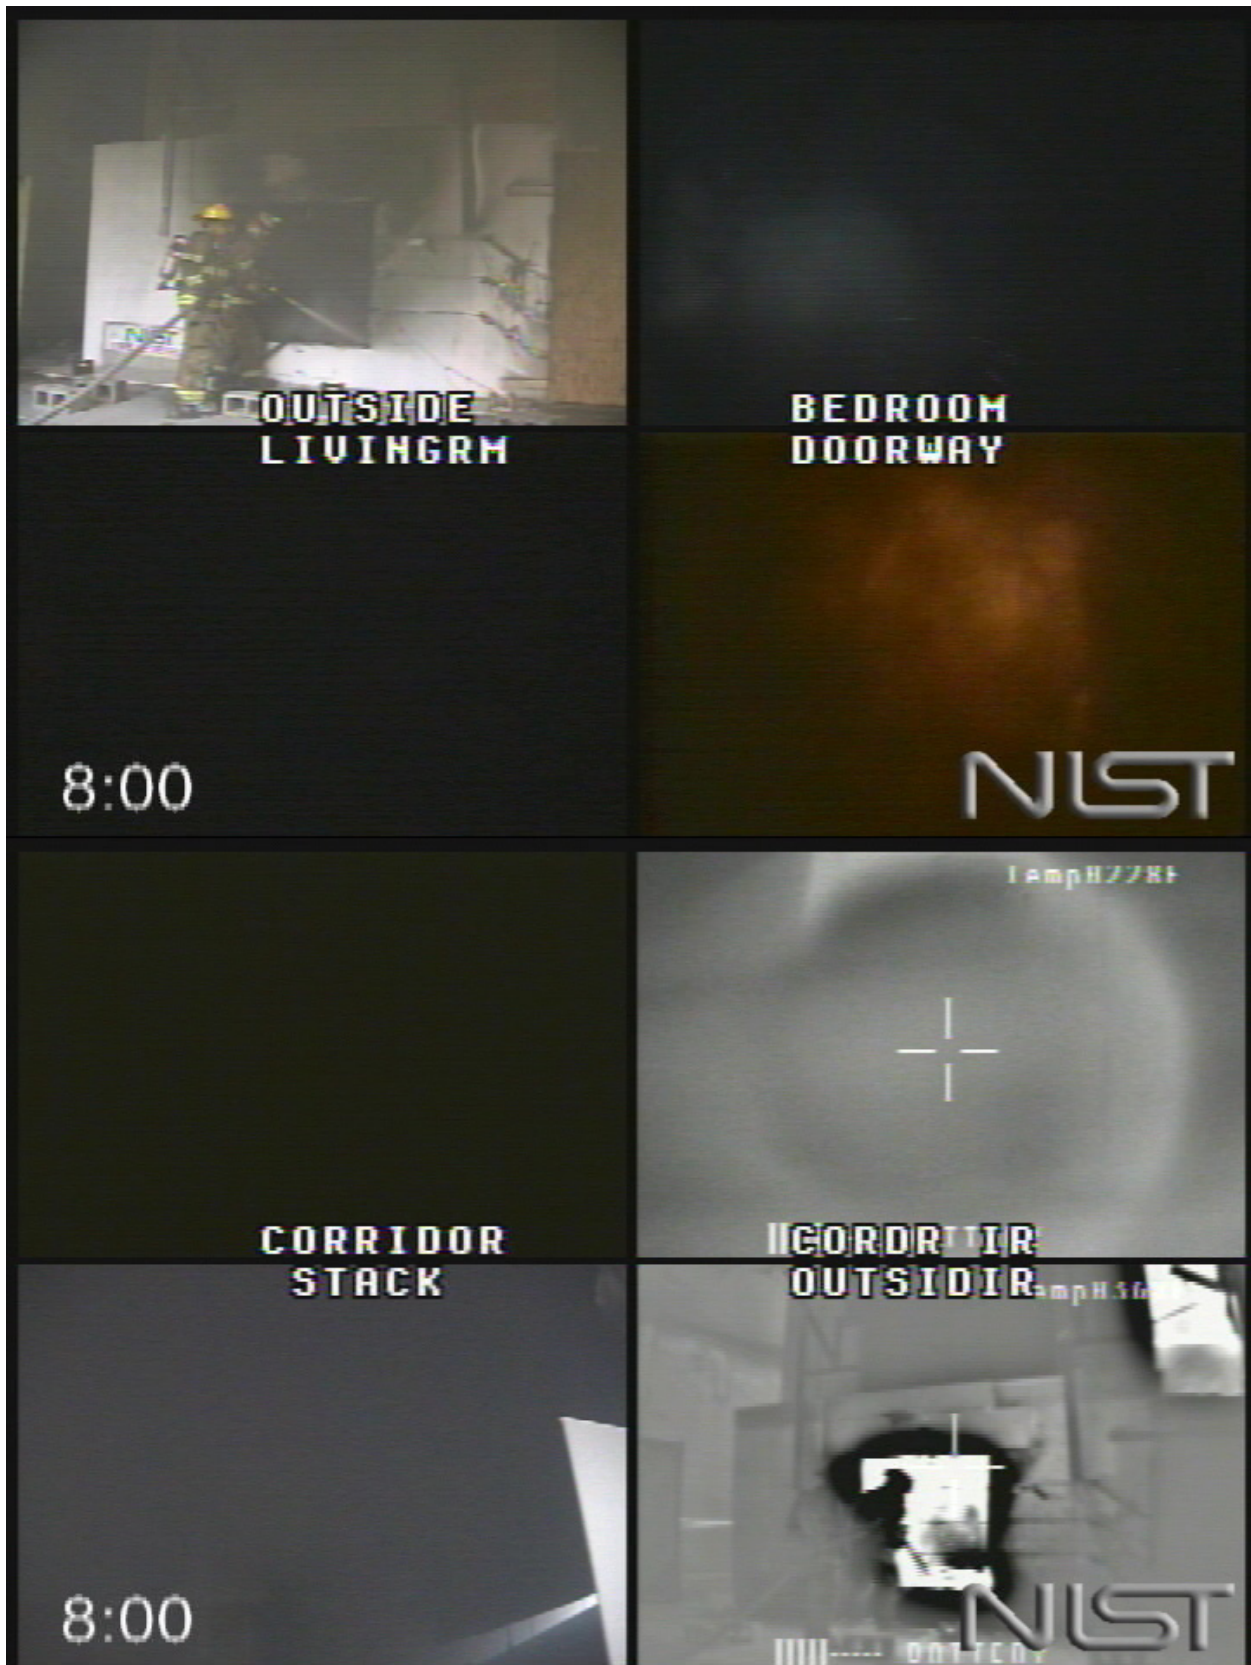
Figure 5.8.1-14. Experiment 8, 480 s after ignition.

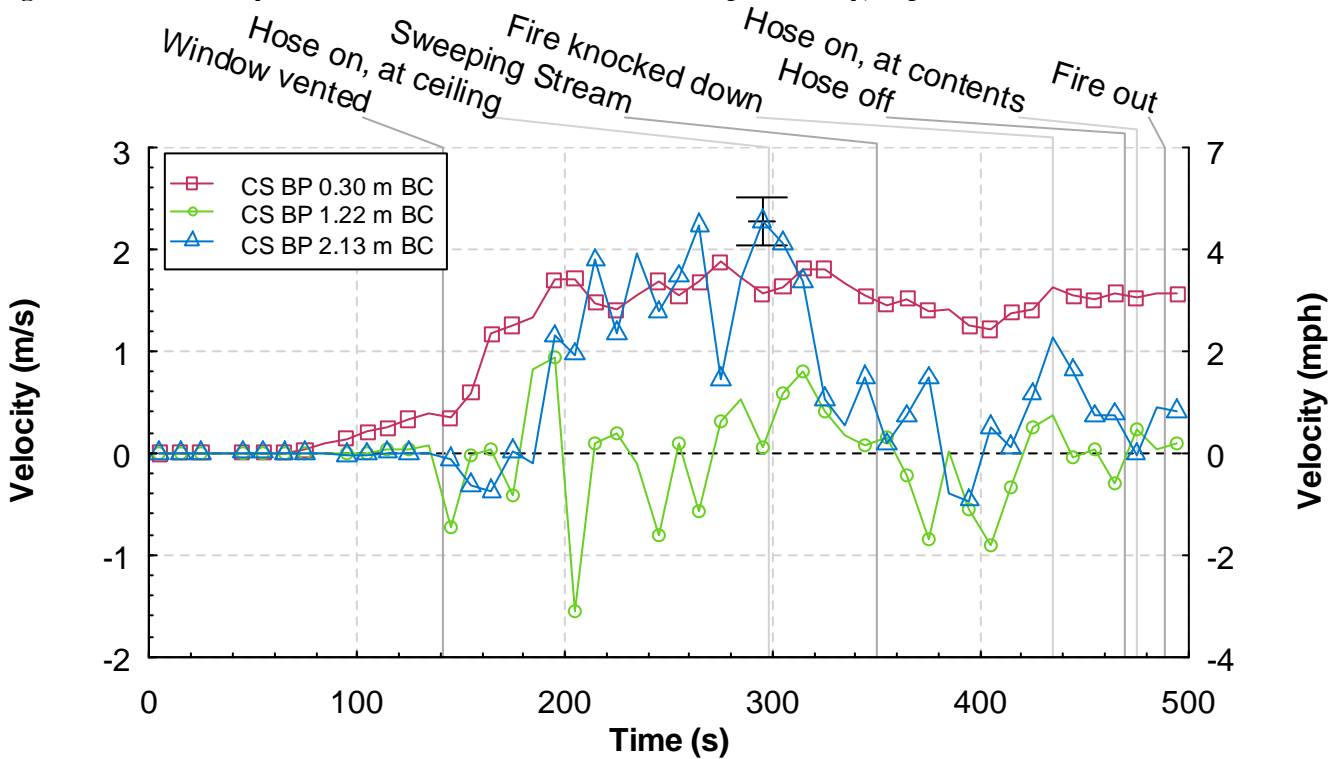
Figure 5.8.6-3. Velocity versus time from the corridor south (CS) bi-directional probe array, Experiment 8.
